Facilities Access Compliance Survey Report for the Santa Clara Valley Open Space Authority

April 2023
SSA Project # 21058

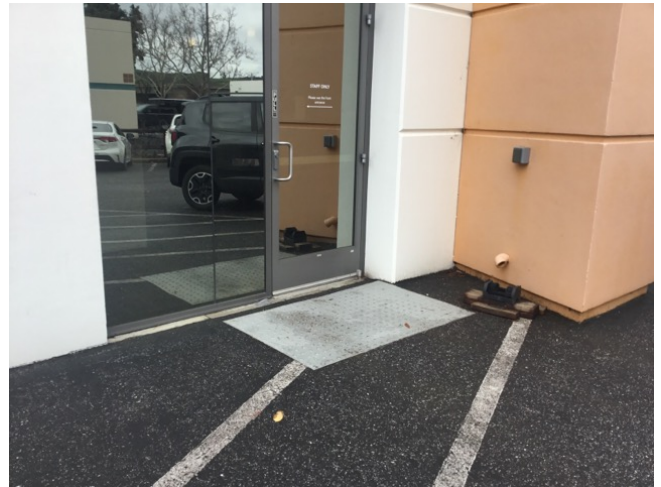
Item no., Rm no. and Name	Existing Architectural Barrier and Proposed Solution	Codes / Mitigation Info	Qty	Unit	Cost	Total
Door						
2503	<ul style="list-style-type: none"> • <i>As-Built Description:</i> Surface of required maneuvering clearance at door slopes more than 1/4":12" (2.0%). • <i>As-Built:</i> 0.2" level changes in door maneuvering clearance. Caused by detectable warnings. • <i>Proposed Solution:</i> Relocate detectable warnings outside the door maneuvering clearance. 	<p>PCODE ID11</p> <p>ADAAG 91 4.13.6</p> <p>ADA 2010 404.2.4.4</p> <p>CBC 2007 1133B.2.4</p> <p>CBC 2019 11B-404.2.4</p>	25	SF	\$120	\$3,000
						<p>Priority 1</p> <p>Severity 3</p>

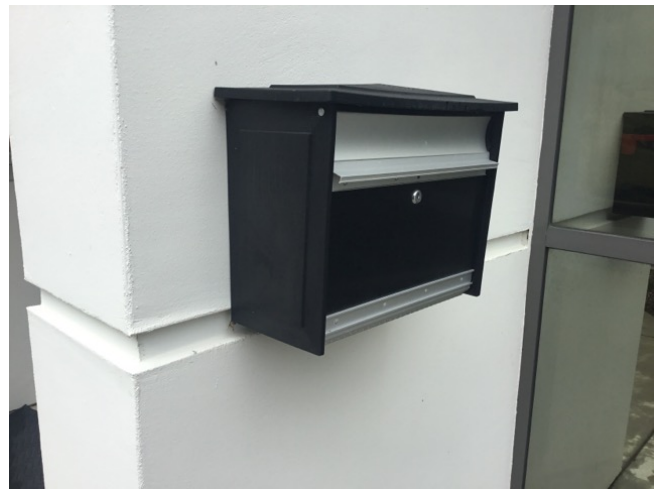
Item no., Rm no. and Name	Existing Architectural Barrier and Proposed Solution	Codes / Mitigation Info	Qty	Unit	Cost	Total
Protrusion Limits						
2502	<ul style="list-style-type: none"> As-Built Description: Protruding objects more than 4" from wall, when bottom of object more than 27" or less than 80" above finished floor. As-Built: 8.5" at 61" AFF Proposed Solution: Add cane detection. 	PCODE EG04 ADAAG 91 4.4.1 ADA 2010 307.2 CBC 2007 1133B.8.6.1 CBC 2019 11B-307.2	1	JOB	\$300	\$300
					Priority	1
					Severity	1

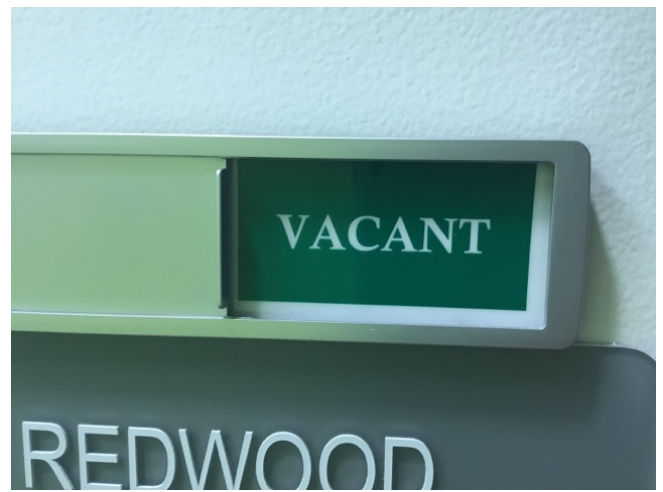
Item no., Rm no. and Name	Existing Architectural Barrier and Proposed Solution	Codes / Mitigation Info	Qty	Unit	Cost	Total
Signage						
2471	<ul style="list-style-type: none"> As-Built Description: Sign characters not readable because they are not sized for viewing distance. As-Built: 3/8" high characters. Proposed Solution: Provide compliant signage. 	PCODE SA02A ADAAG 91 4.30.3 ADA 2010 703.5.5 CBC 2007 1117B.5.4 CBC 2019 11B-306.1 & 11B-902.3	1	JOB	\$270	\$270
					Priority	1
					Severity	3

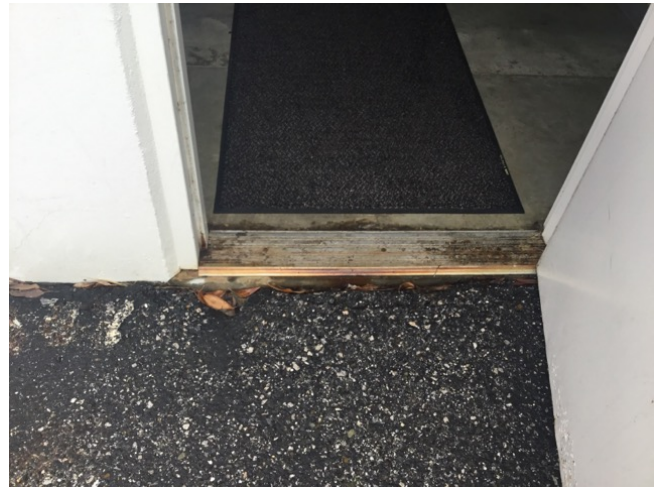
Item no., Rm no. and Name	Existing Architectural Barrier and Proposed Solution	Codes / Mitigation Info	Qty	Unit	Cost	Total
Door Threshold						
2498	<ul style="list-style-type: none"> As-Built Description: Door inaccessible due to threshold or step at door exceeding 1/2". As-Built: 3" Proposed Solution: Repair the surface. 	PCODE ID02A ADAAG 91 4.13.8 ADA 2010 404.2.5 CBC 2007 1133B.2.4.1 CBC 2019 11B-404.2.5	1	JOB	\$1,200	\$1,200
					Priority	1
					Severity	1

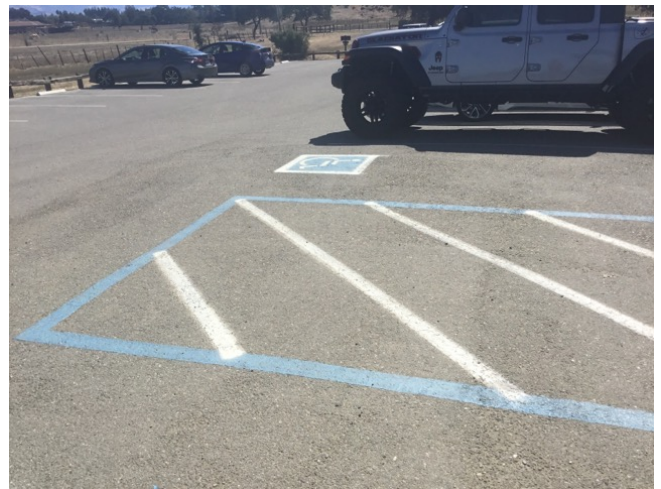
Item no., Rm no. and Name	Existing Architectural Barrier and Proposed Solution	Codes / Mitigation Info	Qty	Unit	Cost	Total
Floor or Ground Surfaces						
2279	<ul style="list-style-type: none"> As-Built Description: Accessible parking space has slope greater than 1/4":12" (2%). As-Built: To 9% Proposed Solution: Modify slope at accessible parking space. 	PCODE EA05 ADAAG 91 4.6.3 ADA 2010 502.4 CBC 2007 1129B.3.3 CBC 2019 11B-502.4	15	SF	\$36	\$540
					Priority	3
					Severity	2

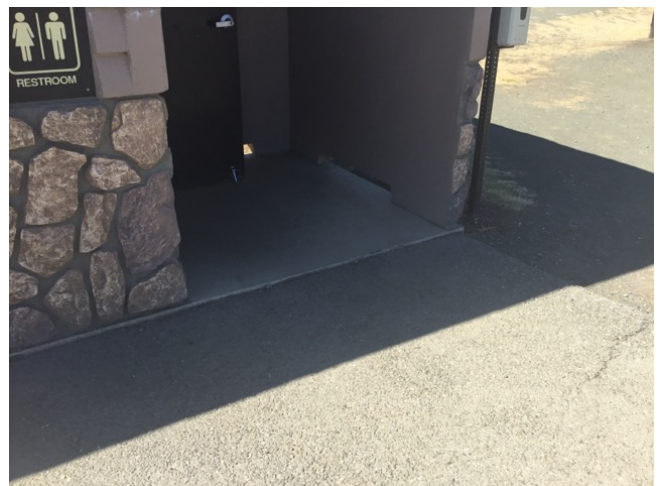
2282	<ul style="list-style-type: none"> • <i>As-Built Description:</i> Walk: Pavement dislocation creates abrupt change in level exceeding 1/2" in accessible route. • <i>As-Built:</i> 1" • <i>Proposed Solution:</i> Remove, replace or repair area of pavement sufficient to correct abrupt change in level. 	PCODE EF03 ADAAG 91 4.3.8 ADA 2010 403.4 CBC 2007 1133B.7.4 CBC 2019 11B-403.4	40	SF	\$63	\$2,520
------	--	--	----	----	------	---------

Priority 2
Severity 1

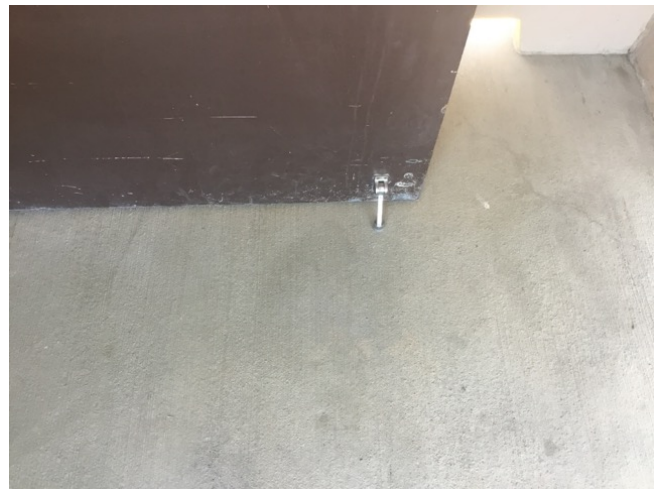
Item no., Rm no. and Name	Existing Architectural Barrier and Proposed Solution	Codes / Mitigation Info	Qty	Unit	Cost	Total
Reach Range						
2284	<ul style="list-style-type: none"> As-Built Description: Reach height to control or access point, where side approach is available, exceeds 48" or is less than 15" in height, or exceeds 10" in depth. As-Built: 5" Proposed Solution: Relocate door stop. 	PCODE IE02 ADAAG 91 4.2.6 ADA 2010 308.3.1 CBC 2007 1118B.6 CBC 2019 11B-308.3	1	JOB	\$300	\$300
					Priority	2
					Severity	3

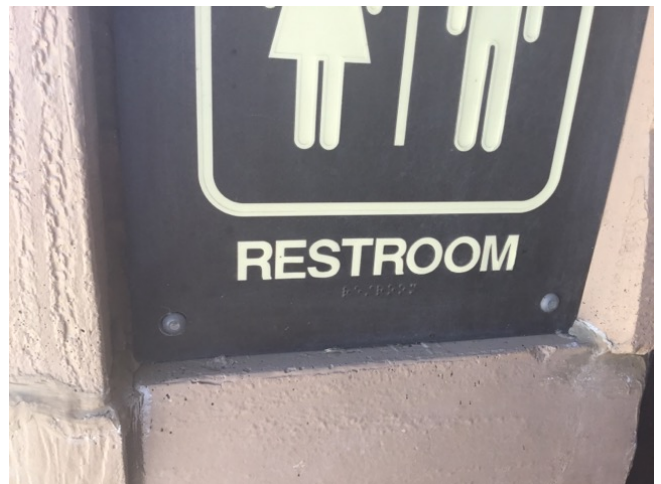
Signage						
2283	<ul style="list-style-type: none"> As-Built Description: Entrance to toilet or bathing facility not identified with ADAAG compliant signage. As-Built: Braille.25" from tactile characters. Braille and dots are nearly touching each other. Proposed Solution: Provide ADA compliant sign mounted at 48" min. above to baseline of the lowest Braille cells and 60" max. to baseline of the highest line of raised characters on nearest adjacent wall, on latch side of a single door (located not to cause a Braille reader to stand within the door swing). 	PCODE SA11A ADAAG 91 4.1.3(16)(a) ADA 2010 216.8 CBC 2019 11B-216.8	1	JOB	\$270	\$270
					Priority	2
					Severity	3

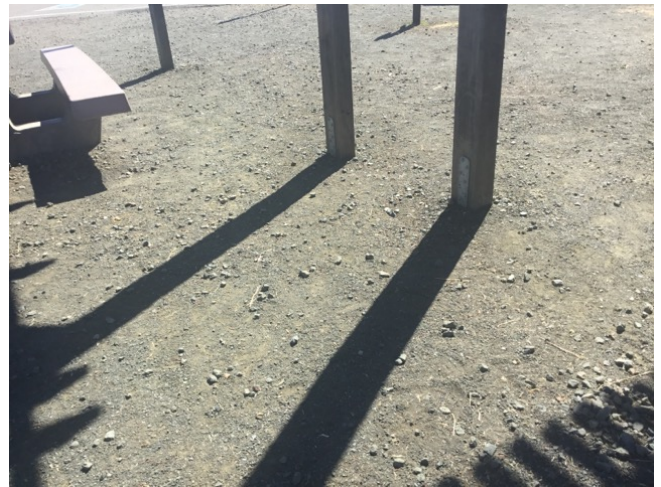
Item no., Rm no. and Name	Existing Architectural Barrier and Proposed Solution	Codes / Mitigation Info	Qty	Unit	Cost	Total
2292	<ul style="list-style-type: none"> As-Built Description: Walk: Pavement dislocation creates abrupt change in level exceeding 1/2" in accessible route. As-Built: To 1" caused by large aggregate. Proposed Solution: Install smaller aggregate. 	PCODE EF03 ADAAG 91 4.3.8 ADA 2010 403.4 CBC 2007 1133B.7.4 CBC 2019 11B-403.4	1	JOB	\$6,000	\$6,000
						Priority 1 Severity 1

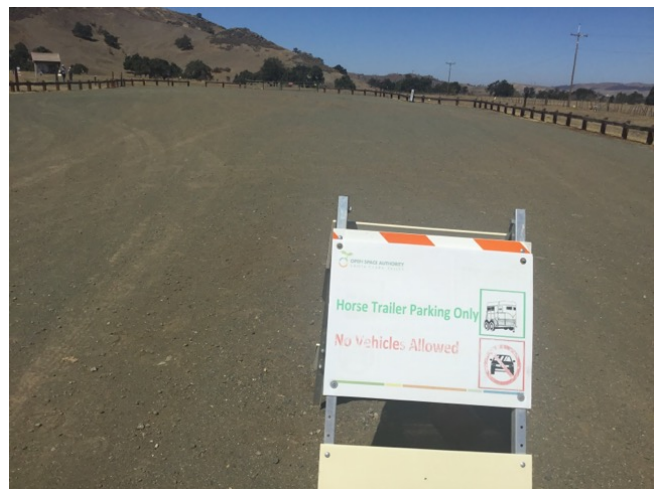
Item no., Rm no. and Name	Existing Architectural Barrier and Proposed Solution	Codes / Mitigation Info	Qty	Unit	Cost	Total
Minimum Number						
2295	<ul style="list-style-type: none"> • <i>As-Built Description:</i> At parking lot with 1-25 spaces, the number of accessible spaces is less than required by code; 1 space required • <i>Proposed Solution:</i> Provide required accessible parking space with sign including a minimum of one van space. 	PCODE EA01A ADAAG 91 4.1.2(5) ADA 2010 208.2 CBC 2007 Tbl. 11B-6 CBC 2019 11B-208.2 Tbl. 11B-208.2	1	JOB	\$9,000	\$9,000
					Priority	3
					Severity	3

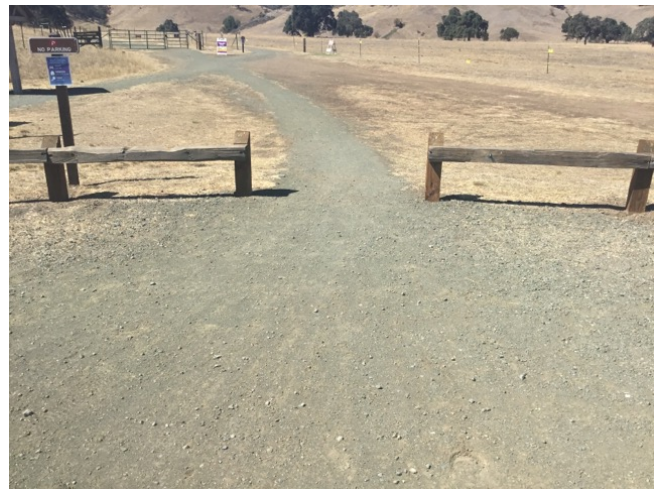
Item no., Rm no. and Name	Existing Architectural Barrier and Proposed Solution	Codes / Mitigation Info	Qty	Unit	Cost	Total
Walk						
2297	<ul style="list-style-type: none"> As-Built Description: Walk: Slope greater than 1:20 (5.0%), and walk does not comply with requirements for ramps. As-Built: 10.5% Proposed Solution: Grade surface. 	PCODE EF01 ADAAG 91 4.3.7 ADA 2010 403.3 CBC 2007 1133B.7.3 CBC 2019 11B-403.3	20	SF	\$75	\$1,500
					Priority	1
					Severity	3

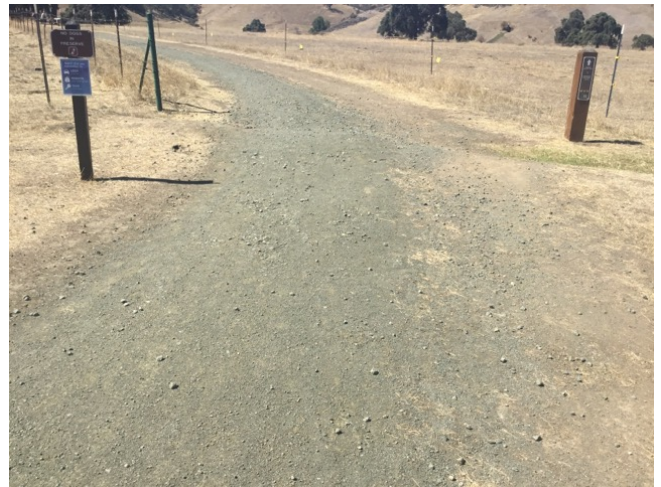
Item no., Rm no. and Name	Existing Architectural Barrier and Proposed Solution	Codes / Mitigation Info	Qty	Unit	Cost	Total
2302	<ul style="list-style-type: none"> As-Built Description: Walk: Pavement dislocation creates abrupt change in level exceeding 1/2" in accessible route. As-Built: To 1" caused by aggregate. Proposed Solution: Install smaller aggregate. Notes: A section approximately 500 feet from the trailhead has 3" aggregate. 	PCODE EF03REF ADAAG 91 4.3.8 ADA 2010 403.4 CBC 2007 1133B.7.4 CBC 2019 11B-403.4		REF		
						Priority 1
						Severity 1

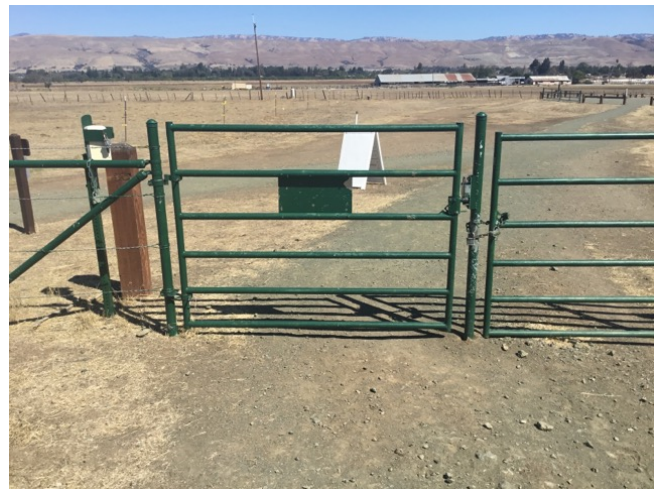
Item no., Rm no. and Name	Existing Architectural Barrier and Proposed Solution	Codes / Mitigation Info	Qty	Unit	Cost	Total
Door						
2309	<ul style="list-style-type: none"> <i>As-Built Description:</i> At push side of door on accessible route, bottom 10" does not have a smooth, uninterrupted surface. <i>Proposed Solution:</i> Provide 10" min. "kick plate" covering width of door when altering area. 	PCODE ID06 ADA 2010 404.2.10 CBC 2007 1133B.2.6 CBC 2019 11B-404.2.10	2	JOB	\$300	\$600
					Priority	1
					Severity	3

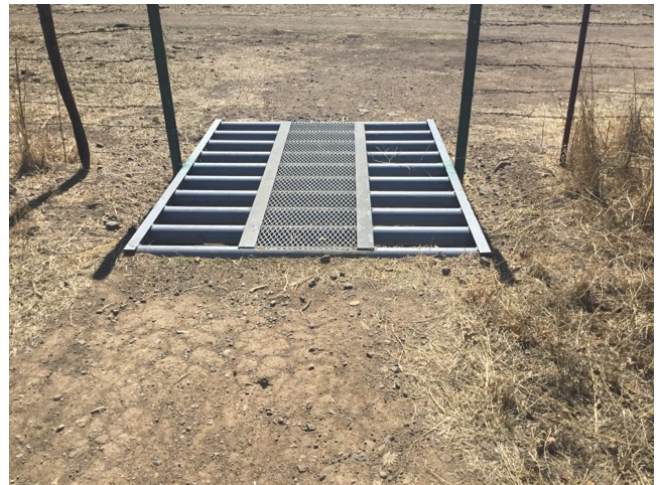
Item no., Rm no. and Name	Existing Architectural Barrier and Proposed Solution	Codes / Mitigation Info	Qty	Unit	Cost	Total
2306	<ul style="list-style-type: none"> As-Built Description: Walk: Grating has grid openings greater than 1/2" along the line of traffic flow. As-Built: 5" Proposed Solution: Replace grates. Install gates at cattle guards. 	<p>PCODE EF04</p> <p>ADAAG 91 4.3.6; 4.5.4</p> <p>ADA 2010 403.2; 302.3</p> <p>CBC 2007 1133B.7.2</p> <p>CBC 2019 11B-403.2; 11B-302.3</p>	2	JOB	\$4,500	\$9,000
						Priority 1
						Severity 3

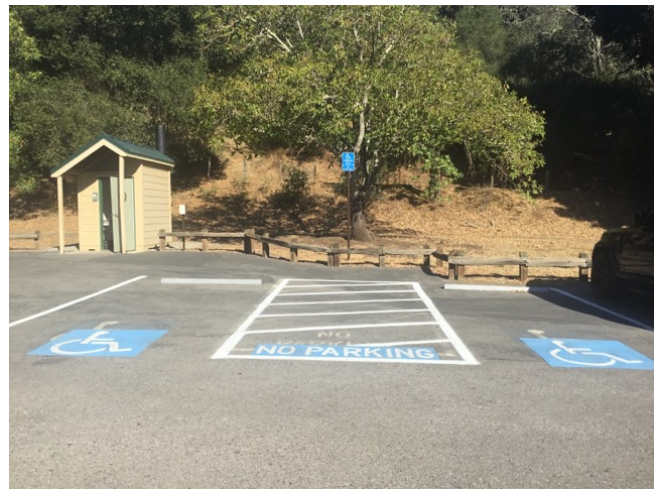
Item no., Rm no. and Name	Existing Architectural Barrier and Proposed Solution	Codes / Mitigation Info	Qty	Unit	Cost	Total
Identification						
2312	<ul style="list-style-type: none"> • <i>As-Built Description:</i> Sign for accessible parking space is missing or non-compliant. • <i>Proposed Solution:</i> Provide compliant parking signage. • <i>Notes:</i> Signs should be placed at the head of each space. 	PCODE EA04B ADAAG 91 4.6.4 ADA 2010 502.6 CBC 2007 1129B.4 CBC 2019 11B-502.6	2	JOB	\$945	\$1,890
						Priority 3
						Severity 3

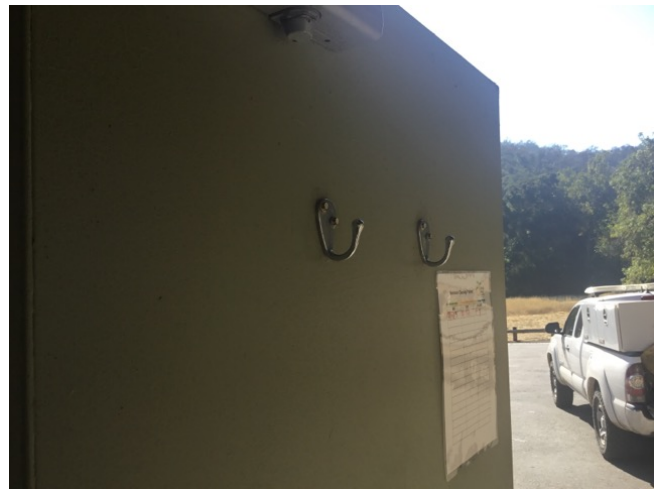
Item no., Rm no. and Name	Existing Architectural Barrier and Proposed Solution	Codes / Mitigation Info	Qty	Unit	Cost	Total
Coat Hook						
2322	<ul style="list-style-type: none"> As-Built Description: Accessible coat hook not within reach range. As-Built: 68" Proposed Solution: Adjust existing or provide new coat hook at maximum 48" height. 	PCODE WG03A ADAAG 91 4.2.5 ADA 2010 603.4 CBC 2007 1118B.5 CBC 2019 11B-603.4	1	JOB	\$150	\$150
					Priority	2
					Severity	3

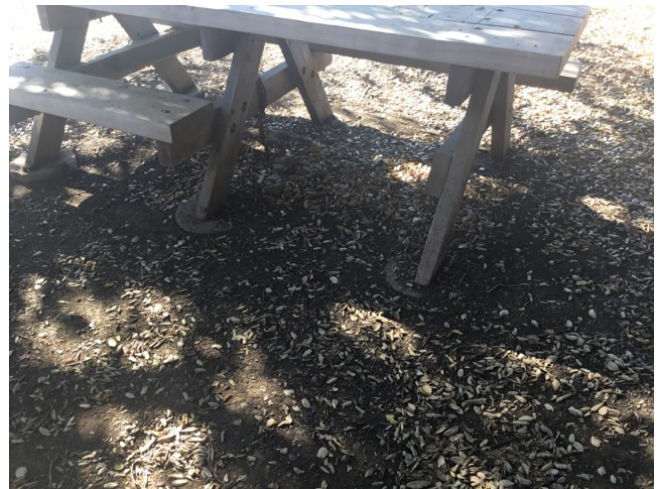
Item no., Rm no. and Name	Existing Architectural Barrier and Proposed Solution	Codes / Mitigation Info	Qty	Unit	Cost	Total
Clear floor space						
2331	<ul style="list-style-type: none"> As-Built Description: Clear space has slopes greater than 1:48. As-Built: 4% Proposed Solution: Modify surface. 	PCODE NI07 ADAAG 91 16.6.6 ADA 2010 305.2 CBC 2007 1132B.1 CBC 2019 11B-305.2	1	JOB		
					Priority	1
					Severity	3

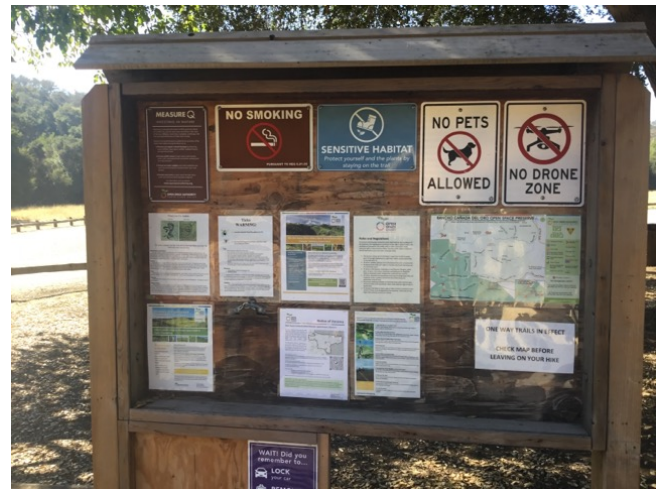
Item no., Rm no. and Name	Existing Architectural Barrier and Proposed Solution	Codes / Mitigation Info	Qty	Unit	Cost	Total
Signage						
2333	<ul style="list-style-type: none"> As-Built Description: Sign characters not readable because they are not sized for viewing distance. As-Built: 1/8" characters. Proposed Solution: Provide compliant signage. 	PCODE SA02A ADAAG 91 4.30.3 ADA 2010 703.5.5 CBC 2007 1117B.5.4 CBC 2019 11B-403.3	1	JOB	\$4,500	\$4,500
					Priority	1
					Severity	3

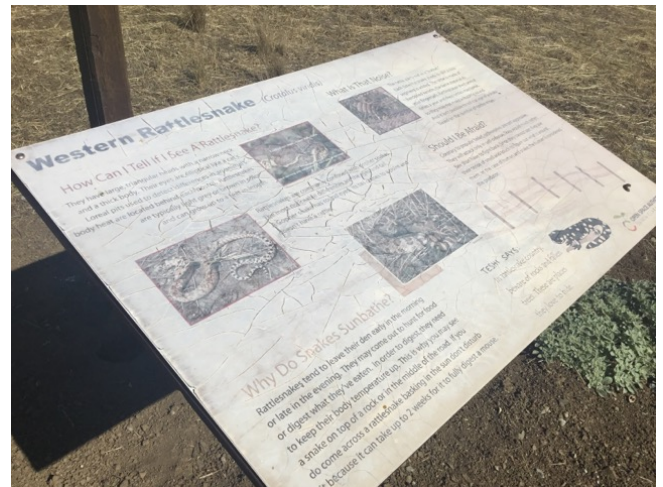
Item no., Rm no. and Name	Existing Architectural Barrier and Proposed Solution	Codes / Mitigation Info	Qty	Unit	Cost	Total
Signage						
2336	<ul style="list-style-type: none"> As-Built Description: Sign characters not readable because they are not sized for viewing distance. As-Built: 3/8" characters Proposed Solution: Provide compliant signage. 	PCODE SA02A ADAAG 91 4.30.3 ADA 2010 703.5.5 CBC 2007 1117B.5.4 CBC 2019 11B-403.3	1	JOB	\$2,400	\$2,400
					Priority	1
					Severity	3

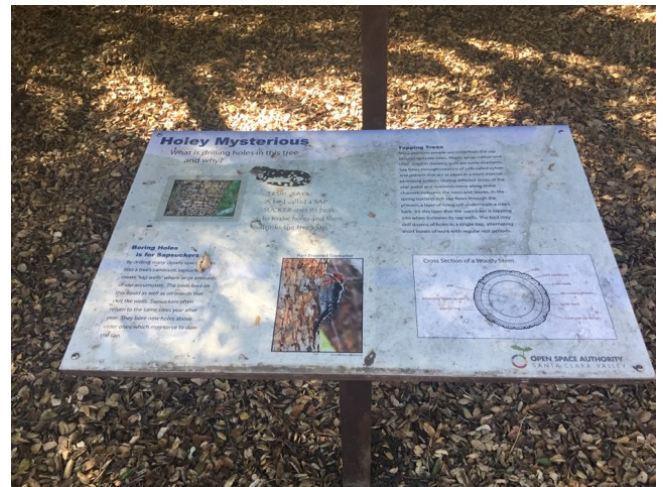
Item no., Rm no. and Name	Existing Architectural Barrier and Proposed Solution	Codes / Mitigation Info	Qty	Unit	Cost	Total
Signage						
2338	<ul style="list-style-type: none"> As-Built Description: Sign characters not readable because they are not sized for viewing distance. As-Built: 3/8" characters Proposed Solution: Provide compliant signage. 	PCODE SA02A ADAAG 91 4.30.3 ADA 2010 703.5.5 CBC 2007 1117B.5.4 CBC 2019 11B-403.3	2	JOB	\$2,400	\$4,800
					Priority	1
					Severity	3

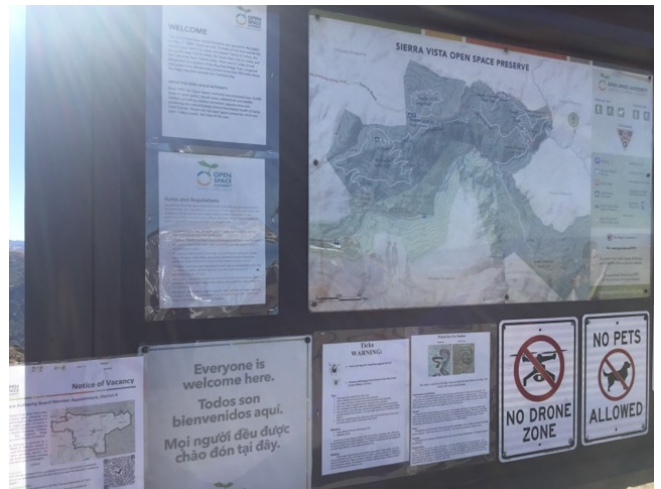
Item no., Rm no. and Name	Existing Architectural Barrier and Proposed Solution	Codes / Mitigation Info	Qty	Unit	Cost	Total
Signage						
2268	<ul style="list-style-type: none"> As-Built Description: Sign characters not readable because they are not sized for viewing distance. As-Built: 1/8"-3/8" characters on informational signs. Proposed Solution: Provide compliant signage. Notes: Includes warning signs and other information re history etc. 	PCODE SA02A ADAAG 91 4.30.3 ADA 2010 703.5.5 CBC 2007 1117B.5.4 CBC 2019 11B-402.2	1	JOB	\$6,000	\$6,000
						Priority 1 Severity 3

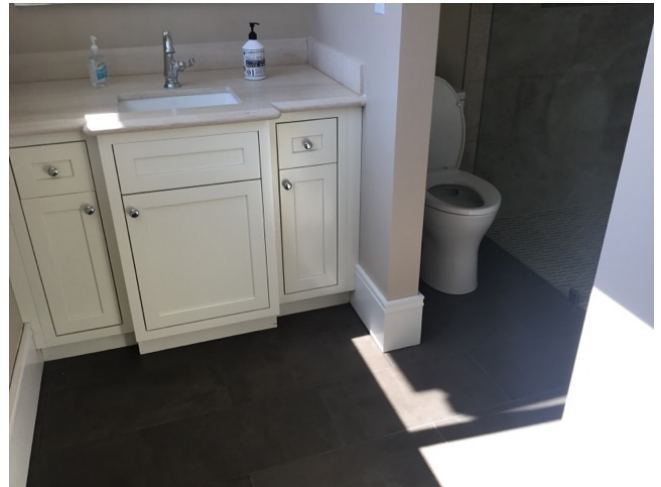
Item no., Rm no. and Name	Existing Architectural Barrier and Proposed Solution	Codes / Mitigation Info	Qty	Unit	Cost	Total
Restroom						
2383	<ul style="list-style-type: none"> • <i>As-Built Description:</i> Single accommodation restroom not accessible; multiple compliance violations. • <i>Proposed Solution:</i> Remodel area to provide single-occupant accessible restroom. 	PCODE WA01 ADAAG 91 4.22 ADA 2010 603.1 CBC 2007 1115B.3.2 CBC 2019 11B-603.1	1	JOB	\$90,000	\$90,000
					Priority	2
					Severity	3

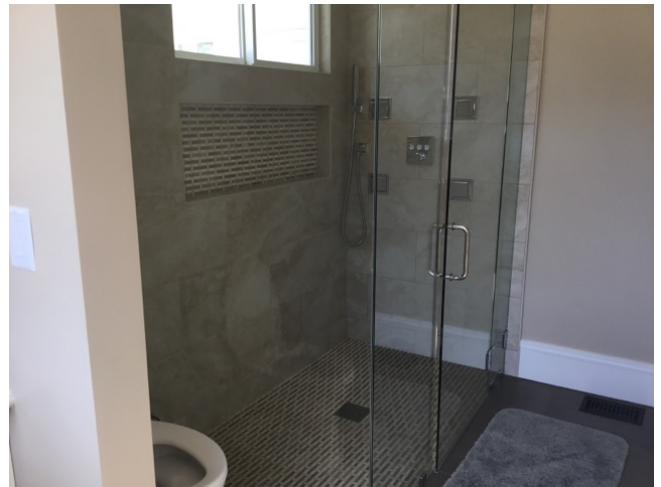
Item no., Rm no. and Name	Existing Architectural Barrier and Proposed Solution	Codes / Mitigation Info	Qty	Unit	Cost	Total
Shower						
2384	<ul style="list-style-type: none"> • <i>As-Built Description:</i> Shower not accessible; multiple compliance violations. • <i>Proposed Solution:</i> Provide accessible shower. 	PCODE WF01REF ADAAG 91 4.21 ADA 2010 608.1 CBC 2019 11B-608.1			REF	
					Priority	2
					Severity	3

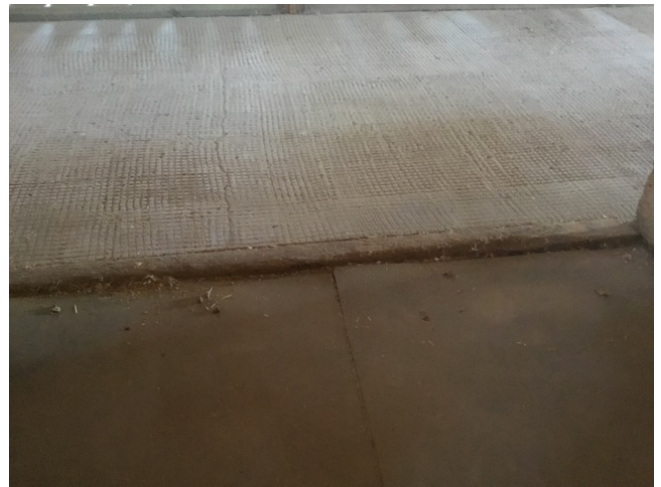
Item no., Rm no. and Name	Existing Architectural Barrier and Proposed Solution	Codes / Mitigation Info	Qty	Unit	Cost	Total
2428	<ul style="list-style-type: none"> • <i>As-Built Description:</i> Walk: Pavement dislocation creates abrupt change in level exceeding 1/2" in accessible route. • <i>As-Built:</i> 2" • <i>Proposed Solution:</i> Remove, replace or repair area of pavement sufficient to correct abrupt change in level. 	PCODE EF03 ADAAG 91 4.3.8 ADA 2010 403.4 CBC 2007 1133B.7.4 CBC 2019 11B-403.4	40	SF	\$63	\$2,520
						Priority 1 Severity 3

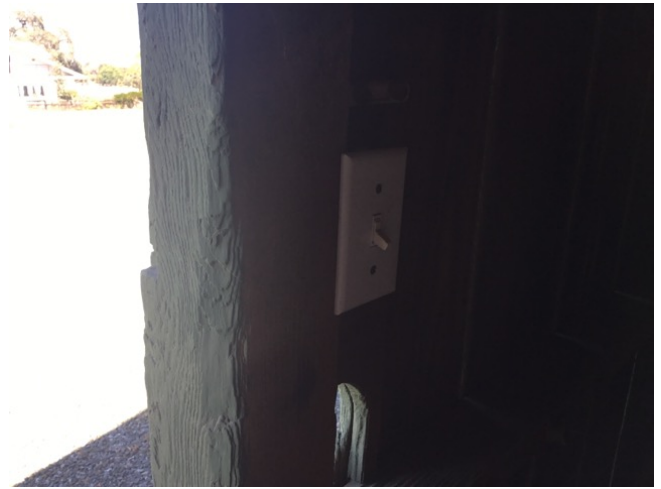
2429	<ul style="list-style-type: none"> • <i>As-Built Description:</i> Electric switch or control mounted less than 15" measured to the bottom of the outlet box or greater than 48 inches measured to the top of the outlet box. • <i>As-Built:</i> 54" • <i>Proposed Solution:</i> Relocate light switches or control to between 15" and 48" height. • <i>Notes:</i> 11B-203.12 Animal containment areas Recommendation. 	<p>PCODE IC01</p> <p>ADAAG 91 4.2.5 & 6</p> <p>ADA 2010 308.2.1 &</p> <p>CBC 2007 1117B.6.3</p> <p>CBC 2019 11B-308.2.1 & 11B-308.2.2</p>	1	JOB	\$900	\$900
						<p>Priority 3</p> <p>Severity 3</p>
