Facilities Access Compliance Survey Report for the Santa Clara Valley Open Space Authority

Santa Clara Valley Open Space Access Compliance Survey Report

Santa Clara Valley
April 2023
SSA Project #: 21058

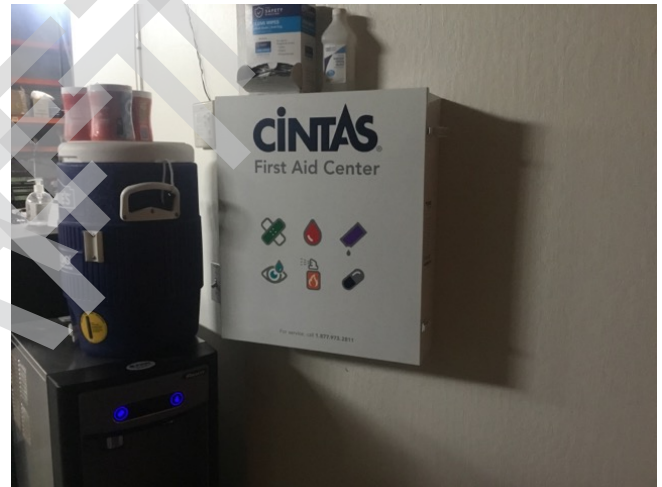
²⁴⁶² **3** • *As-Built Description:*
 Protruding objects more than 4" from wall, when bottom of object more than 27" or less than 80" above finished floor.

4 • *As-Built:* **5.75" at 43" AFF**

6 • *Notes:*
Ensure all items in the first aid kit remain a minimum of 15 inches AFF. The top latch is 62 inches AFF.

5 • *Proposed Solution:*
 Lower first aid kit so The bottom edge is below 27 inches AFF and the top latch is below 48 inches AFF.

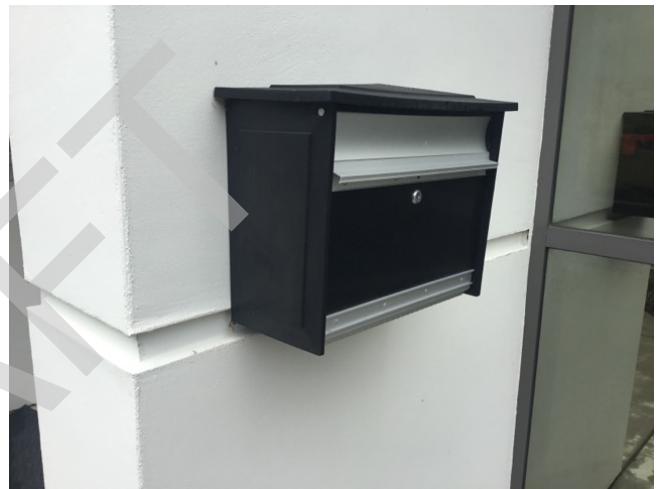
Item no., Rm no. and Name	Existing Architectural Barrier and Proposed Solution	Codes / Mitigation Info	Qty	Unit	Cost	Total
Protrusion Limits						
2502	<ul style="list-style-type: none"> As-Built Description: Protruding objects more than 4" from wall, when bottom of object more than 27" or less than 80" above finished floor. As-Built: 8.5" at 61" AFF Proposed Solution: Add cane detection. 	PCODE EG04 ADAAG 91 4.4.1 ADA 2010 307.2 CBC 2007 1133B.8.6.1 CBC 2019 11B-307.2	1	JOB	\$300	\$300
						Priority 1 Severity 1

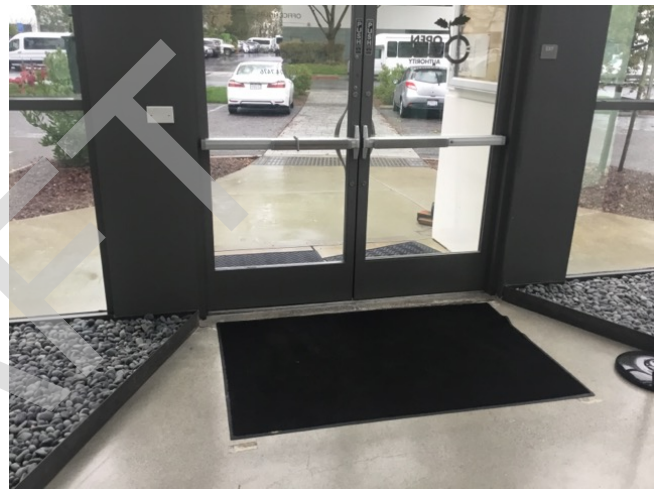
Item no., Rm no. and Name	Existing Architectural Barrier and Proposed Solution	Codes / Mitigation Info	Qty	Unit	Cost	Total
Door Threshold						
2436	<ul style="list-style-type: none"> As-Built Description: Door inaccessible due to threshold or step at door exceeding 1/2". .62" Proposed Solution: Modify threshold. 	PCODE ID02A ADAAG 91 4.13.8 ADA 2010 404.2.5 CBC 2007 1133B.2.4.1 CBC 2019 11B-404.2.5	1	JOB	\$1,200	\$1,200
					Priority	1
					Severity	1

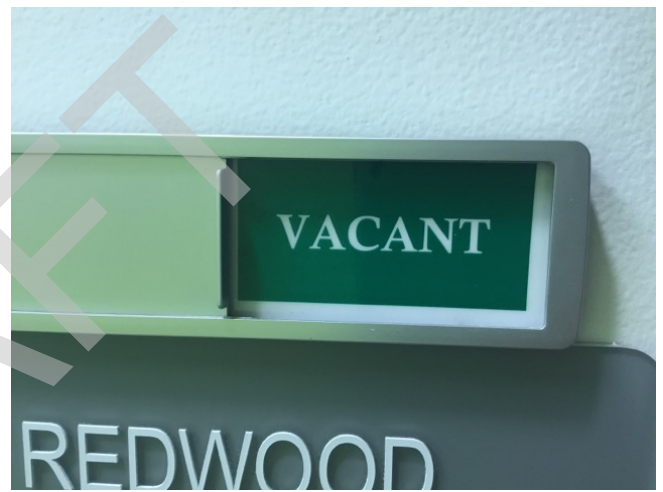
Item no., Rm no. and Name	Existing Architectural Barrier and Proposed Solution	Codes / Mitigation Info	Qty	Unit	Cost	Total
Signage						
2471	<ul style="list-style-type: none"> As-Built Description: Sign characters not readable because they are not sized for viewing distance. As-Built: 3/8" high characters. Proposed Solution: Provide compliant signage. 	PCODE SA02A ADAAG 91 4.30.3 ADA 2010 703.5.5 CBC 2007 1117B.5.4 CBC 2019 11B-306.1 & 11B-902.3	1	JOB	\$270	\$270
					Priority	1
					Severity	3

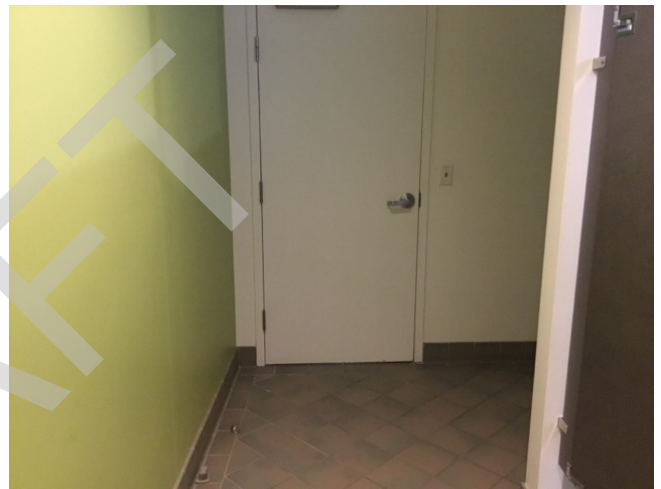
Item no., Rm no. and Name	Existing Architectural Barrier and Proposed Solution	Codes / Mitigation Info	Qty	Unit	Cost	Total
Door Swing						
2477	<ul style="list-style-type: none"> As-Built Description: Front approach: At pull side, door does not have clear and level maneuvering space measuring door width plus 18" x 60". (24" x 60" at exterior doors). As-Built: 54" Proposed Solution: Change door swing. 	PCODE ID23 ADAAG 91 Fig. 25(a) ADA 2010 404.2.4 CBC 2007 11B-26A(a) CBC 2019 11B-404.2.4	1	JOB	\$1,500	\$1,500
					Priority	2
					Severity	3

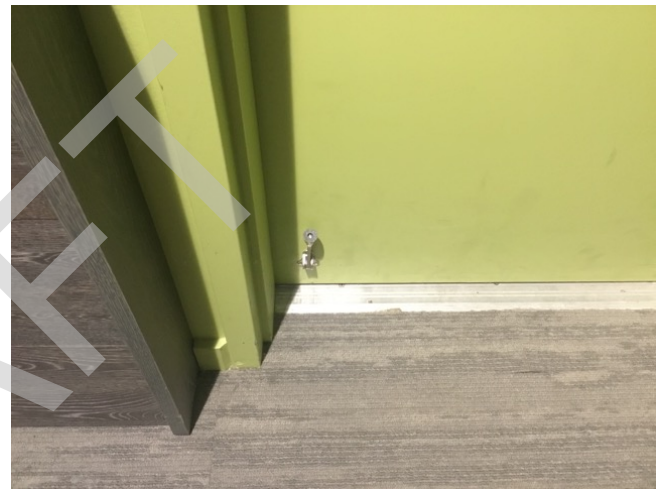
Item no., Rm no. and Name	Existing Architectural Barrier and Proposed Solution	Codes / Mitigation Info	Qty	Unit	Cost	Total
Reach Range						
2447	<ul style="list-style-type: none"> As-Built Description: Reach height to control or access point, where side approach is available, exceeds 48" or is less than 15" in height, or exceeds 10" in depth. As-Built: 3" AFF Proposed Solution: Modify equipment or mounting. 	PCODE IE02REF ADAAG 91 4.2.6 ADA 2010 308.3.1 CBC 2007 1118B.6 CBC 2019 11B-308.3				REF
						Priority 1 Severity 3

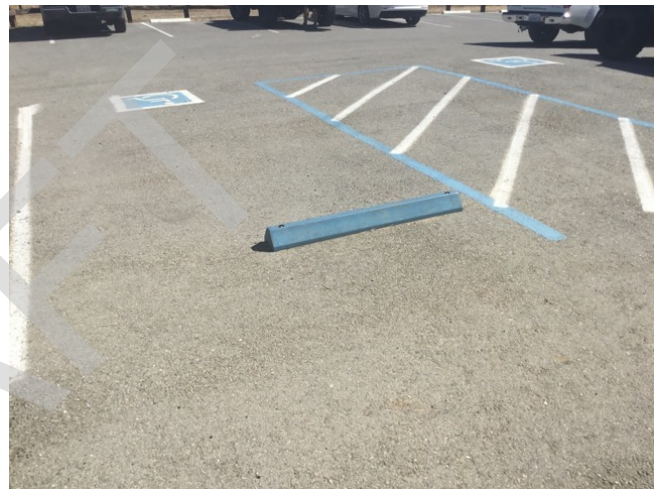
Item no., Rm no. and Name	Existing Architectural Barrier and Proposed Solution	Codes / Mitigation Info	Qty	Unit	Cost	Total
Parking						
2280	<ul style="list-style-type: none"> As-Built Description: Accessible parking space smaller than 8' wide (CA only: 9' x 18'). As-Built: 106.5"-107" wide Proposed Solution: Modify parking space(s) to create accessible space. 	PCODE EA02A ADAAG 91 4.6.3 ADA 2010 502.2 CBC 2007 1129B.3.1 CBC 2019 11B-502.2	2	JOB	\$600	\$1,200
					Priority	3
					Severity	3

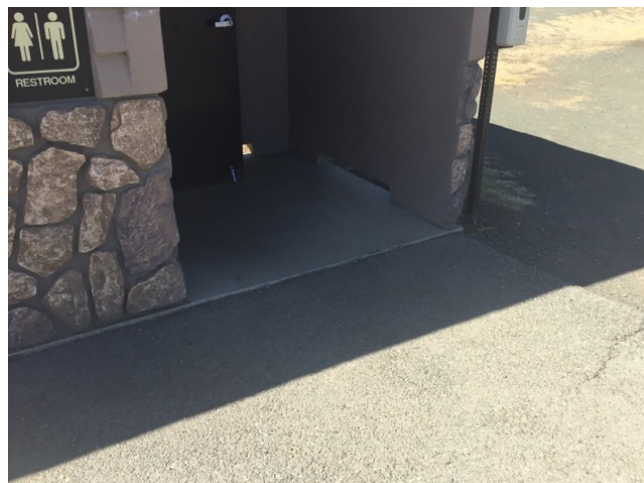
2282	<ul style="list-style-type: none"> • <i>As-Built Description:</i> Walk: Pavement dislocation creates abrupt change in level exceeding 1/2" in accessible route. • <i>As-Built:</i> 1" • <i>Proposed Solution:</i> Remove, replace or repair area of pavement sufficient to correct abrupt change in level. 	PCODE EF03 ADAAG 91 4.3.8 ADA 2010 403.4 CBC 2007 1133B.7.4 CBC 2019 11B-403.4	40	SF	\$63	\$2,520
------	--	--	----	----	------	---------

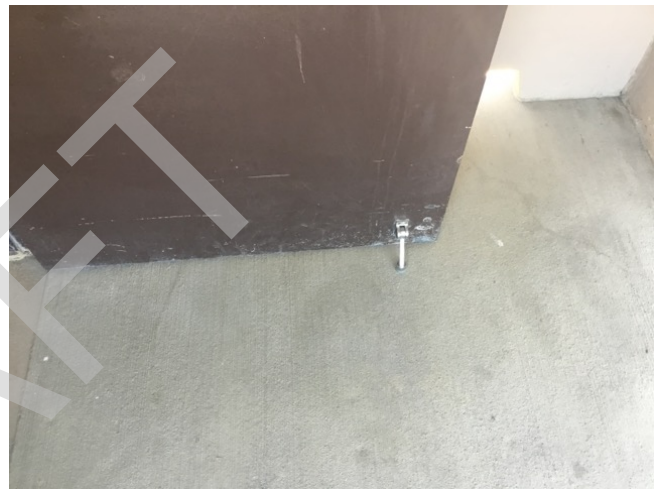
Item no., Rm no. and Name	Existing Architectural Barrier and Proposed Solution	Codes / Mitigation Info	Qty	Unit	Cost	Total
Door Stopper						
2285	<ul style="list-style-type: none"> <i>As-Built Description:</i> At push side of door on accessible route, bottom 10" does not have a smooth, uninterrupted surface. <i>Proposed Solution:</i> Remove door stopper when altering area. Provide rubber wedge. 	PCODE ID06A ADA 2010 404.2.10 CBC 2007 1133B.2.6 CBC 2019 11B-404.2.10	1	JOB	\$75	\$75
					Priority	2
					Severity	3

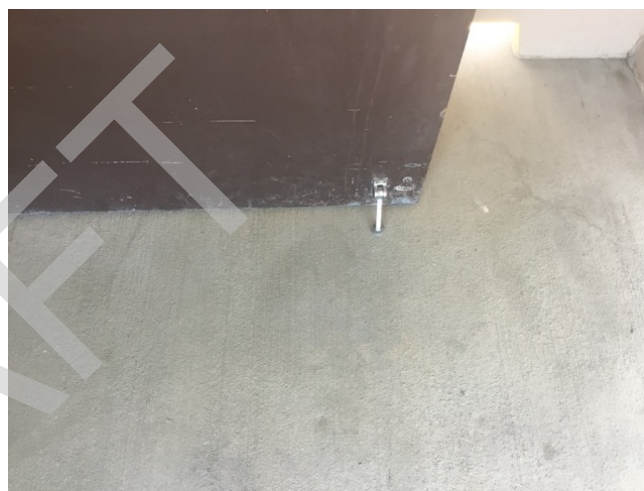
Item no., Rm no. and Name	Existing Architectural Barrier and Proposed Solution	Codes / Mitigation Info	Qty	Unit	Cost	Total
Reach Range						
2284	<ul style="list-style-type: none"> As-Built Description: Reach height to control or access point, where side approach is available, exceeds 48" or is less than 15" in height, or exceeds 10" in depth. As-Built: 5" Proposed Solution: Relocate door stop. 	PCODE IE02 ADAAG 91 4.2.6 ADA 2010 308.3.1 CBC 2007 1118B.6 CBC 2019 11B-308.3	1	JOB	\$300	\$300
					Priority	2
					Severity	3

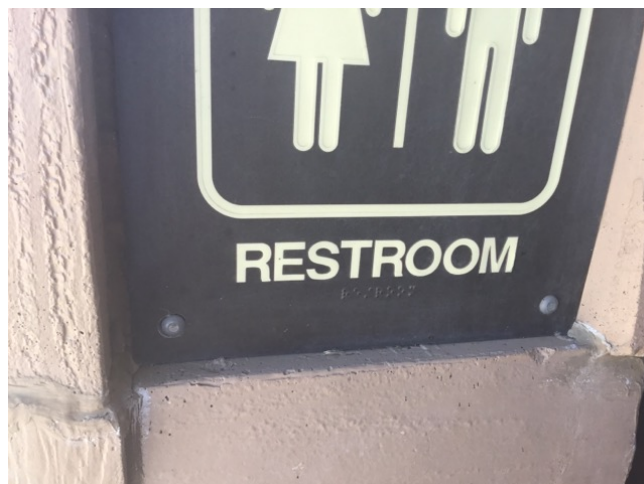
Signage						
2283	<ul style="list-style-type: none"> As-Built Description: Entrance to toilet or bathing facility not identified with ADAAG compliant signage. As-Built: Braille.25" from tactile characters. Braille and dots are nearly touching each other. Proposed Solution: Provide ADA compliant sign mounted at 48" min. above to baseline of the lowest Braille cells and 60" max. to baseline of the highest line of raised characters on nearest adjacent wall, on latch side of a single door (located not to cause a Braille reader to stand within the door swing). 	PCODE SA11A ADAAG 91 4.1.3(16)(a) ADA 2010 216.8 CBC 2019 11B-216.8	1	JOB	\$270	\$270
					Priority	2
					Severity	3

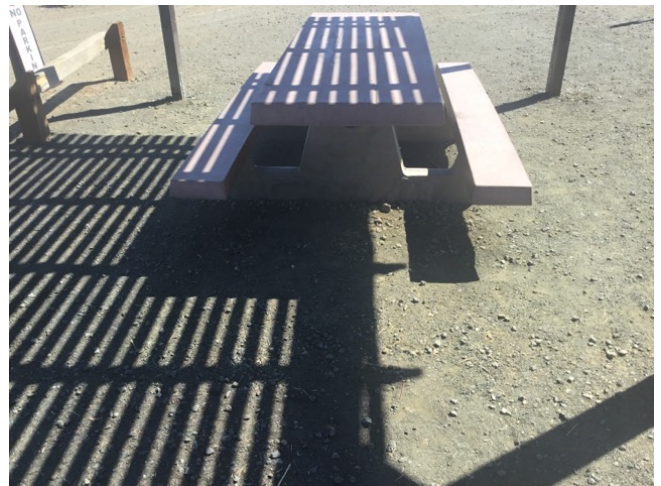
2293	<ul style="list-style-type: none"> As-Built Description: Clear space has slopes greater than 1:48. As-Built: To 10% caused by uneven surface Proposed Solution: Grade surface. 	PCODE NI07 ADAAG 91 16.6.6 ADA 2010 305.2 CBC 2007 1132B.1 CBC 2019 11B-305.2	1	JOB		
						Priority 1
						Severity 3

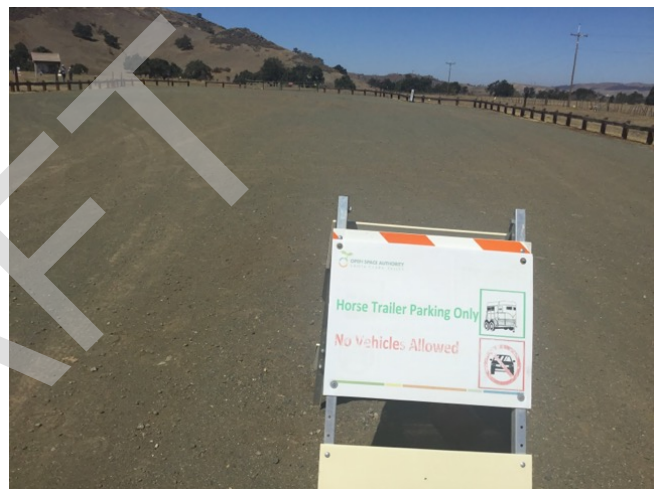
Item no., Rm no. and Name	Existing Architectural Barrier and Proposed Solution	Codes / Mitigation Info	Qty	Unit	Cost	Total
Minimum Number						
2295	<ul style="list-style-type: none"> • <i>As-Built Description:</i> At parking lot with 1-25 spaces, the number of accessible spaces is less than required by code; 1 space required • <i>Proposed Solution:</i> Provide required accessible parking space with sign including a minimum of one van space. 	PCODE EA01A ADAAG 91 4.1.2(5) ADA 2010 208.2 CBC 2007 Tbl. 11B-6 CBC 2019 11B-208.2 Tbl. 11B-208.2	1	JOB	\$9,000	\$9,000
						Priority 3 Severity 3

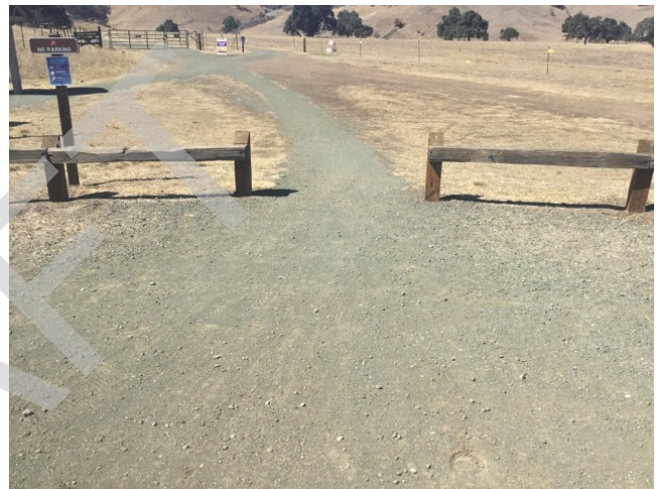
Item no., Rm no. and Name	Existing Architectural Barrier and Proposed Solution	Codes / Mitigation Info	Qty	Unit	Cost	Total
Walk						
2297	<ul style="list-style-type: none"> As-Built Description: Walk: Slope greater than 1:20 (5.0%), and walk does not comply with requirements for ramps. As-Built: 10.5% Proposed Solution: Grade surface. 	PCODE EF01 ADAAG 91 4.3.7 ADA 2010 403.3 CBC 2007 1133B.7.3 CBC 2019 11B-403.3	20	SF	\$75	\$1,500
					Priority	1
					Severity	3

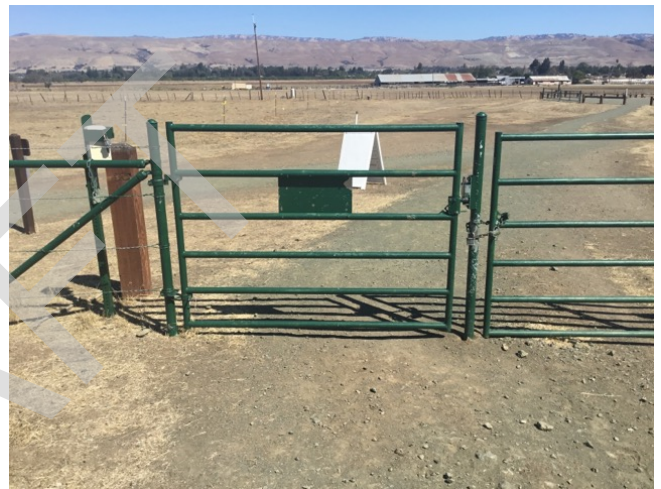
Item no., Rm no. and Name	Existing Architectural Barrier and Proposed Solution	Codes / Mitigation Info	Qty	Unit	Cost	Total
Door						
2309	<ul style="list-style-type: none"> <i>As-Built Description:</i> At push side of door on accessible route, bottom 10" does not have a smooth, uninterrupted surface. <i>Proposed Solution:</i> Provide 10" min. "kick plate" covering width of door when altering area. 	PCODE ID06 ADA 2010 404.2.10 CBC 2007 1133B.2.6 CBC 2019 11B-404.2.10	2	JOB	\$300	\$600
					Priority	1
					Severity	3

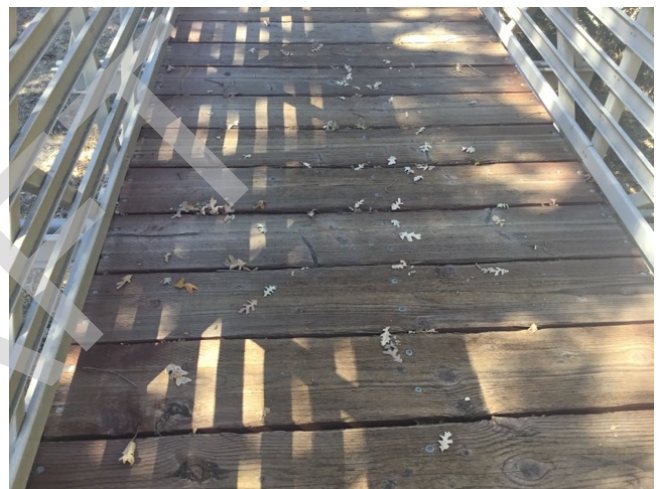
Item no., Rm no. and Name	Existing Architectural Barrier and Proposed Solution	Codes / Mitigation Info	Qty	Unit	Cost	Total
Floor or Ground Surface						
2305	<ul style="list-style-type: none"> • <i>As-Built Description:</i> Walk: Grating has grid openings greater than 1/2" along the line of traffic flow. • <i>Proposed Solution:</i> Relocate and add surface material. 	PCODE EF04 ADAAG 91 4.3.6; 4.5.4 ADA 2010 403.2; 302.3 CBC 2007 1133B.7.2 CBC 2019 11B-403.2; 11B-302.3	1	JOB	\$9,000	\$9,000
					Priority	1
					Severity	3

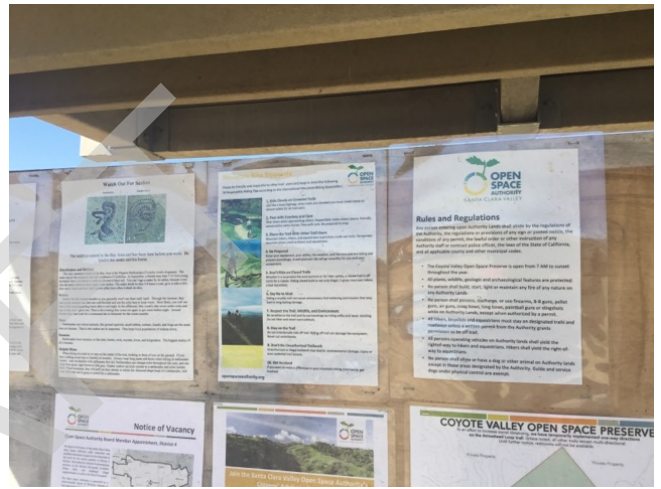
Item no., Rm no. and Name	Existing Architectural Barrier and Proposed Solution	Codes / Mitigation Info	Qty	Unit	Cost	Total
2299	<ul style="list-style-type: none"> As-Built Description: Sign characters not readable because they are not sized for viewing distance. .125" Proposed Solution: Provide compliant signage. 	PCODE SA02A ADAAG 91 4.30.3 ADA 2010 703.5.5 CBC 2007 1117B.5.4 CBC 2019 11B-403.3	1	JOB	\$4,500	\$4,500
					Priority	1
					Severity	3

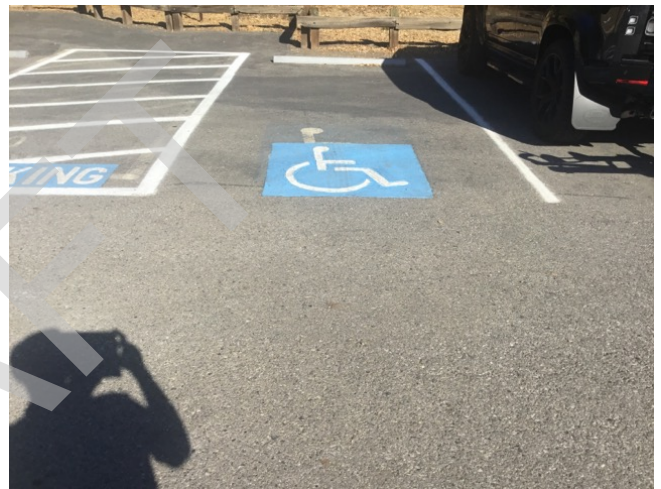
Item no., Rm no. and Name	Existing Architectural Barrier and Proposed Solution	Codes / Mitigation Info	Qty	Unit	Cost	Total
Parking						
2313	<ul style="list-style-type: none"> As-Built Description: Accessible parking space smaller than 8' wide (CA only: 9' x 18'). As-Built: 103" wide Proposed Solution: Modify parking space(s) to create accessible space. 	PCODE EA02A ADAAG 91 4.6.3 ADA 2010 502.2 CBC 2007 1129B.3.1 CBC 2019 11B-502.2	1	JOB	\$600	\$600
					Priority	3
					Severity	3

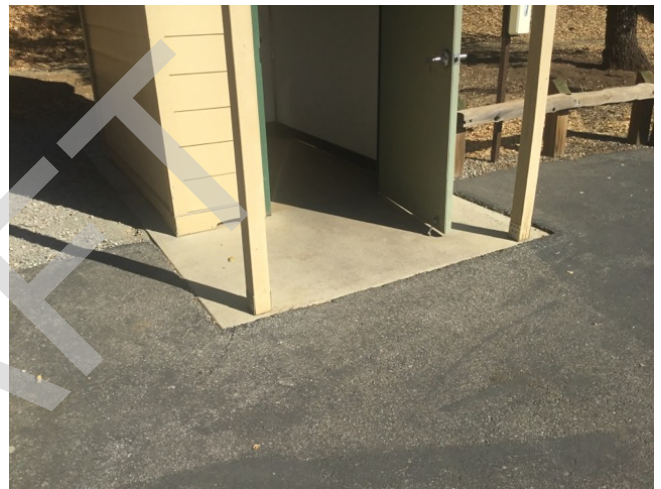
Item no., Rm no. and Name	Existing Architectural Barrier and Proposed Solution	Codes / Mitigation Info	Qty	Unit	Cost	Total
Door						
2317	<ul style="list-style-type: none"> As-Built Description: Surface of required maneuvering clearance at door slopes more than 1/4":12" (2.0%). .75" level change in the DMC. Proposed Solution: Modify surface slope at door. 	PCODE ID11 ADAAG 91 4.13.6 ADA 2010 404.2.4.4 CBC 2007 1133B.2.4 CBC 2019 11B-404.2.4	20	SF	\$120	\$2,400
						Priority 2
						Severity 3

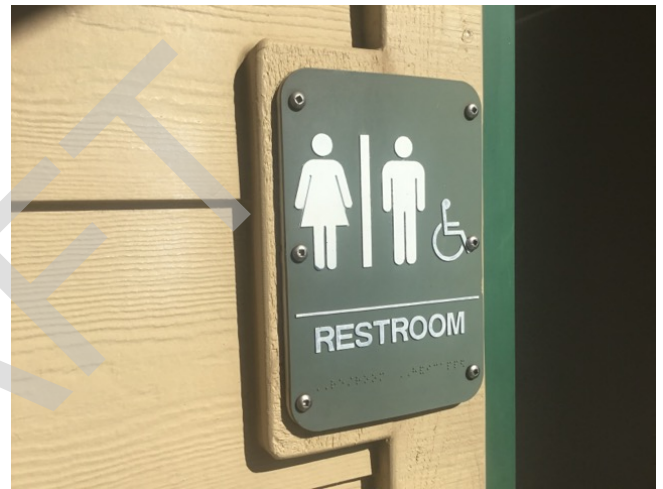
Item no., Rm no. and Name	Existing Architectural Barrier and Proposed Solution	Codes / Mitigation Info	Qty	Unit	Cost	Total
Signage						
2319	<ul style="list-style-type: none"> As-Built Description: Sign characters are not sans serif, upper case, and/or raised 1/32" min. As-Built: Spaces between tactile characters <1/16". Braille 3/4" from tactile characters. Proposed Solution: Provide compliant signage. 	PCODE SA04 ADAAG 91 4.30.4 ADA 2010 703.2 CBC 2007 1117B.5.5 CBC 2019 11B-216.6	1	JOB	\$270	\$270
						Priority 2 Severity 3
