Facilities Access Compliance Survey Report for the Santa Clara Valley Open Space Authority

April 2023
SSA Project # 21058

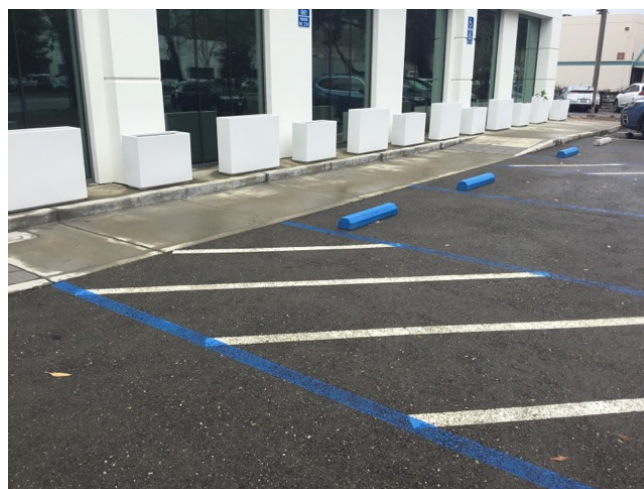
2505

- *As-Built Description:*
36" wide band of truncated domes not provided at walkway or crossing adjoining a vehicular way, if surfaces are not separated by a curb, railing, or other element.
- *Proposed Solution:*
Provide 36" wide, contrasting color, band of truncated domes between pedestrian and vehicular area.

- **Notes:**
The detectable warnings are not yellow and they do not appear to contrast sufficiently with the adjacent surfaces.

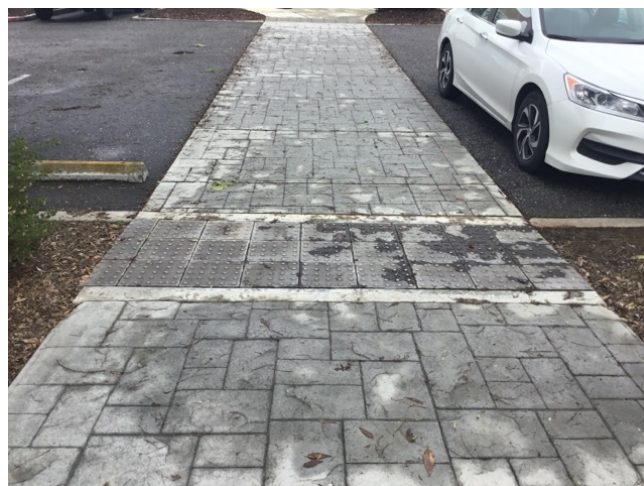
Item no., Rm no. and Name	Existing Architectural Barrier and Proposed Solution	Codes / Mitigation Info	Qty	Unit	Cost	Total
Door						
2503	<ul style="list-style-type: none"> • <i>As-Built Description:</i> Surface of required maneuvering clearance at door slopes more than 1/4":12" (2.0%). • <i>As-Built:</i> 0.2" level changes in door maneuvering clearance. Caused by detectable warnings. • <i>Proposed Solution:</i> Relocate detectable warnings outside the door maneuvering clearance. 	<p>PCODE ID11</p> <p>ADAAG 91 4.13.6</p> <p>ADA 2010 404.2.4.4</p> <p>CBC 2007 1133B.2.4</p> <p>CBC 2019 11B-404.2.4</p>	25	SF	\$120	\$3,000
						<p>Priority 1</p> <p>Severity 3</p>

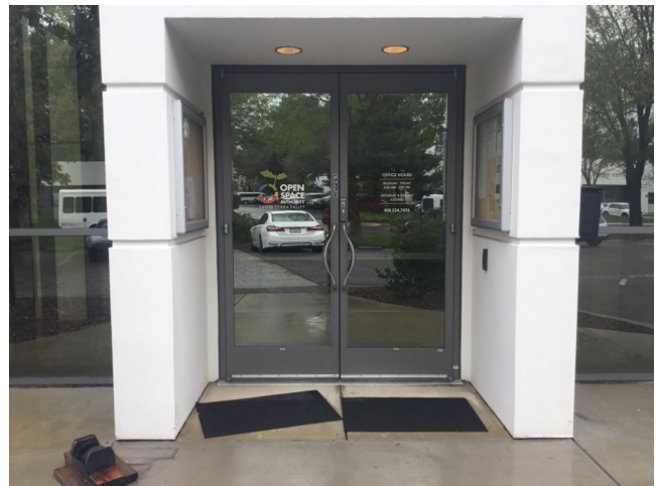
Item no., Rm no. and Name	Existing Architectural Barrier and Proposed Solution	Codes / Mitigation Info	Qty	Unit	Cost	Total
Door Threshold						
2436	<ul style="list-style-type: none"> As-Built Description: Door inaccessible due to threshold or step at door exceeding 1/2". .62" Proposed Solution: Modify threshold. 	PCODE ID02A ADAAG 91 4.13.8 ADA 2010 404.2.5 CBC 2007 1133B.2.4.1 CBC 2019 11B-404.2.5	1	JOB	\$1,200	\$1,200
					Priority	1
					Severity	1

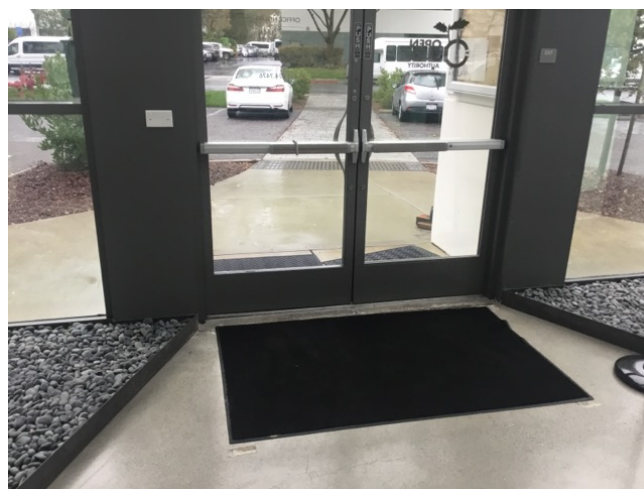
2437	<ul style="list-style-type: none"> As-Built Description: Signs containing tactile characters is not located so that a clear floor space of 18" min x 18" min., centered on the tactile characters, is provided beyond the arc of any door swing between the closed position and 45 degree open position. As-Built: Stones obstruct the CLFS. Proposed Solution: Modify stone display. 	PCODE SA07B ADA 2010 703.4.2 CBC 2019 11B-703.4.2	1	JOB	\$1,500	\$1,500
					Priority	1
					Severity	1

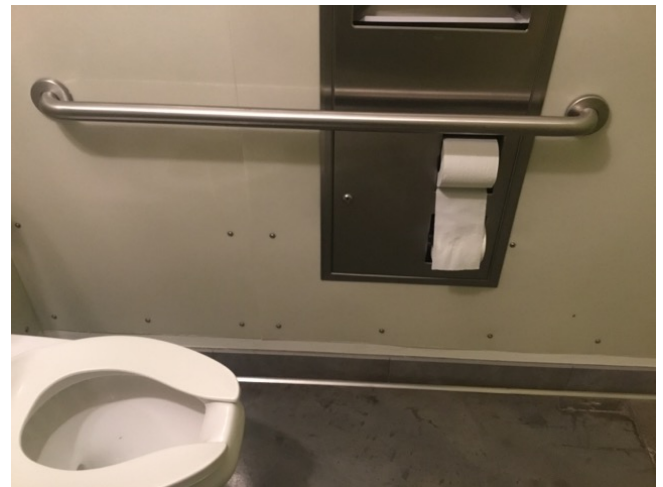
2455

- *As-Built Description:*
Accessories/dispensers in accessible stall located closer than 1-1/2" below or 12" above grab bar impedes its use.
- *As-Built:* **1.325" to toilet paper dispenser enclosure.**
- *Proposed Solution:*
Relocate accessories/dispensers to be no closer than 1-1/2" below and 12" above grab bars (except if accessories are recessed, flush with wall, and have no sharp edges).

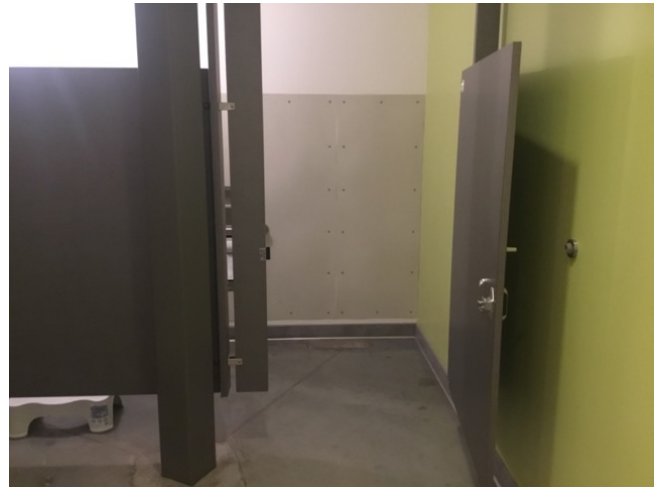
Item no., Rm no. and Name	Existing Architectural Barrier and Proposed Solution	Codes / Mitigation Info	Qty	Unit	Cost	Total
Toilet Stall						
2449	<ul style="list-style-type: none"> As-Built Description: Toilet stall less than 60" wide. As-Built: 58" wide at 47" from rear wall. Obstructed by cross support. Proposed Solution: Provide new accessible stall. 	PCODE WB06 ADAAG 91 4.17.3 ADA 2010 604.8.1.1 CBC 2007 1115B.3.1.4.1 CBC 2019 11B-604.8.1.1	1	JOB	\$4,500	\$4,500
					Priority	2
					Severity	3

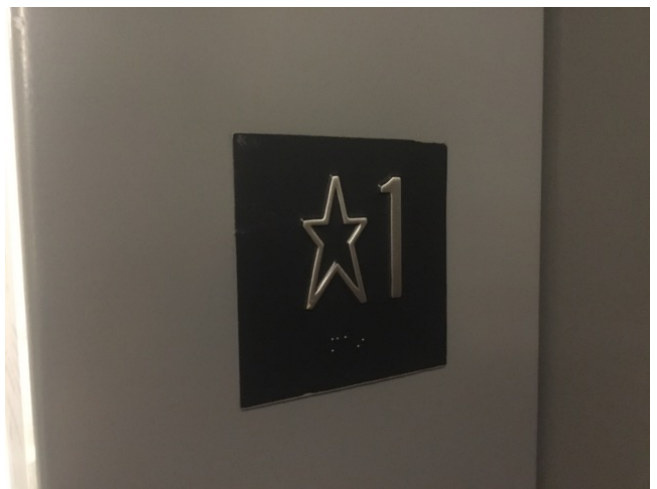
Item no., Rm no. and Name	Existing Architectural Barrier and Proposed Solution	Codes / Mitigation Info	Qty	Unit	Cost	Total
Signage						
2468	<ul style="list-style-type: none"> As-Built Description: Sign does not have non-glare finish and/or good color contrast (dark on light or light on dark). As-Built: Hoistway signs on both floors have glare. Proposed Solution: Provide compliant signage. 	PCODE SA03 ADAAG 91 4.30.5 ADA 2010 703.5.1 CBC 2007 1117B.5.5 CBC 2019 11B -407.4.7.1.3	2	JOB	\$270	\$540
						Priority 1 Severity 4

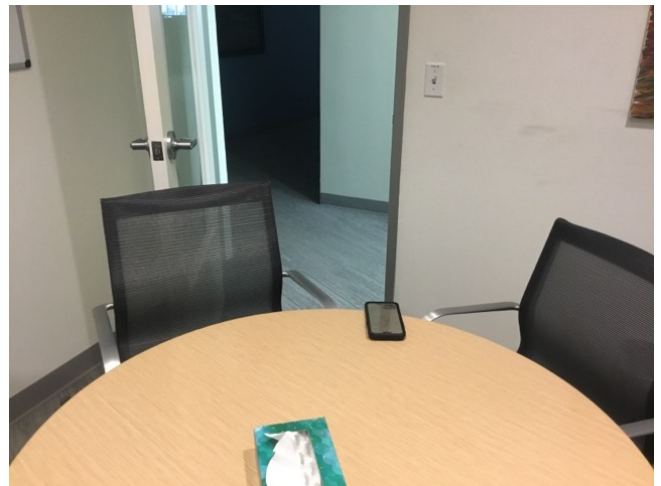
2469

12 Redwood Conference

Door Swing

• *As-Built Description:*

Front approach: At pull side, door does not have clear and level maneuvering space measuring door width plus 18" x 60". (24" x 60" at exterior doors).

Priority 1

Severity 1

Remove or relocate furniture or storage items.

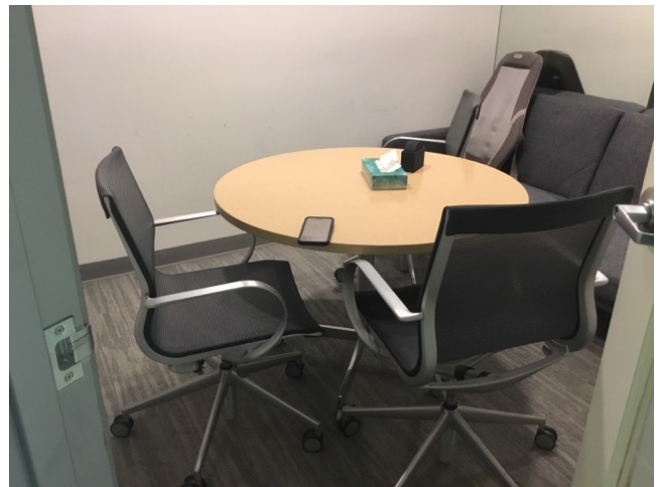
Item no., Rm no. and Name	Existing Architectural Barrier and Proposed Solution	Codes / Mitigation Info	Qty	Unit	Cost	Total
Non-Fixed Desk						
2470	<ul style="list-style-type: none"> As-Built Description: Accessible non-fixed table or desk (top 28" to 34" high; knee space at least 27" high x 19" deep x 30" wide) not provided. As-Built: 9" deep toe clearance. Proposed Solution: Provide table or desk with accessible dimensions when purchasing new furniture. 	PCODE IN02A ADAAG 91 4.32.3 & .4 ADA 2010 306.1 CBC 2007 1122B.3 & 4 CBC 2019 11B-306.1 & 11B-902.3	1	JOB	\$4,800	\$4,800
					Priority	1
					Severity	3

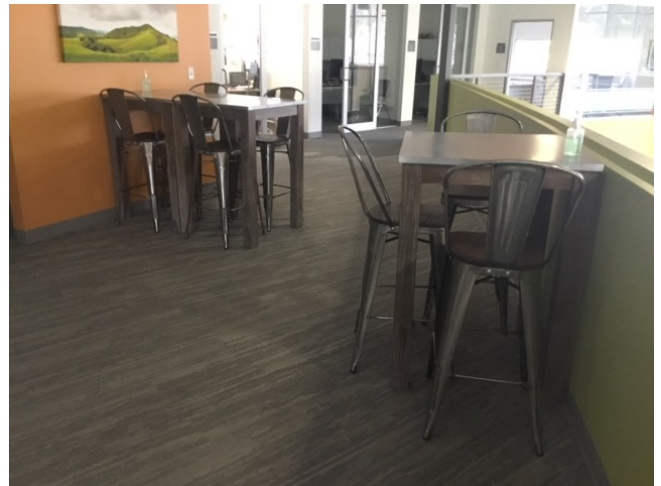
2474

13 Coffee

Non-Fixed Desk

• *As-Built Description:*
 Accessible non-fixed table or desk (top 28" to 34" high; knee space at least 27" high x 19" deep x 30" wide) not provided.

• *As-Built:* **42" to the top.**

Provide table or desk with accessible dimensions when purchasing new furniture.

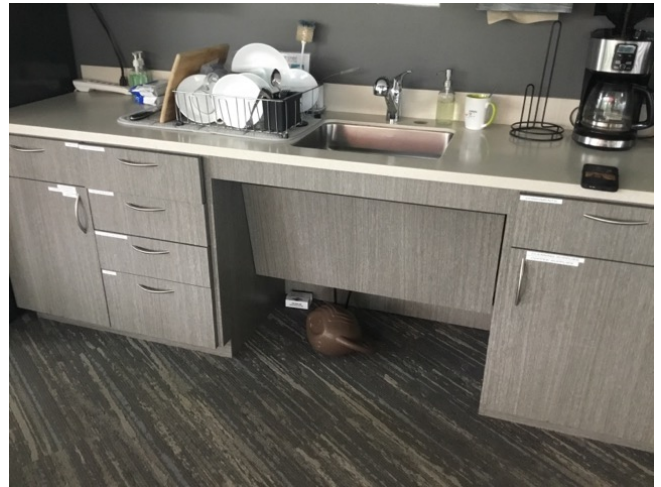
Reach Range

2472	<ul style="list-style-type: none"> As-Built Description: Reach height to control or access point, exceeds 48" or is less than 15". As-Built: 18" deep toe clearance. 20" reach to faucet handle. Proposed Solution: Provide 20" minimum toe clearance or relocate the faucet handle. 	PCODE IE01 ADAAG 91 4.2.5 ADA 2010 308.2.1 CBC 2007 1118B.5 CBC 2019 11B-308.2.1	1	JOB	\$300	\$300
------	--	--	---	-----	-------	-------

Priority 4

Severity 3

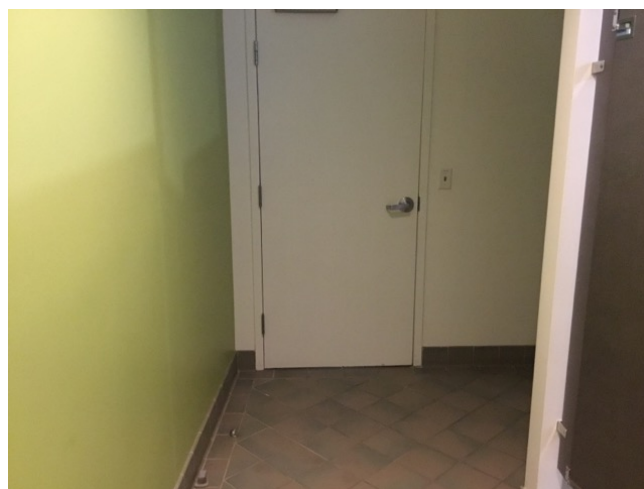
Item no., Rm no. and Name	Existing Architectural Barrier and Proposed Solution	Codes / Mitigation Info	Qty	Unit	Cost	Total
Door Swing						
2477	<ul style="list-style-type: none"> As-Built Description: Front approach: At pull side, door does not have clear and level maneuvering space measuring door width plus 18" x 60". (24" x 60" at exterior doors). As-Built: 54" Proposed Solution: Change door swing. 	PCODE ID23 ADAAG 91 Fig. 25(a) ADA 2010 404.2.4 CBC 2007 11B-26A(a) CBC 2019 11B-404.2.4	1	JOB	\$1,500	\$1,500
					Priority	2
					Severity	3

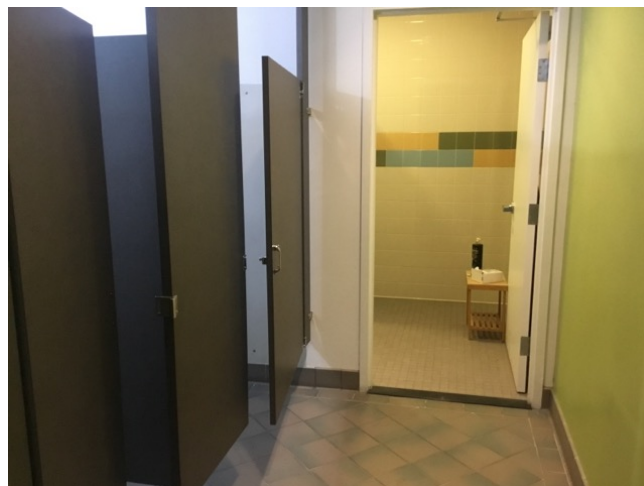
2478	<ul style="list-style-type: none"> As-Built Description: Front approach: At pull side, door does not have clear and level maneuvering space measuring door width plus 18" x 60". (24" x 60" at exterior doors). As-Built: 54" Proposed Solution: Remove standard compartment and completely remodel the accessible compartment. 	PCODE ID23B ADAAG 91 Fig. 25(a) ADA 2010 404.2.4 CBC 2007 11B-26A(a) CBC 2019 11B-404.2.4	1	JOB	\$16,800	\$16,800
					Priority	2
					Severity	3

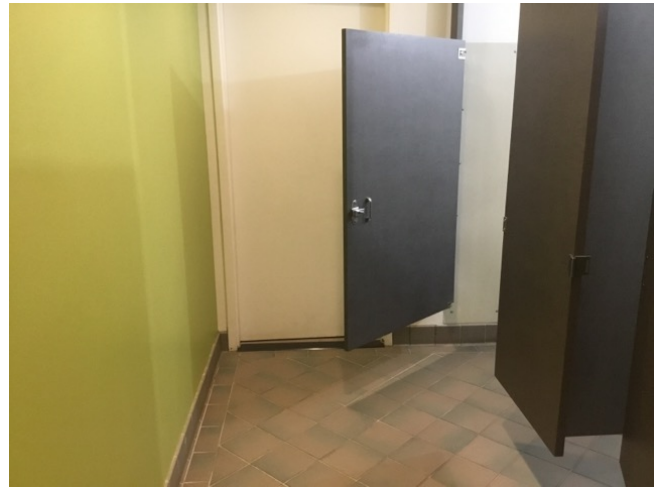
Item no., Rm no. and Name	Existing Architectural Barrier and Proposed Solution	Codes / Mitigation Info	Qty	Unit	Cost	Total
Door Swing						
2485	<ul style="list-style-type: none"> As-Built Description: Front approach: At pull side, door does not have clear and level maneuvering space measuring door width plus 18" x 60". (24" x 60" at exterior doors). As-Built: 53" Proposed Solution: Remodel compartment. 	PCODE ID23B ADAAG 91 Fig. 25(a) ADA 2010 404.2.4 CBC 2007 11B-26A(a) CBC 2019 11B-404.2.4	1	JOB	\$16,800	\$16,800
						Priority 2
						Severity 3

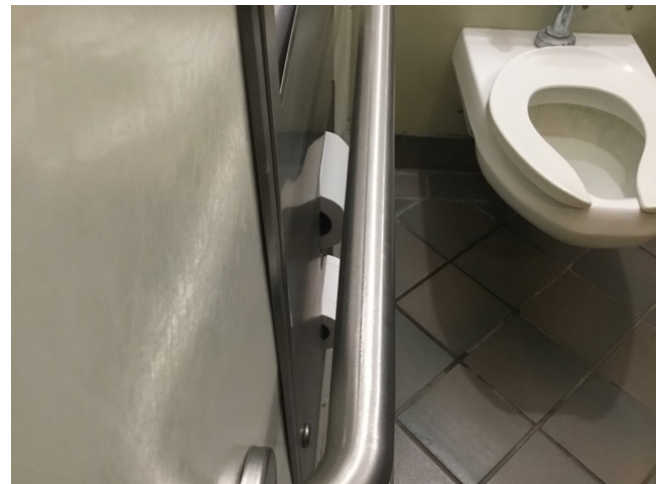
2489

- *As-Built Description:*
Accessories/dispensers in accessible stall located closer than 1-1/2" below or 12" above grab bar impedes its use.
- *As-Built:* **1.25"**
- *Proposed Solution:*
Relocate accessories/dispensers to be no closer than 1-1/2" below and 12" above grab bars (except if accessories are recessed, flush with wall, and have no sharp edges).

Priority **2**

Severity **3**

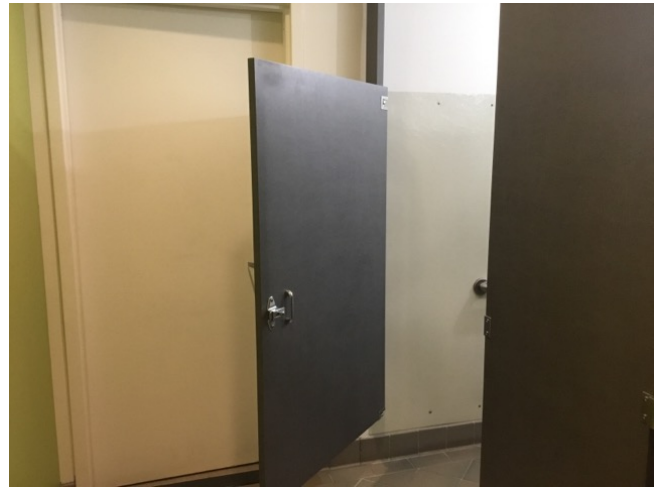
Item no., Rm no. and Name	Existing Architectural Barrier and Proposed Solution	Codes / Mitigation Info	Qty	Unit	Cost	Total
Stall Door						
2486	<ul style="list-style-type: none"> • <i>As-Built Description:</i> Stall door to accessible compartment not self closing. • <i>Proposed Solution:</i> Adjust closer. 	PCODE WB05B ADAAG 91 4.22.4 ADA 2010 604.8.1.2 CBC 2007 1115B.3.1.4.4 CBC 2019 11B-604.8.1.2	1	JOB	\$75	\$75
					Priority	2
					Severity	3

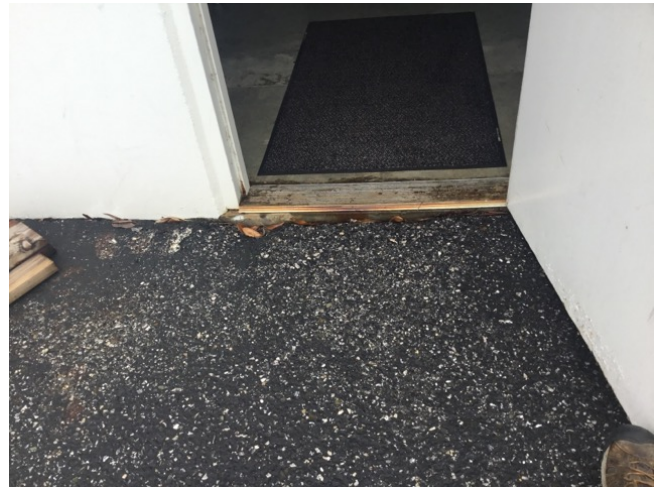
Item no., Rm no. and Name	Existing Architectural Barrier and Proposed Solution	Codes / Mitigation Info	Qty	Unit	Cost	Total
Door						
2499	<ul style="list-style-type: none"> As-Built Description: Surface of required maneuvering clearance at door slopes more than 1/4":12" (2.0%). As-Built: 4% Proposed Solution: Modify surface slope at door. 	PCODE ID11 ADAAG 91 4.13.6 ADA 2010 404.2.4.4 CBC 2007 1133B.2.4 CBC 2019 11B-404.2.4	20	SF	\$120	\$2,400
						Priority 1
						Severity 3

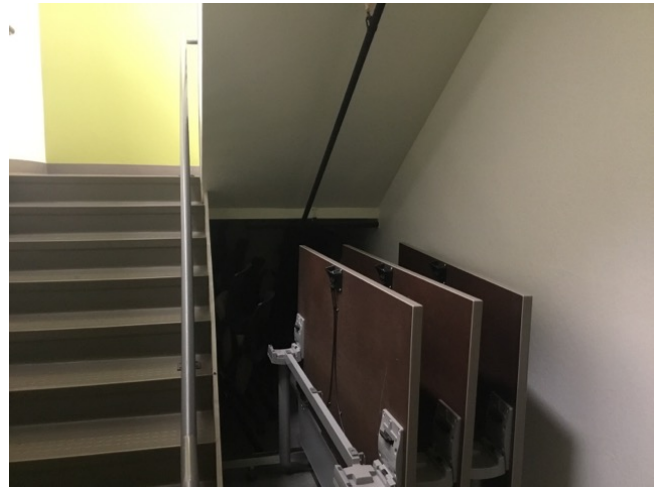
Item no., Rm no. and Name	Existing Architectural Barrier and Proposed Solution	Codes / Mitigation Info	Qty	Unit	Cost	Total
Vertical Clearance						
2496	<ul style="list-style-type: none"> As-Built Description: Overhead clearance less than 80" above finished floor. As-Built: Between 27" and 80" AFF Proposed Solution: Provide cane-detectable railing to mark area of low clearance. 	PCODE EG01A ADAAG 91 4.4.2 ADA 2010 307.4 CBC 2007 1133B.8.6.2 CBC 2019 11B-307.4	4	LF	\$300	\$1,200
						Priority 1
						Severity 1

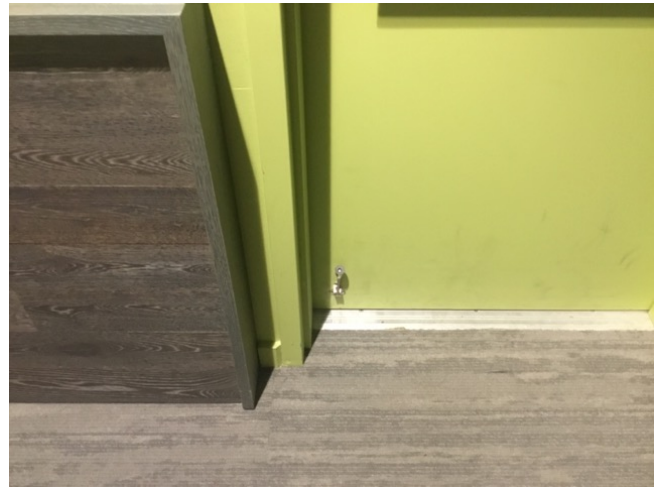
Item no., Rm no. and Name	Existing Architectural Barrier and Proposed Solution	Codes / Mitigation Info	Qty	Unit	Cost	Total
Door Stopper						
2445	<ul style="list-style-type: none"> • <i>As-Built Description:</i> At push side of door on accessible route, bottom 10" does not have a smooth, uninterrupted surface. • <i>Proposed Solution:</i> Relocate doorstop. 	<p>PCODE ID06A</p> <p>ADA 2010 404.2.10</p> <p>CBC 2007 1133B.2.6</p> <p>CBC 2019 11B-404.2.10</p>	10	JOB	\$1,800	\$18,000
						<p>Priority 1</p> <p>Severity 3</p>

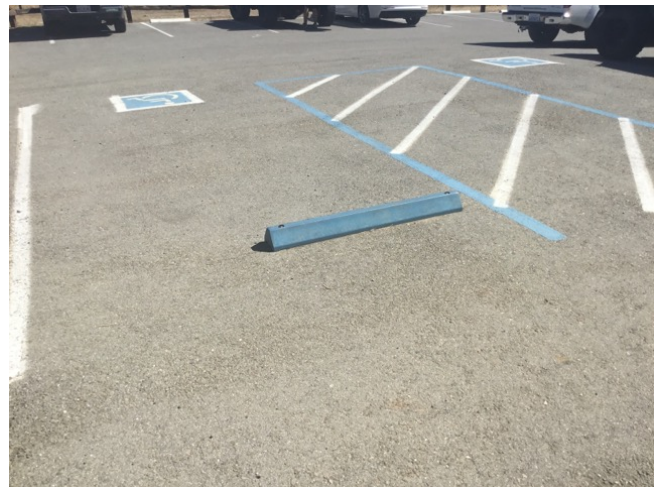
Item no., Rm no. and Name	Existing Architectural Barrier and Proposed Solution	Codes / Mitigation Info	Qty	Unit	Cost	Total
Parking						
2280	<ul style="list-style-type: none"> As-Built Description: Accessible parking space smaller than 8' wide (CA only: 9' x 18'). As-Built: 106.5"-107" wide Proposed Solution: Modify parking space(s) to create accessible space. 	PCODE EA02A ADAAG 91 4.6.3 ADA 2010 502.2 CBC 2007 1129B.3.1 CBC 2019 11B-502.2	2	JOB	\$600	\$1,200
					Priority	3
					Severity	3

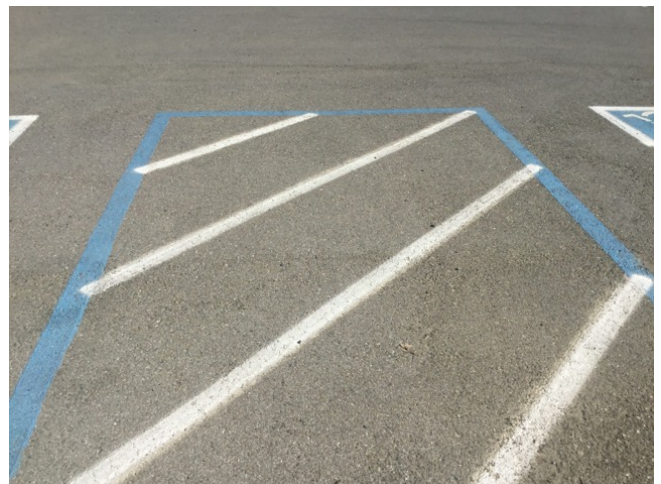
2281	<ul style="list-style-type: none"> As-Built Description: The words "NO PARKING" not painted on the ground within loading and unloading access aisle (12" min high white letters), located so that it is visible to traffic enforcement officials (required in CA only). Proposed Solution: Provide the words "NO PARKING" in each access aisle, painted in 12" high letters, when altering area. 	PCODE EA04D CBC 2007 1129B.3.1 CBC 2019 11B-502.3.3	1	JOB	\$300	\$300
					Priority	3
					Severity	4

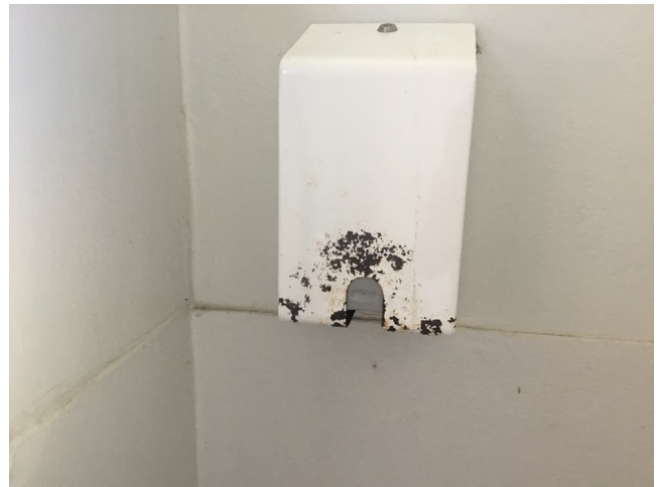
Item no., Rm no. and Name	Existing Architectural Barrier and Proposed Solution	Codes / Mitigation Info	Qty	Unit	Cost	Total
2287	<ul style="list-style-type: none"> • <i>As-Built Description:</i> Dispensers in sanitary facilities, such as for towels, soap, sanitary napkins, seat covers, etc., and waste receptacles more than 48" (CA only: 40") from floor to highest operating slot or control. • <i>As-Built:</i> 51" • <i>Proposed Solution:</i> Relocate existing restroom accessories. 	PCODE WG01A ADAAG 91 4.23.7 ADA 2010 308.2.1 CBC 2007 1115B.8.3 CBC 2019 11B-603.5	1	JOB	\$300	\$300

Priority 2
Severity 3

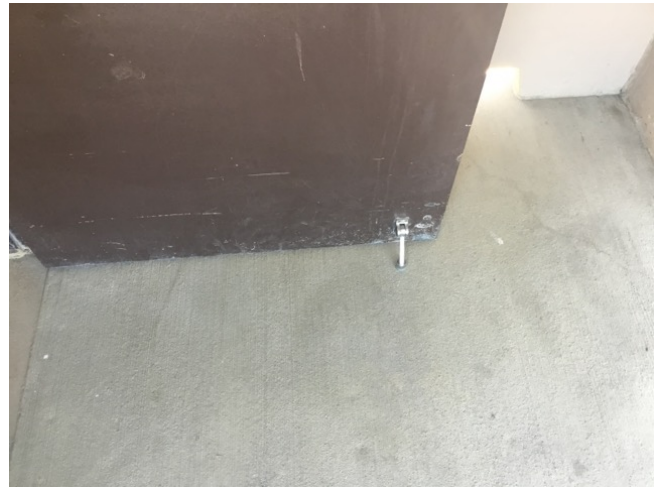
Item no., Rm no. and Name	Existing Architectural Barrier and Proposed Solution	Codes / Mitigation Info	Qty	Unit	Cost	Total
Door Stopper						
2285	<ul style="list-style-type: none"> <i>As-Built Description:</i> At push side of door on accessible route, bottom 10" does not have a smooth, uninterrupted surface. <i>Proposed Solution:</i> Remove door stopper when altering area. Provide rubber wedge. 	PCODE ID06A ADA 2010 404.2.10 CBC 2007 1133B.2.6 CBC 2019 11B-404.2.10	1	JOB	\$75	\$75
					Priority	2
					Severity	3

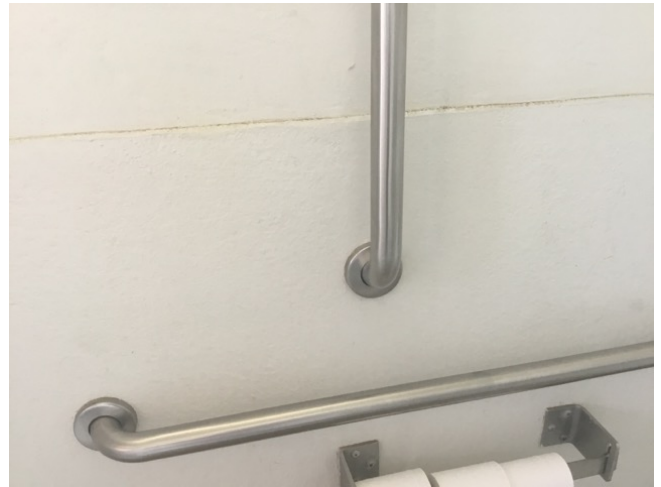
Item no., Rm no. and Name	Existing Architectural Barrier and Proposed Solution	Codes / Mitigation Info	Qty	Unit	Cost	Total
Grab Bars						
2288	<ul style="list-style-type: none"> • <i>As-Built Description:</i> Accessories/dispensers in accessible stall located closer than 1-1/2" below or 12" above grab bar impedes its use. • <i>As-Built:</i> 6" • <i>Proposed Solution:</i> Remove the vertical grab bar. 	PCODE WB07I ADAAG 91 4.26.2 ADA 2010 609.3 CBC 2007 1133B.4.2.5 CBC 2019 11B-609.3	1	JOB	\$225	\$225
					Priority	2
					Severity	3

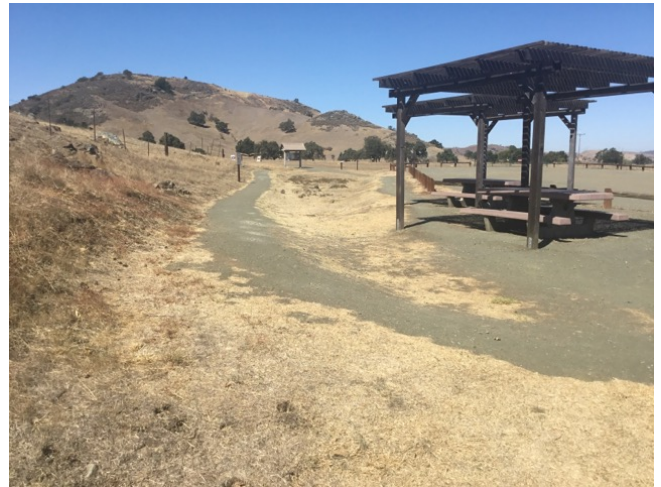
Item no., Rm no. and Name	Existing Architectural Barrier and Proposed Solution	Codes / Mitigation Info	Qty	Unit	Cost	Total
Cross Slope						
2294	<ul style="list-style-type: none"> As-Built Description: Cross slope more than 1":48" (2.083%). As-Built: To 13% Proposed Solution: Modify cross slope. Notes: Occurs on both trails from picnic and restrooms to information and trail head. 	PCODE EF07 ADAAG 91 4.3.7 ADA 2010 403.3 CBC 2007 1133B.7.1.3 CBC 2019 11B-403.3	1600	SF	\$30	\$48,000
					Priority	1
					Severity	3

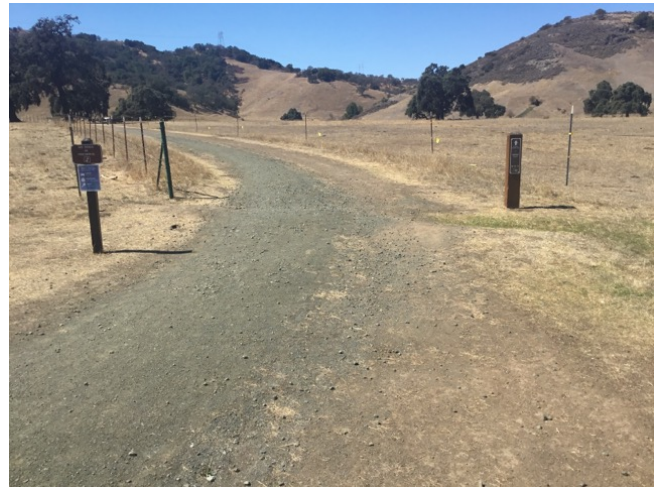
Item no., Rm no. and Name	Existing Architectural Barrier and Proposed Solution	Codes / Mitigation Info	Qty	Unit	Cost	Total
Cross Slope						
2303	<ul style="list-style-type: none"> As-Built Description: Cross slope more than 1":48" (2.083%). As-Built: Varies. 6.4% cross slopes. 11% slopes. Proposed Solution: Modify slope and cross slope. Notes: Occurs sporadically throughout the level portion of the trail. Consider whether the widened and graded portions of the trail are "improved". See 11B-246.7 	PCODE EF07 ADAAG 91 4.3.7 ADA 2010 403.3 CBC 2007 1133B.7.1.3 CBC 2019 11B-403.3	1000	SF	\$21	\$210,000
						Priority 1 Severity 3

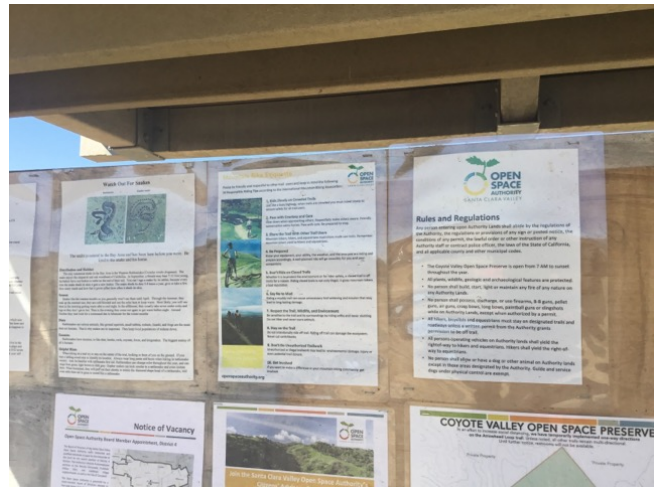
Item no., Rm no. and Name	Existing Architectural Barrier and Proposed Solution	Codes / Mitigation Info	Qty	Unit	Cost	Total
2299	<ul style="list-style-type: none"> As-Built Description: Sign characters not readable because they are not sized for viewing distance. .125" Proposed Solution: Provide compliant signage. 	PCODE SA02A ADAAG 91 4.30.3 ADA 2010 703.5.5 CBC 2007 1117B.5.4 CBC 2019 11B-403.3	1	JOB	\$4,500	\$4,500
					Priority	1
					Severity	3

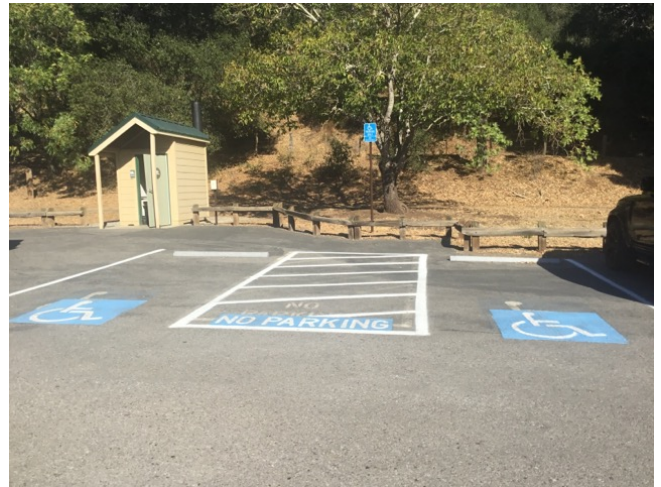
Item no., Rm no. and Name	Existing Architectural Barrier and Proposed Solution	Codes / Mitigation Info	Qty	Unit	Cost	Total
Floor or Ground Surfaces						
2311	<ul style="list-style-type: none"> As-Built Description: Accessible parking space has slope greater than 1/4":12" (2%). As-Built: To 4% Proposed Solution: Modify slope at accessible parking space. 	PCODE EA05 ADAAG 91 4.6.3 ADA 2010 502.4 CBC 2007 1129B.3.3 CBC 2019 11B-502.4	468	SF	\$36	\$16,848
					Priority	3
					Severity	3

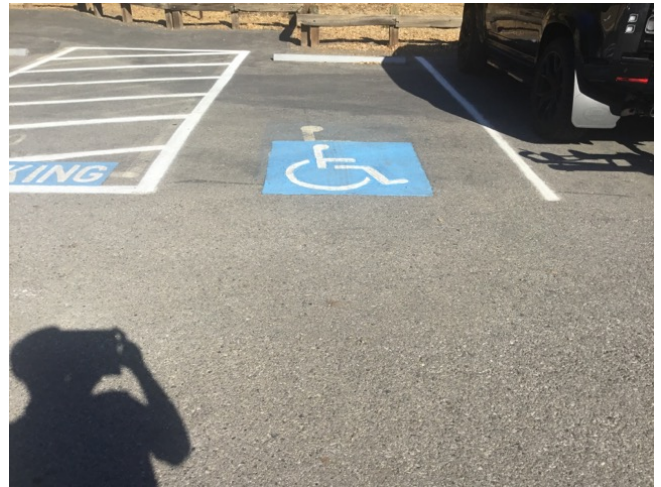
Item no., Rm no. and Name	Existing Architectural Barrier and Proposed Solution	Codes / Mitigation Info	Qty	Unit	Cost	Total
Parking						
2313	<ul style="list-style-type: none"> As-Built Description: Accessible parking space smaller than 8' wide (CA only: 9' x 18'). As-Built: 103" wide Proposed Solution: Modify parking space(s) to create accessible space. 	PCODE EA02A ADAAG 91 4.6.3 ADA 2010 502.2 CBC 2007 1129B.3.1 CBC 2019 11B-502.2	1	JOB	\$600	\$600
					Priority	3
					Severity	3

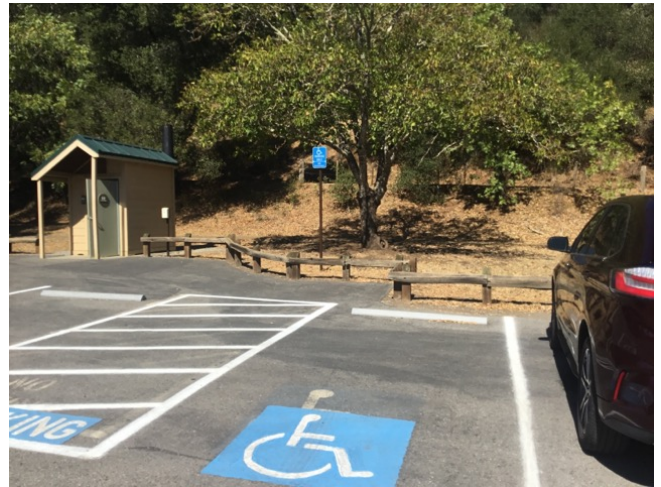
Item no., Rm no. and Name	Existing Architectural Barrier and Proposed Solution	Codes / Mitigation Info	Qty	Unit	Cost	Total
<u>Parking Signage</u>						
2345	<ul style="list-style-type: none"> • <i>As-Built Description:</i> No "Tow Away" sign at parking lot entrance (required in CA only). • <i>Proposed Solution:</i> Provide "Tow Away" sign at parking lot entrance when altering area. 	<p>PCODE EA04C</p> <p>CBC 2007 1129B.4</p> <p>CBC 2019 11B-502.8.2</p>	1	JOB	\$975	\$975
						<p>Priority 3</p> <p>Severity 3</p>

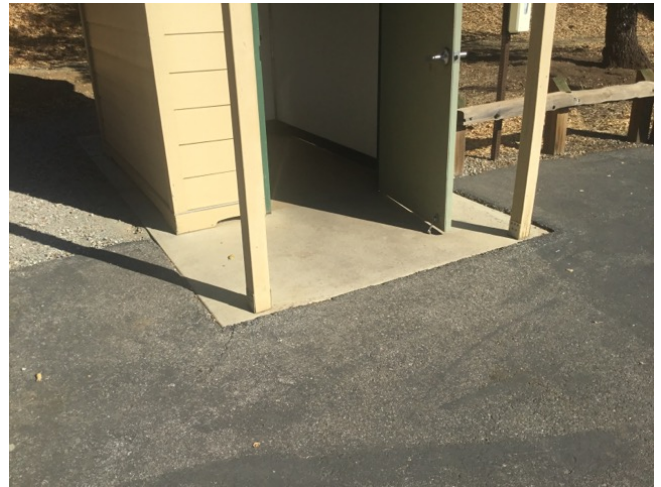
Item no., Rm no. and Name	Existing Architectural Barrier and Proposed Solution	Codes / Mitigation Info	Qty	Unit	Cost	Total
Door						
2317	<ul style="list-style-type: none"> As-Built Description: Surface of required maneuvering clearance at door slopes more than 1/4":12" (2.0%). .75" level change in the DMC. Proposed Solution: Modify surface slope at door. 	PCODE ID11 ADAAG 91 4.13.6 ADA 2010 404.2.4.4 CBC 2007 1133B.2.4 CBC 2019 11B-404.2.4	20	SF	\$120	\$2,400
						Priority 2
						Severity 3

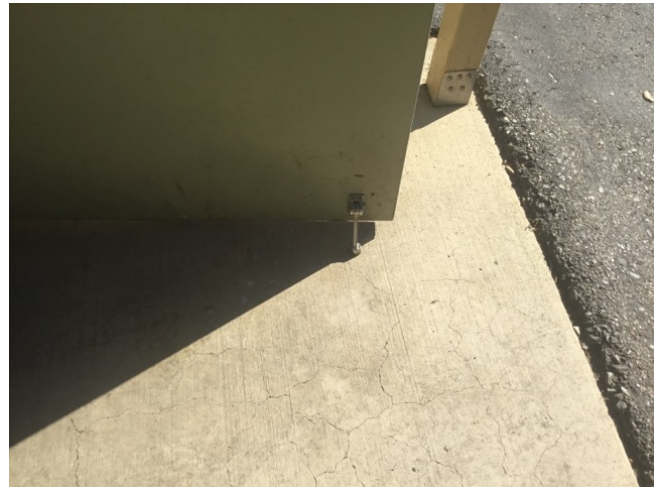
Item no., Rm no. and Name	Existing Architectural Barrier and Proposed Solution	Codes / Mitigation Info	Qty	Unit	Cost	Total
Reach Range						
2320	<ul style="list-style-type: none"> As-Built Description: Reach height to control or access point, where side approach is available, exceeds 48" or is less than 15" in height, or exceeds 10" in depth. As-Built: 5" Proposed Solution: Relocate the door stop. 	PCODE IE02 ADAAG 91 4.2.6 ADA 2010 308.3.1 CBC 2007 1118B.6 CBC 2019 11B-308.3	1	JOB	\$300	\$300
						Priority 2
						Severity 3

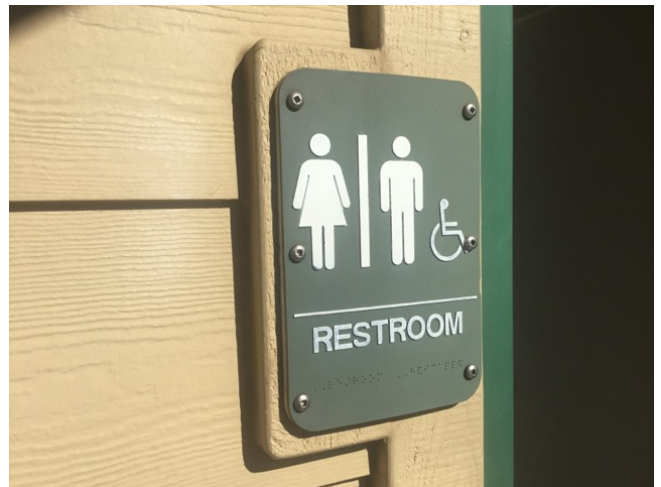
Item no., Rm no. and Name	Existing Architectural Barrier and Proposed Solution	Codes / Mitigation Info	Qty	Unit	Cost	Total
Signage						
2319	<ul style="list-style-type: none"> As-Built Description: Sign characters are not sans serif, upper case, and/or raised 1/32" min. As-Built: Spaces between tactile characters <1/16". Braille 3/4" from tactile characters. Proposed Solution: Provide compliant signage. 	PCODE SA04 ADAAG 91 4.30.4 ADA 2010 703.2 CBC 2007 1117B.5.5 CBC 2019 11B-216.6	1	JOB	\$270	\$270
						Priority 2 Severity 3

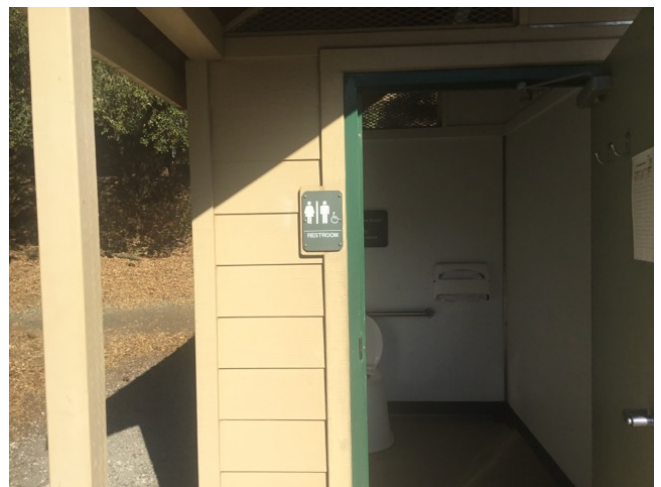
2318	<ul style="list-style-type: none"> As-Built Description: Signs containing tactile characters is not located so that a clear floor space of 18" min x 18" min., centered on the tactile characters, is provided beyond the arc of any door swing between the closed position and 45 degree open position. As-Built: 5.5" from door swing. Proposed Solution: Relocate compliant signage on latch side of door located at compliant height with a clear floor space. 	PCODE SA07B ADA 2010 703.4.2 CBC 2019 11B-703.4.2	1	JOB	\$150	\$150
						Priority 2 Severity 3

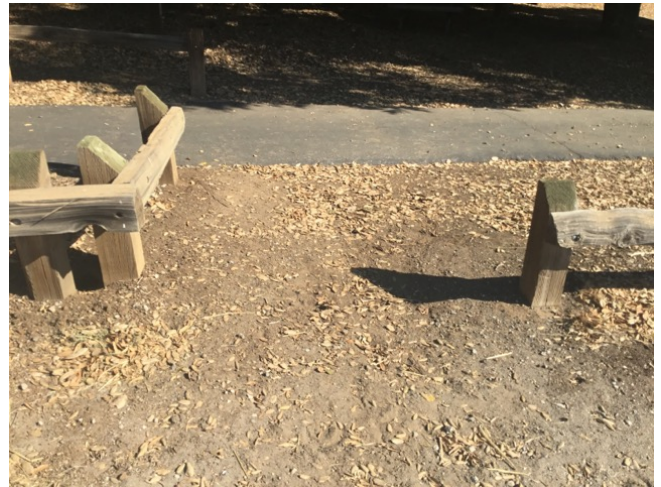
2329	<ul style="list-style-type: none"> As-Built Description: Cross slope more than 1":48" (2.083%). As-Built: 8% Proposed Solution: Modify cross slope. 	PCODE EF07	8	SF	\$75	\$600
		ADAAG 91 4.3.7				
		ADA 2010 403.3				
		CBC 2007 1133B.7.1.3				
		CBC 2019 11B-403.3				
						Priority 1 Severity 3

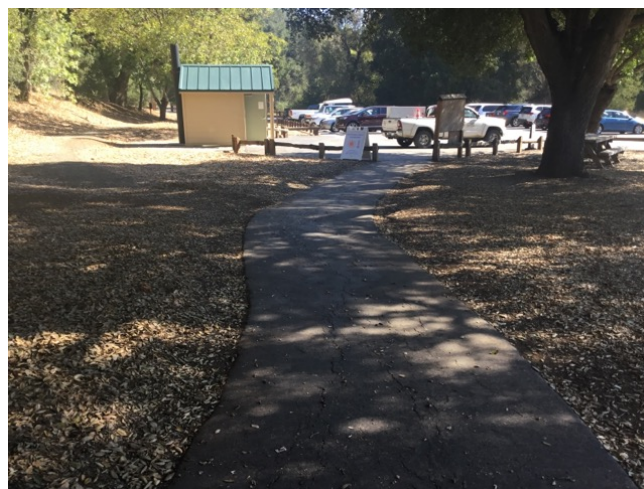
Item no., Rm no. and Name	Existing Architectural Barrier and Proposed Solution	Codes / Mitigation Info	Qty	Unit	Cost	Total
2335	<ul style="list-style-type: none"> As-Built Description: Cross slope more than 1":48" (2.083%). As-Built: 3.5% Proposed Solution: Modify cross slope. 	PCODE EF07 ADAAG 91 4.3.7 ADA 2010 403.3 CBC 2007 1133B.7.1.3 CBC 2019 11B-403.3	50	SF	\$75	\$3,750
					Priority	1
					Severity	3

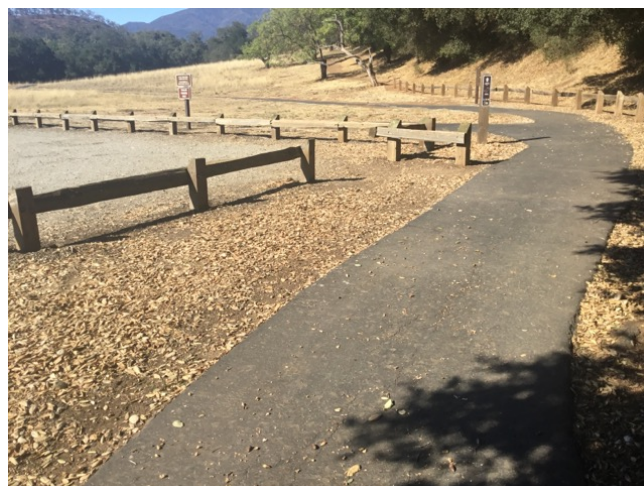
2327	<ul style="list-style-type: none"> As-Built Description: 36" wide band of truncated domes not provided at walkway or crossing adjoining a vehicular way, if surfaces are not separated by a curb, railing, or other element. Proposed Solution: Provide 36" wide, contrasting color, band of truncated domes between pedestrian and vehicular area. 	PCODE EG09 ADAAG 91 4.29.5 CBC 2007 1133B.8.5 CBC 2019 11B-705.1.2.5	10	LF	\$81	\$810
					Priority	1
					Severity	1

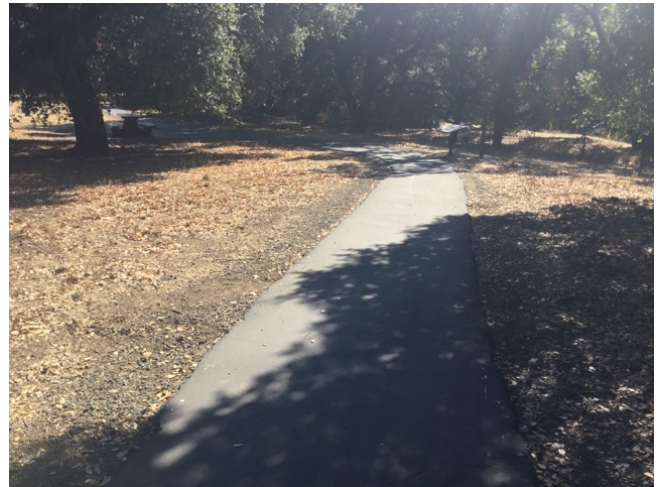
Item no., Rm no. and Name	Existing Architectural Barrier and Proposed Solution	Codes / Mitigation Info	Qty	Unit	Cost	Total
Walk						
2340	<ul style="list-style-type: none"> As-Built Description: Walk: Slope greater than 1:20 (5.0%), and walk does not comply with requirements for ramps. As-Built: 6.8% Proposed Solution: Modify walk/sidewalk slope to 1:20 or less. 	PCODE EF01 ADAAG 91 4.3.7 ADA 2010 403.3 CBC 2007 1133B.7.3 CBC 2019 11B-403.3	100	SF	\$75	\$7,500
						Priority 1
						Severity 3

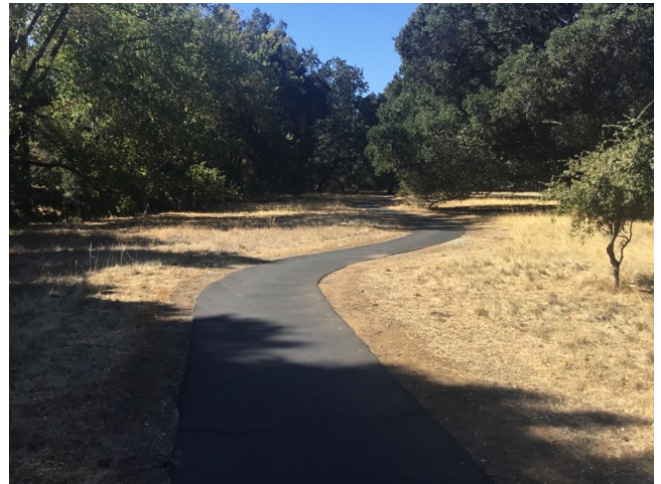
7 Accessible Trail North

Changes in Level

2344 • *As-Built Description:*
Walk: Pavement dislocation creates abrupt change in level exceeding 1/2" in accessible route.

- *As-Built:* **1"**
- *Proposed Solution:*

Remove, replace or repair area of pavement sufficient to correct abrupt change in level.

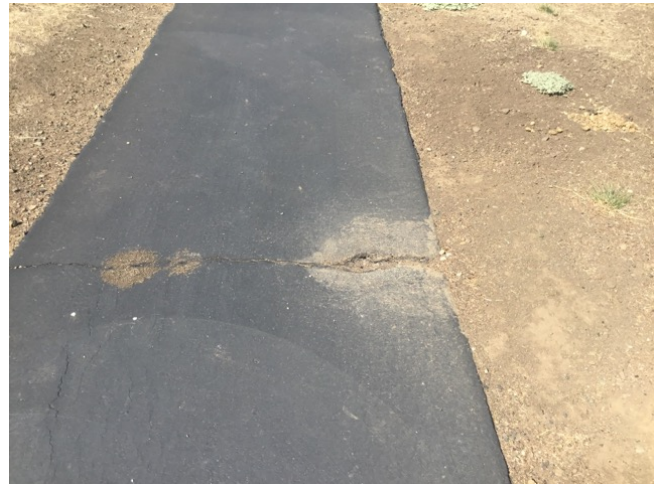
Item no., Rm no. and Name	Existing Architectural Barrier and Proposed Solution	Codes / Mitigation Info	Qty	Unit	Cost	Total
Cross Slope						
2342	<ul style="list-style-type: none"> As-Built Description: Cross slope more than 1":48" (2.083%). As-Built: To 6.8% Proposed Solution: Modify cross slope. 	PCODE EF07 ADAAG 91 4.3.7 ADA 2010 403.3 CBC 2007 1133B.7.1.3 CBC 2019 11B-403.3	20	SF	\$75	\$1,500
					Priority	1
					Severity	3

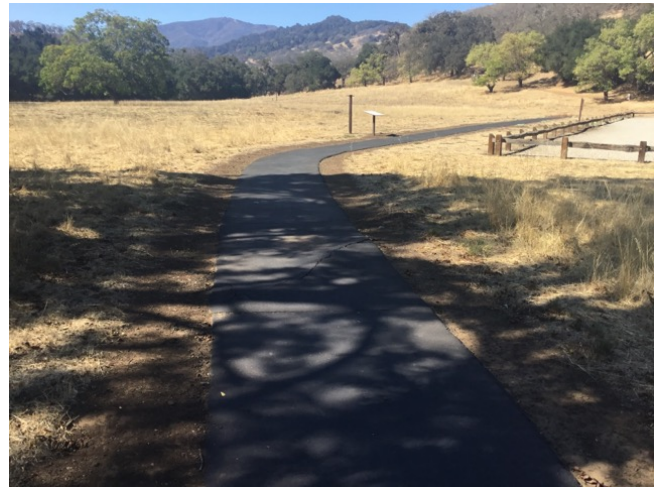
Signage

2343 • *As-Built Description:*
Sign characters not readable because they are not sized for viewing distance.

• *As-Built: 3/8" characters.*

In addition there are characters with unusual font and the stroke thickness is approximately 10%. Occurs on signs throughout.

Provide compliant signage.

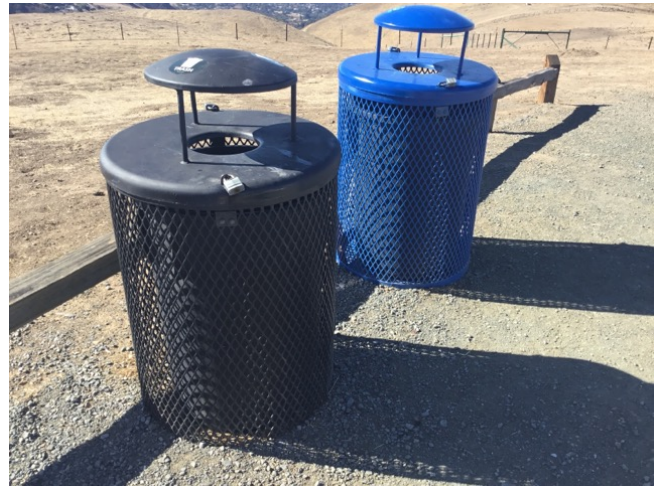
Item no., Rm no. and Name	Existing Architectural Barrier and Proposed Solution	Codes / Mitigation Info	Qty	Unit	Cost	Total
Cross Slope						
2270	<ul style="list-style-type: none"> As-Built Description: Cross slope more than 1":48" (2.083%). As-Built: To 4.4% Proposed Solution: Modify cross slope. Notes: Provide an accessible route to all elements including bike racks. 	PCODE EF07 ADAAG 91 4.3.7 ADA 2010 403.3 CBC 2007 1133B.7.1.3 CBC 2019 11B-403.3	1000	SF	\$75	\$75,000
					Priority	1
					Severity	3

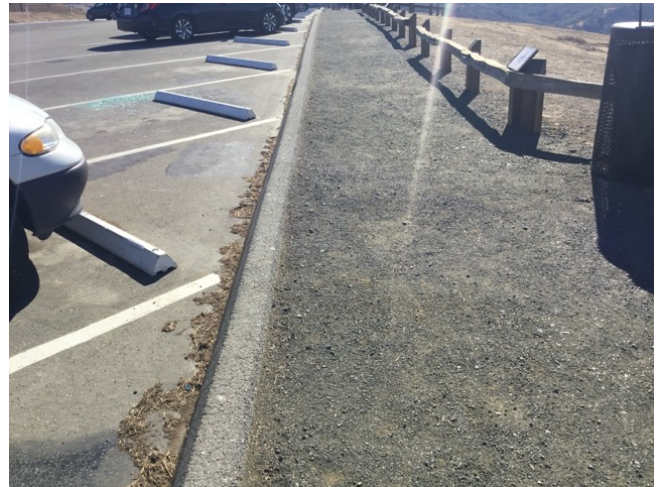
Item no., Rm no. and Name	Existing Architectural Barrier and Proposed Solution	Codes / Mitigation Info	Qty	Unit	Cost	Total
Curb Ramp						
2267	<ul style="list-style-type: none"> • <i>As-Built Description:</i> No curb ramp available where an accessible route crosses a curb. • <i>Proposed Solution:</i> Provide new curb ramp. 	PCODE EH01 ADAAG 91 4.7.1 ADA 2010 303.4 CBC 2007 1127B.5.1 CBC 2019 11B-402.2	1	JOB	\$7,500	\$7,500
					Priority	1
					Severity	2

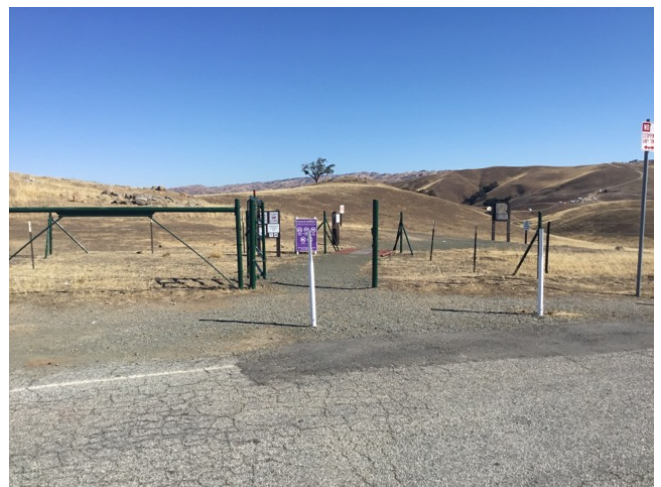
Item no., Rm no. and Name	Existing Architectural Barrier and Proposed Solution	Codes / Mitigation Info	Qty	Unit	Cost	Total
Signage						
2276	<ul style="list-style-type: none"> As-Built Description: Sign characters not readable because they are not sized for viewing distance. As-Built: 1/8"-3/8" characters. Proposed Solution: Provide compliant signage. 	PCODE SA02A ADAAG 91 4.30.3 ADA 2010 703.5.5 CBC 2007 1117B.5.4 CBC 2019 11B-403.3	1	JOB	\$4,500	\$4,500
					Priority	3
					Severity	3

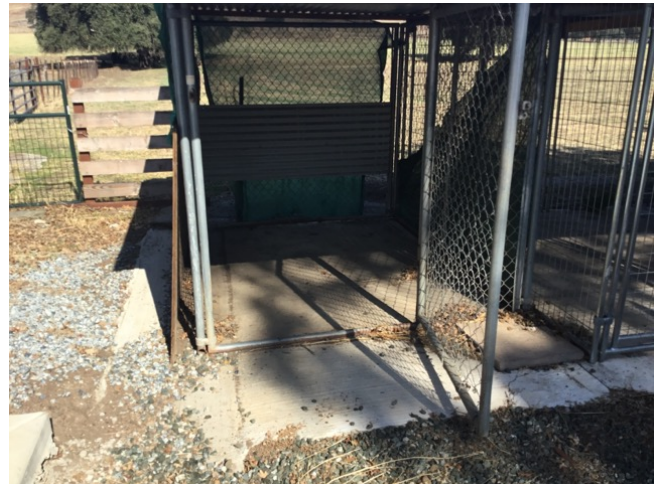
Item no., Rm no. and Name	Existing Architectural Barrier and Proposed Solution	Codes / Mitigation Info	Qty	Unit	Cost	Total
2357	<ul style="list-style-type: none"> • <i>As-Built Description:</i> Cross slope more than 1":48" (2.083%). • <i>As-Built:</i> 5.2% • <i>Proposed Solution:</i> Modify cross slope. • <i>Notes:</i> See exceptions for animal containment areas. 	PCODE EF07 ADAAG 91 4.3.7 ADA 2010 403.3 CBC 2007 1133B.7.1.3 CBC 2019 11B-403.3	500	SF	\$75	\$37,500
					Priority	1
					Severity	2

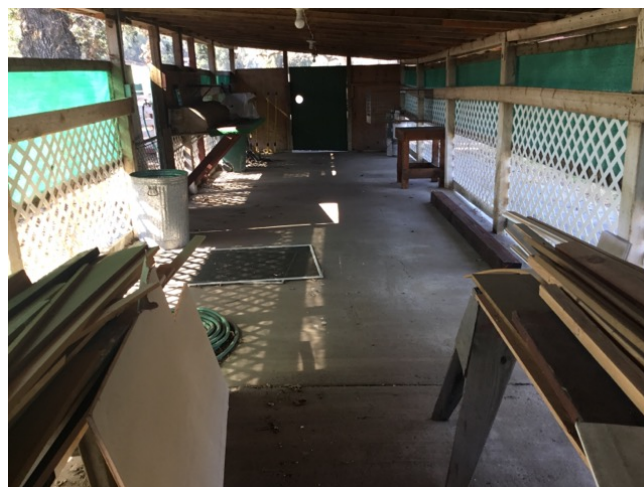
Door

2356	<ul style="list-style-type: none"> • <i>As-Built Description:</i> At push side of door on accessible route, bottom 10" does not have a smooth, uninterrupted surface. • <i>Proposed Solution:</i> Provide 10" min. "kick plate" covering width of door when altering area. • <i>Notes:</i> This element complies with Safe Harbor if altered or constructed before March 15, 2012. See exceptions for animal containment areas. However accessibility should be provided if the public is provided access. 	PCODE ID06 ADA 2010 404.2.10 CBC 2007 1133B.2.6 CBC 2019 11B-404.2.10	1	JOB	\$300	\$300
					Priority	1
					Severity	3

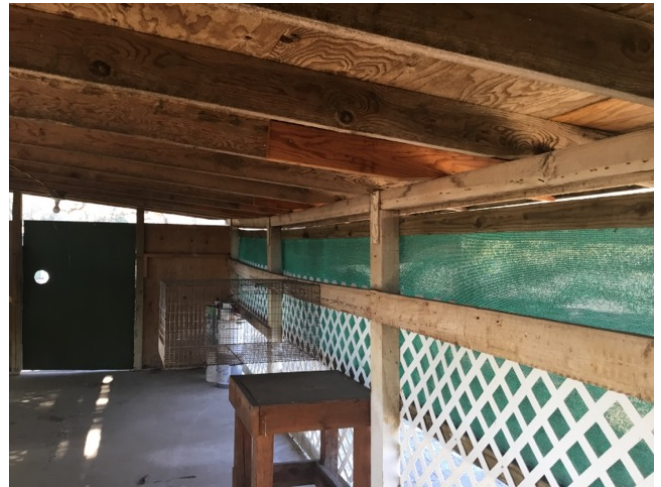
2353	<ul style="list-style-type: none"> • <i>As-Built Description:</i> Overhead clearance less than 80" above finished floor. • <i>As-Built:</i> 72" • <i>Proposed Solution:</i> Alter ceiling. • <i>Notes:</i> See exceptions for animal containment areas. Consider modifications for safety . 	PCODE EG01AREF				REF
		ADAAG 91 4.4.2				
		ADA 2010 307.4				
		CBC 2007 1133B.8.6.2				
		CBC 2019 11B-307.4				
						Priority 1 Severity 1

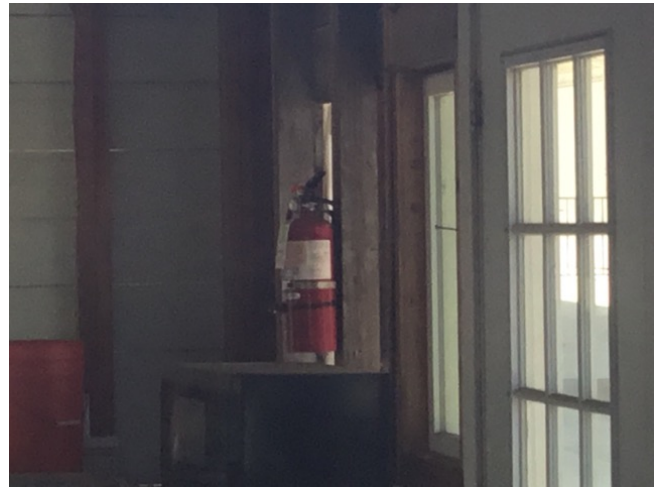
Item no., Rm no. and Name	Existing Architectural Barrier and Proposed Solution	Codes / Mitigation Info	Qty	Unit	Cost	Total
Reach Range						
2364	<ul style="list-style-type: none"> As-Built Description: Reach height to control or access point, where side approach is available, exceeds 48" or is less than 15" in height, or exceeds 10" in depth. As-Built: Fire extinguisher 65" AFF. Proposed Solution: Modify equipment or mounting. 	PCODE IE02 ADAAG 91 4.2.6 ADA 2010 308.3.1 CBC 2007 1118B.6 CBC 2019 11B-308.3	1	JOB	\$300	\$300
						Priority 1
						Severity 3

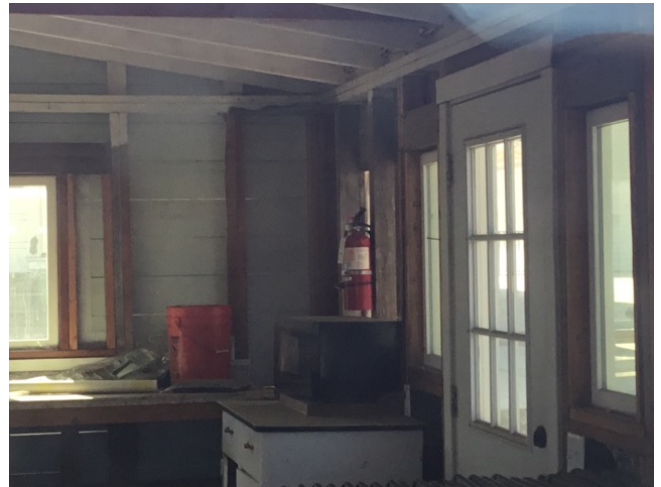
Item no., Rm no. and Name	Existing Architectural Barrier and Proposed Solution	Codes / Mitigation Info	Qty	Unit	Cost	Total
Sink						
2366	<ul style="list-style-type: none"> As-Built Description: Sink rim higher than 34" above floor. As-Built: 37" Proposed Solution: Remodel sink cabinet to lower sink. Notes: No access at time of survey. Approximation. 	PCODE IN06 ADAAG 91 4.24.2 ADA 2010 606.3 CBC 2007 1115B.4.7.1 CBC 2019 11B-606.3	1	JOB	\$5,250	\$5,250
						Priority 3
						Severity 3
