Facilities Access Compliance Survey Report for the Santa Clara Valley Open Space Authority

April 2023
SSA Project # 21058

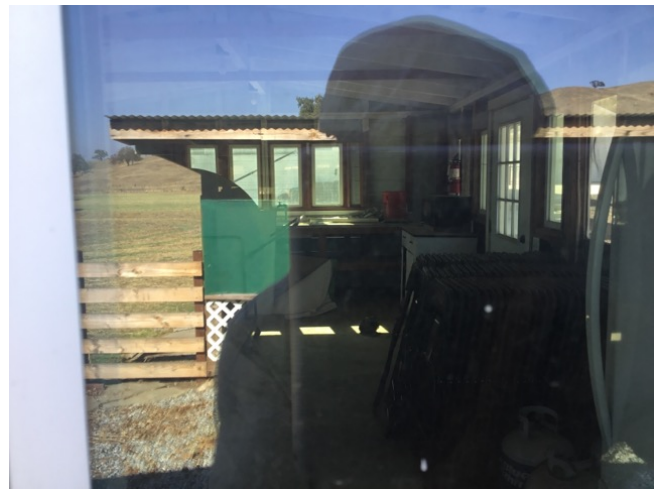
2367	<ul style="list-style-type: none"> As-Built Description: Sink does not have knee space min. 27" high x 19" deep x 30" wide. Proposed Solution: Remodel sink cabinet. 	PCODE IN06A ADAAG 91 4.24.3 ADA 2010 606.2 CBC 2007 1115B.4.7.1 CBC 2019 11B-606.2	1	JOB	\$5,250	\$5,250
						Priority 3
						Severity 3

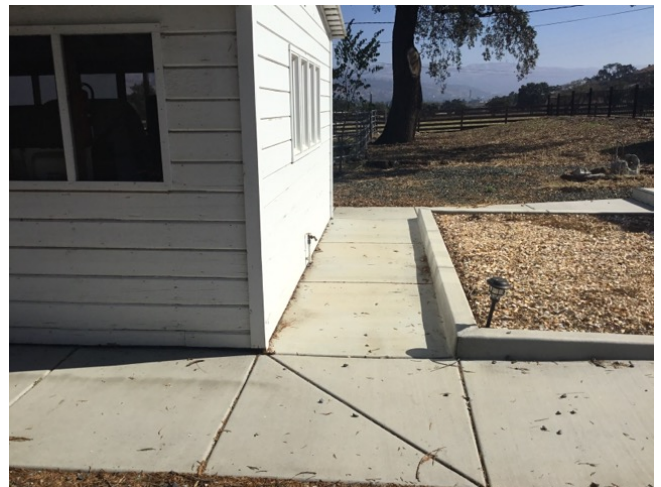
2362	<ul style="list-style-type: none"> As-Built Description: Walk more than 36" but less than 48" wide (required in CA only). As-Built: 39" to pipe 46" to wall. Proposed Solution: Enlarge width of walk to 48". 	<p>PCODE EF08</p> <p>CBC 2007 1133B.7.1</p> <p>CBC 2019 11B-403.5.1.3</p>	20	SF	\$135	\$2,700
						<p>Priority 1</p> <p>Severity 3</p>

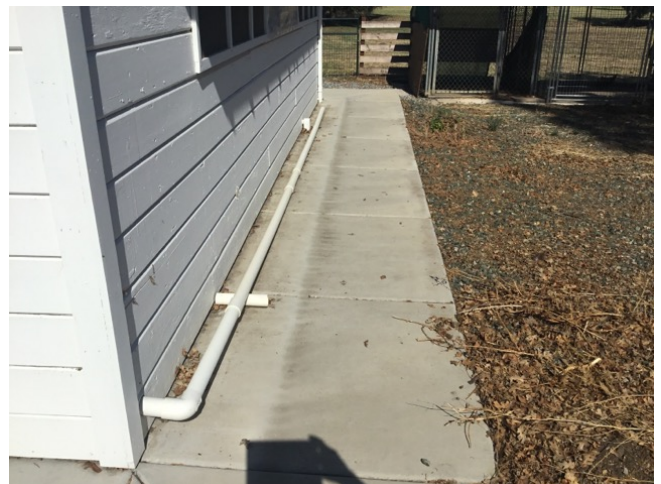
Item no., Rm no. and Name	Existing Architectural Barrier and Proposed Solution	Codes / Mitigation Info	Qty	Unit	Cost	Total
2359	<ul style="list-style-type: none"> • <i>As-Built Description:</i> Walk more than 36" but less than 48" wide (required in CA only). • <i>As-Built:</i> 47" • <i>Proposed Solution:</i> Enlarge width of walk to 48". 	<p>PCODE EF08REF</p> <p>ADA 2010 403.5</p> <p>CBC 2007 1133B.7.1</p> <p>CBC 2019 11B-403.5.1.3</p>		REF		
						<p>Priority 1</p> <p>Severity 3</p>

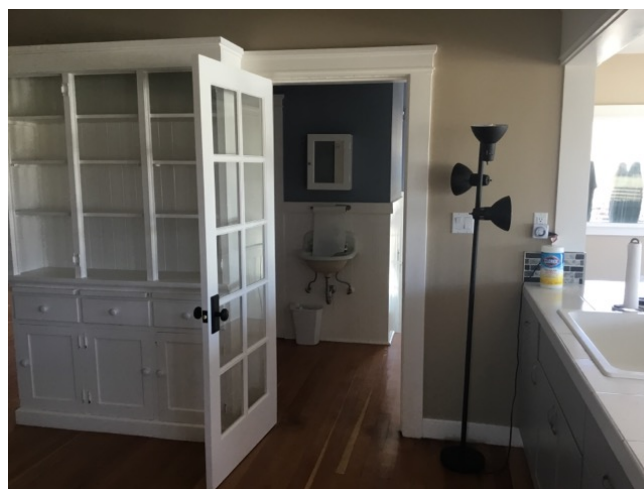
2390 • *As-Built Description:*
 Door on accessible route has less than 32" clear and 80" (78" min. to closer if provided) opening width when 90° open.

• *As-Built:* **71" high at 32" wide**

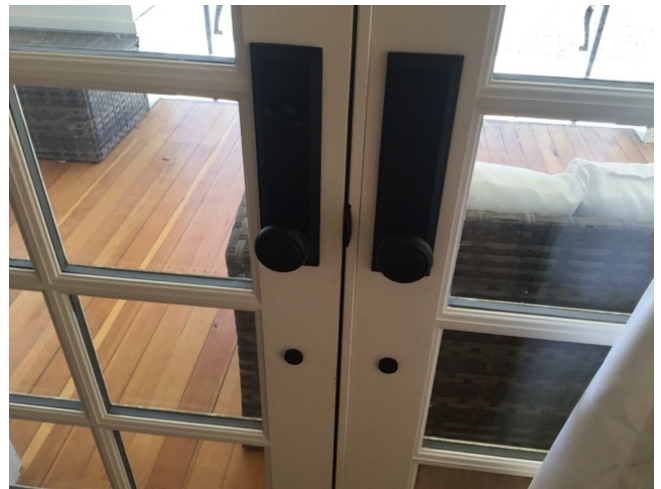
Item no., Rm no. and Name	Existing Architectural Barrier and Proposed Solution	Codes / Mitigation Info	Qty	Unit	Cost	Total
Door Threshold						
2376	<ul style="list-style-type: none"> As-Built Description: Door inaccessible due to threshold or step at door exceeding 1/2". As-Built: 1" Proposed Solution: Modify threshold. 	PCODE ID02A ADAAG 91 4.13.8 ADA 2010 404.2.5 CBC 2007 1133B.2.4.1 CBC 2019 11B-404.2.5	8	JOB	\$1,200	\$9,600
					Priority	1
					Severity	1

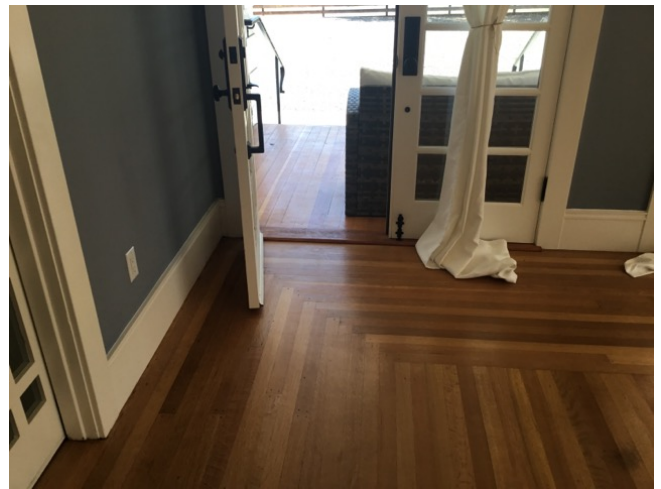
2411	<ul style="list-style-type: none"> As-Built Description: Door inaccessible due to threshold or step at door exceeding 1/2". As-Built: 2.5" Proposed Solution: Modify threshold when providing access with ramps or other accessible routes. 	PCODE ID02A ADAAG 91 4.13.8 ADA 2010 404.2.5 CBC 2007 1133B.2.4.1 CBC 2019 11B-404.2.5	2	JOB	\$1,200	\$2,400
					Priority	1
					Severity	1

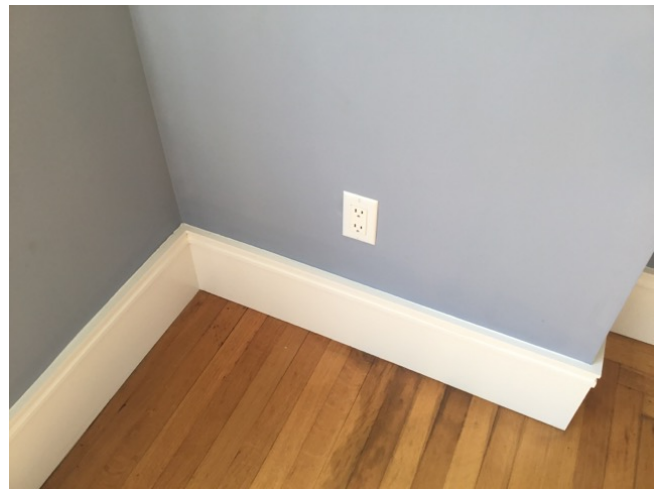
Item no., Rm no. and Name	Existing Architectural Barrier and Proposed Solution	Codes / Mitigation Info	Qty	Unit	Cost	Total
2374	<ul style="list-style-type: none"> <i>As-Built Description:</i> Electric switch or control mounted less than 15" measured to the bottom of the outlet box or greater than 48 inches measured to the top of the outlet box. <i>As-Built:</i> 50.5" to switch. 52" to top of the box. <i>Proposed Solution:</i> Relocate light switches or control to between 15" and 48" height. <i>Notes:</i> Includes upstairs. It appears the house was recently remodeled. Verify whether safe harbor applies. 	PCODE IC01 ADAAG 91 4.2.5 & 6 ADA 2010 308.2.1 & CBC 2007 1117B.6.3 CBC 2019 11B-308.2.1 & 11B-308.2.2	14	JOB	\$900	\$12,600
						Priority 3 Severity 3

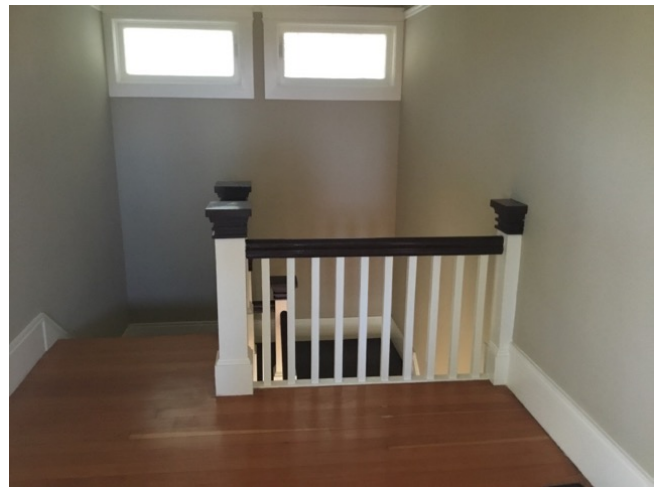
Item no., Rm no. and Name	Existing Architectural Barrier and Proposed Solution	Codes / Mitigation Info	Qty	Unit	Cost	Total
Handrails						
2401	<ul style="list-style-type: none"> • <i>As-Built Description:</i> Handrail not provided at stairs or ramp, required on both sides (not required at curb ramps or adjacent to seating areas). • <i>Proposed Solution:</i> Provide new handrail for each side including extensions. 	PCODE ED01 ADAAG 91 4.8.5 & 4.9.4 ADA 2010 505.2 CBC 2007 1133B.4.1.1 & .5.5 CBC 2019 11B-505.2	12	LF	\$285	\$3,420
					Priority	3
					Severity	3

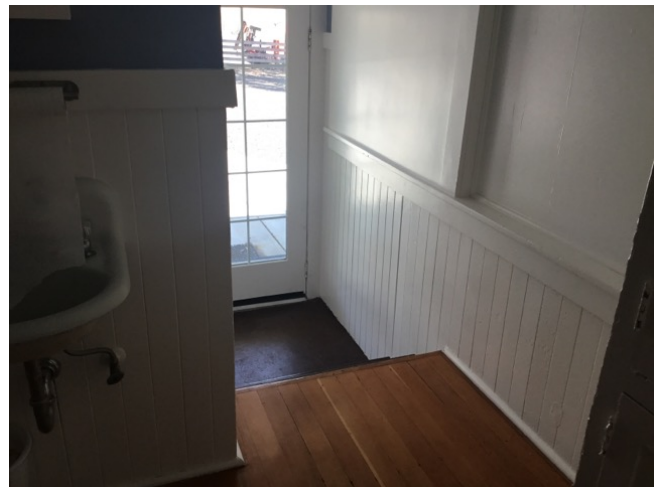
Item no., Rm no. and Name	Existing Architectural Barrier and Proposed Solution	Codes / Mitigation Info	Qty	Unit	Cost	Total
2405	<ul style="list-style-type: none"> • <i>As-Built Description:</i> Handrail not provided at stairs or ramp, required on both sides (not required at curb ramps or adjacent to seating areas). • <i>Proposed Solution:</i> Provide new handrail for each side including extensions. 	PCODE ED01 ADAAG 91 4.8.5 & 4.9.4 ADA 2010 505.2 CBC 2007 1133B.4.1.1 & .5.5 CBC 2019 11B-505.2	60	LF	\$285	\$17,100
					Priority	3
					Severity	3

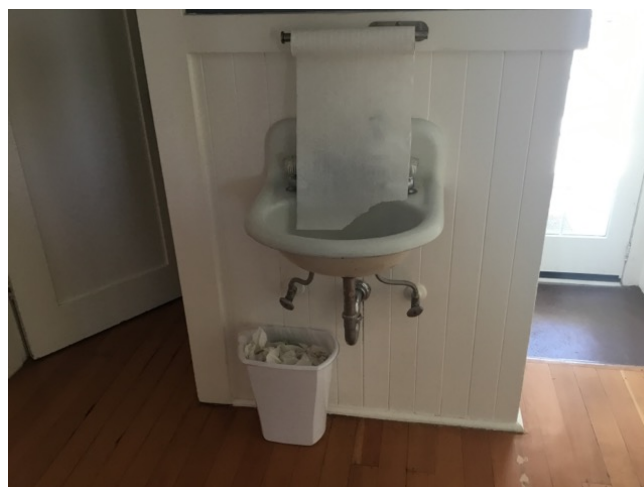
2378	<ul style="list-style-type: none"> As-Built Description: Operable part(s) require tight grasping, pinching, or twisting of the wrist with one hand. As-Built: 10lbs Proposed Solution: Modify or replace the operable part(s) to not require tight grasping, pinching, or twisting of the wrist with one hand. 	PCODE IC02 ADAAG 91 4.27.4 ADA 2010 309.4 CBC 2007 1117B.6.4 CBC 2019 11B-309.4	5	JOB	\$900	\$4,500
------	--	---	---	-----	-------	---------

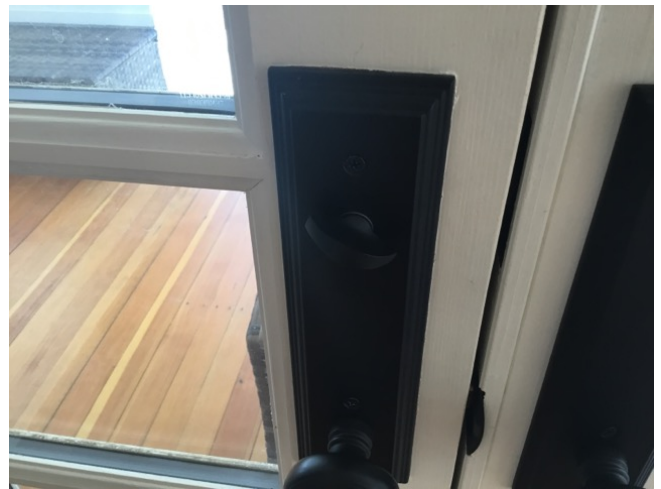
2408	<ul style="list-style-type: none"> As-Built Description: Operable part(s) require tight grasping, pinching, or twisting of the wrist with one hand. As-Built: Not operable without grasping. Proposed Solution: Modify or replace the operable part(s) to not require tight grasping, pinching, or twisting of the wrist with one hand. 	PCODE IC02 ADAAG 91 4.27.4 ADA 2010 309.4 CBC 2007 1117B.6.4 CBC 2019 11B-309.4	1	JOB	\$900	\$900
------	---	---	---	-----	-------	-------

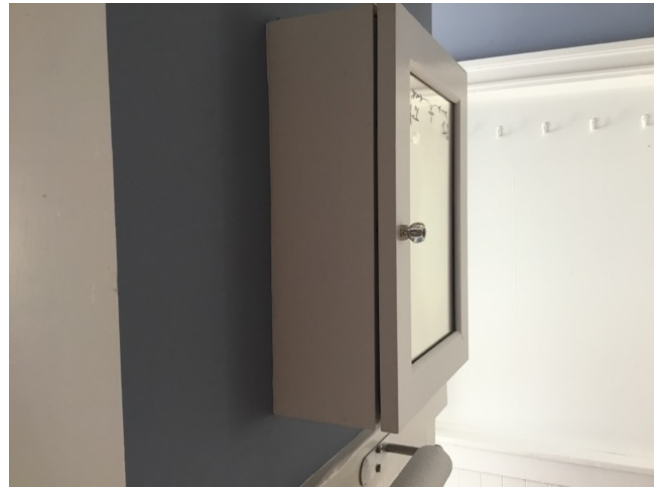
2412	<ul style="list-style-type: none"> • <i>As-Built Description:</i> Protruding objects more than 4" from wall, when bottom of object more than 27" or less than 80" above finished floor. • <i>As-Built:</i> 5" at 75". 6" at 78". • <i>Proposed Solution:</i> Remove/relocate protruding object. Patch existing surface. 	PCODE EG04 ADAAG 91 4.4.1 ADA 2010 307.2 CBC 2007 1133B.8.6.1 CBC 2019 11B-307.2	2	JOB	\$300	\$600
------	---	--	---	-----	-------	-------

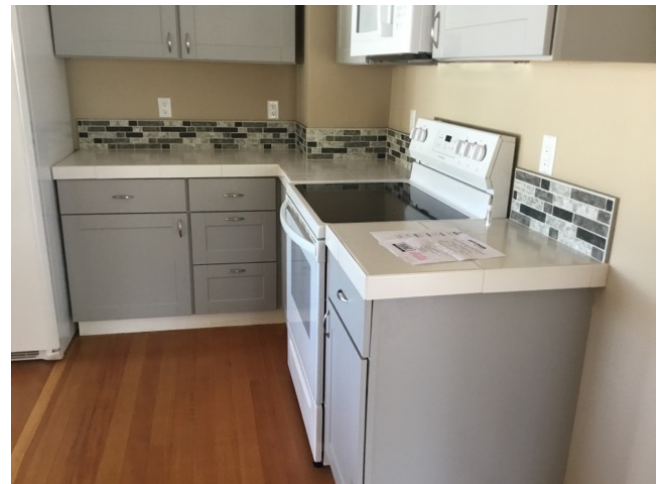
Item no., Rm no. and Name	Existing Architectural Barrier and Proposed Solution	Codes / Mitigation Info	Qty	Unit	Cost	Total
2382	<ul style="list-style-type: none"> As-Built Description: Reach height to control or access point, where side approach is available, exceeds 48" or is less than 15" in height, or exceeds 10" in depth. As-Built: 66" Proposed Solution: Modify equipment or mounting. 	PCODE IE02 ADAAG 91 4.2.6 ADA 2010 308.3.1 CBC 2007 1118B.6 CBC 2019 11B-308.3	1	JOB	\$300	\$300

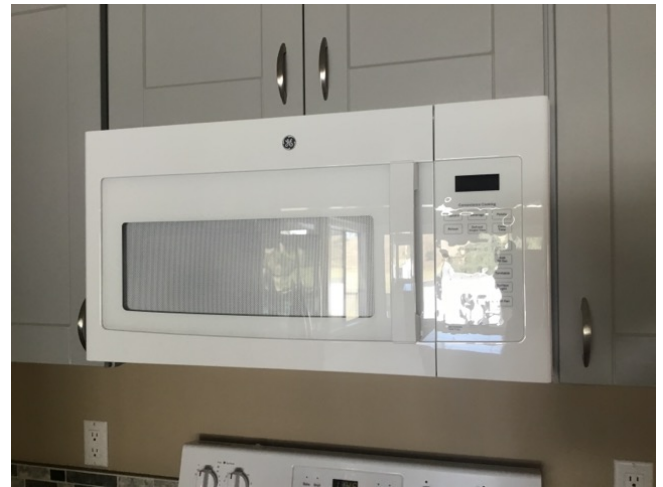
2392	<ul style="list-style-type: none"> As-Built Description: Reach height to control or access point, where side approach is available, exceeds 48" or is less than 15" in height, or exceeds 10" in depth. As-Built: 63" Proposed Solution: Modify equipment or mounting. 	PCODE IE02 ADAAG 91 4.2.6 ADA 2010 308.3.1 CBC 2007 1118B.6 CBC 2019 11B-308.3	1	JOB	\$300	\$300
------	--	--	---	-----	-------	-------

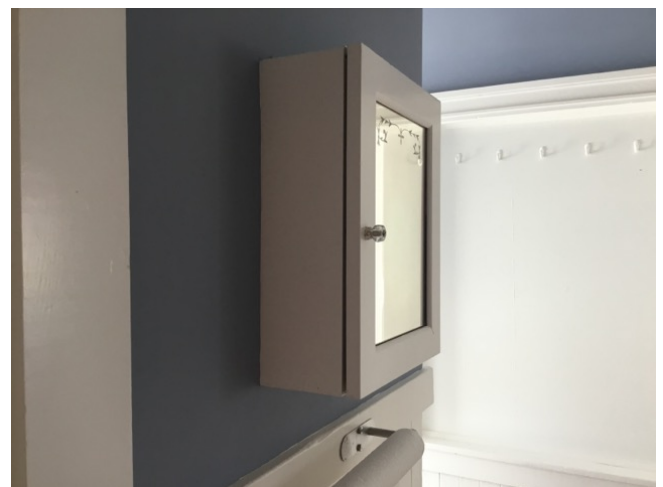
Item no., Rm no. and Name	Existing Architectural Barrier and Proposed Solution	Codes / Mitigation Info	Qty	Unit	Cost	Total
2394	<ul style="list-style-type: none"> • <i>As-Built Description:</i> Reach height to control or access point, where side approach is available, exceeds 48" or is less than 15" in height, or exceeds 10" in depth. • <i>As-Built:</i> 75" • <i>Proposed Solution:</i> Modify equipment or mounting. 	PCODE IE02 ADAAG 91 4.2.6 ADA 2010 308.3.1 CBC 2007 1118B.6 CBC 2019 11B-308.3	1	JOB	\$300	\$300
						Priority 3 Severity 3

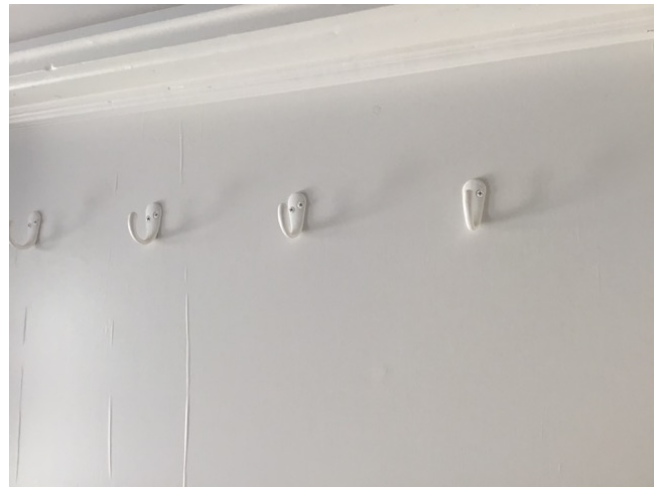
2400	<ul style="list-style-type: none"> • <i>As-Built Description:</i> Reach height to control or access point, where side approach is available, exceeds 48" or is less than 15" in height, or exceeds 10" in depth. • <i>As-Built:</i> 24" deep 52" AFF. • <i>Proposed Solution:</i> Modify equipment or mounting. 	PCODE IE02 ADAAG 91 4.2.6 ADA 2010 308.3.1 CBC 2007 1118B.6 CBC 2019 11B-308.3	1	JOB	\$300	\$300
						Priority 3 Severity 3

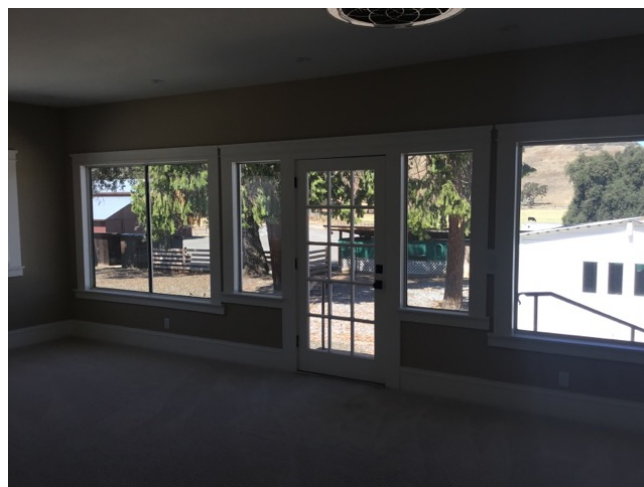
2434	<ul style="list-style-type: none"> As-Built Description: At door leading into exit corridor: Where required exit signs are installed, signs to provide exiting information for people with vision impairment are not provided. Proposed Solution: Provide raised letter/Braille "EXIT ROUTE" sign at door. 	PCODE SA10D ADAAG 91 4.1.3(16) ADA 2010 216.4.1 CBC 2007 1011.3 CBC 2019 11B-216.4.1	7	JOB	\$270	\$1,890
						Priority 1 Severity 3

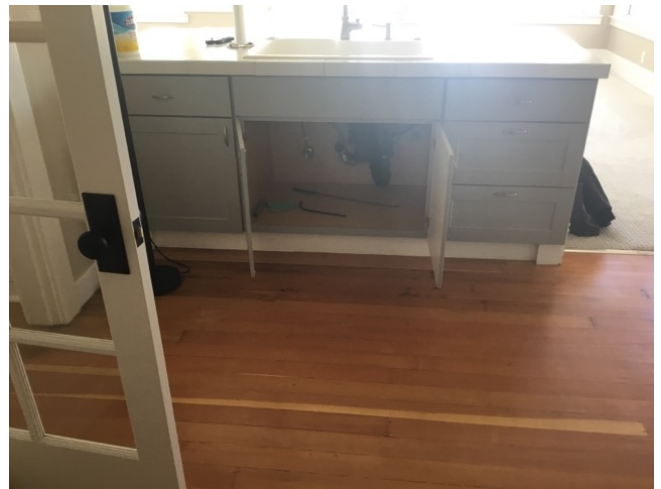
2398	<ul style="list-style-type: none"> • <i>As-Built Description:</i> Sink does not have knee space min. 27" high x 19" deep x 30" wide. • <i>Proposed Solution:</i> Remodel sink cabinet. 	PCODE IN06A ADAAG 91 4.24.3 ADA 2010 606.2 CBC 2007 1115B.4.7.1 CBC 2019 11B-606.2	1	JOB	\$5,250	\$5,250
						Priority 3 Severity 3

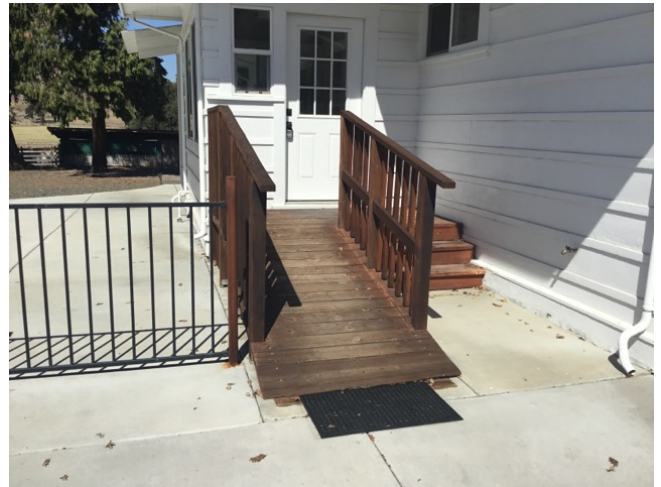
Item no., Rm no. and Name	Existing Architectural Barrier and Proposed Solution	Codes / Mitigation Info	Qty	Unit	Cost	Total
Slope						
2410	<ul style="list-style-type: none"> As-Built Description: Slope greater than 1:12 (8.3%). As-Built: 22% Proposed Solution: Demolish existing and provide new ramp with handrails. Notes: Multiple barriers at the main entrance ramp and stairs. 	PCODE EB02 ADAAG 91 4.8.2 ADA 2010 405.2 CBC 2007 1133B.5.3 CBC 2019 11B-405.2	100	SF	\$300	\$30,000
					Priority	3
					Severity	3

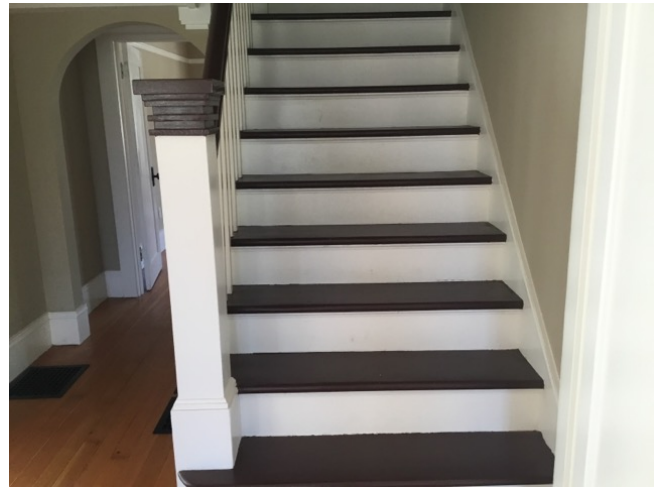
Item no., Rm no. and Name	Existing Architectural Barrier and Proposed Solution	Codes / Mitigation Info	Qty	Unit	Cost	Total
Stairs						
2386	<ul style="list-style-type: none"> <i>As-Built Description:</i> Stair tread width less than 11", measured horizontally from nosing to nosing. <i>Proposed Solution:</i> Rebuild stair as needed. <i>Notes:</i> Consider whether technically feasible. 	PCODE EC06 ADAAG 91 4.9.2 ADA 2010 504.2 CBC 2007 1133B.4.5.3 CBC 2019 11B-504.2	80	LF	\$225	\$18,000
						Priority 3
						Severity 3

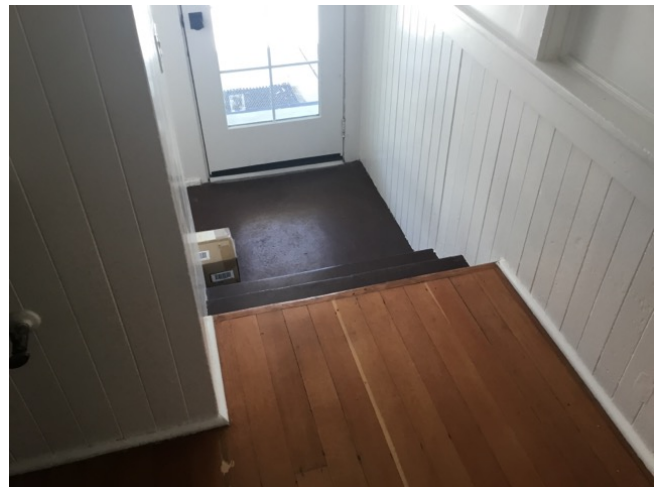
2402	<ul style="list-style-type: none"> As-Built Description: The leading 2" of the tread does not have visual contrast of dark-on-light or light-on-dark from the remainder of the tread. Proposed Solution: Provide 2" min., 4" max. wide contrasting color strip 1" max. from nosing on top & bottom treads when altering area. 	<p>PCODE II02B</p> <p>ADA 2010 504.4</p> <p>CBC 2007 1133B.4.4</p> <p>CBC 2019 11B-504.4.1</p>	8	LF	\$42	\$336
------	---	--	---	----	------	-------

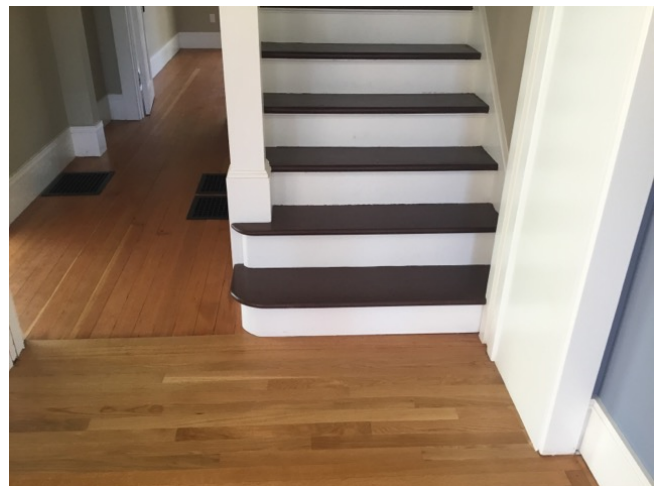
2403	<ul style="list-style-type: none"> As-Built Description: The leading 2" of the tread does not have visual contrast of dark-on-light or light-on-dark from the remainder of the tread. Proposed Solution: Provide 2" min., 4" max. wide contrasting color strip 1" max. from nosing on top & bottom treads when altering area. 	<p>PCODE II02B</p> <p>ADA 2010 504.4</p> <p>CBC 2007 1133B.4.4</p> <p>CBC 2019 11B-504.4.1</p>	16	LF	\$42	\$672
------	---	--	----	----	------	-------

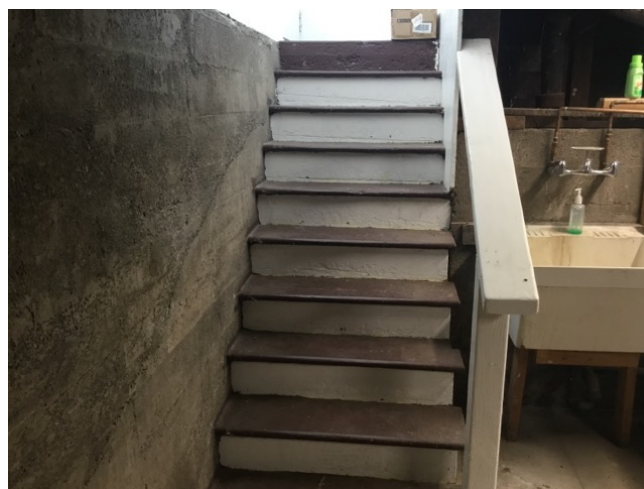
Item no., Rm no. and Name	Existing Architectural Barrier and Proposed Solution	Codes / Mitigation Info	Qty	Unit	Cost	Total
Stairways						
2397	<ul style="list-style-type: none"> As-Built Description: Exterior stair substantially out of compliance. As-Built: Consider technical feasibility. Proposed Solution: Provide complete new stair, 4 ft. wide with landing and handrails. 	PCODE EC09 ADAAG 91 4.9 ADA 2010 504 CBC 2007 1133B.4 CBC 2019 11B-504	100	IN	\$270	\$27,000
					Priority	3
					Severity	3

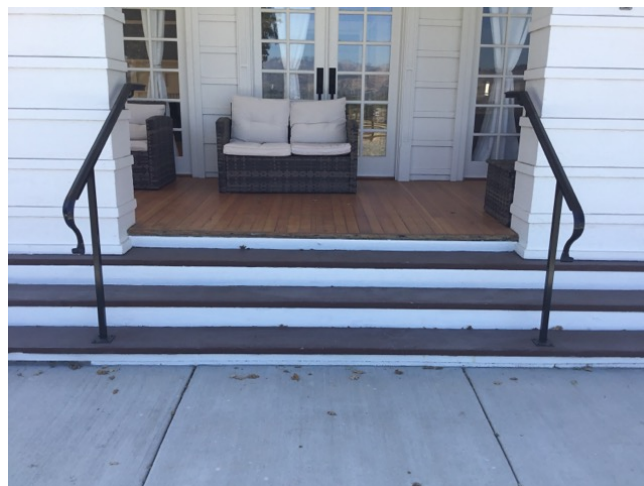
2406	<ul style="list-style-type: none"> As-Built Description: Exterior stair substantially out of compliance. Proposed Solution: Provide complete new stair, 4 ft. wide with landing and handrails. Notes: The surveyor did not find any compliant stairs on the exterior or interior of the building. There are no compliant accessible routes between the levels. 	PCODE EC09 ADAAG 91 4.9 ADA 2010 504 CBC 2007 1133B.4 CBC 2019 11B-504	400	IN	\$270	\$108,000
					Priority	3
					Severity	3

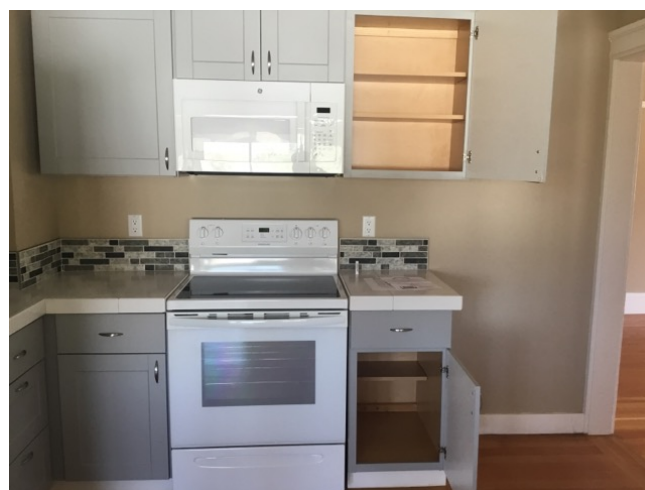
2371	<ul style="list-style-type: none"> As-Built Description: At least one of each type of fixed or built-in storage facility, including cabinets, shelves, closets, and drawers is not accessible. (50% of shelf space) As-Built: 5" and 59" to low shelves. Approximately 20% accessible storage. Proposed Solution: Provide accessible storage areas as required. 	PCODE KC05 ADAAG 91 13.3.2(8) ADA 2010 804.5 CBC 2007 1111B.5.1 CBC 2019 11B-804.5	1	JOB	\$18,000	\$18,000
------	---	--	---	-----	----------	----------

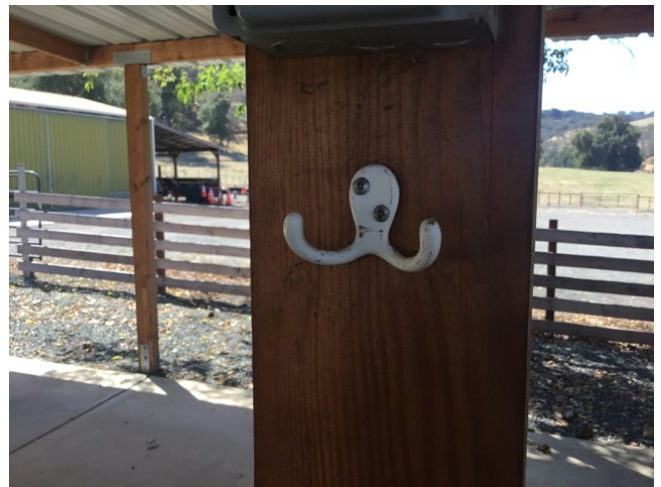
Item no., Rm no. and Name	Existing Architectural Barrier and Proposed Solution	Codes / Mitigation Info	Qty	Unit	Cost	Total
Reach Range						
2416	<ul style="list-style-type: none"> As-Built Description: Reach height to control or access point, where side approach is available, exceeds 48" or is less than 15" in height, or exceeds 10" in depth. As-Built: 61" Proposed Solution: Modify equipment or mounting. 	PCODE IE02 ADAAG 91 4.2.6 ADA 2010 308.3.1 CBC 2007 1118B.6 CBC 2019 11B-308.3	1	JOB	\$300	\$300
					Priority	3
					Severity	3

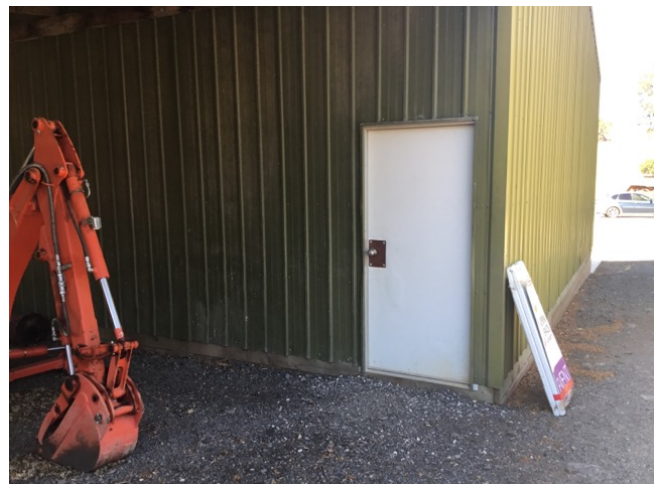
2418	<ul style="list-style-type: none"> • <i>As-Built Description:</i> At time of survey, room was locked and could not be accessed. • <i>Proposed Solution:</i> Verify elements in room are compliant with ADA. 	<p>PCODE XA03</p> <p>CBC 2019 11B-403.5.1.3</p>		REF		
------	---	---	--	-----	--	--

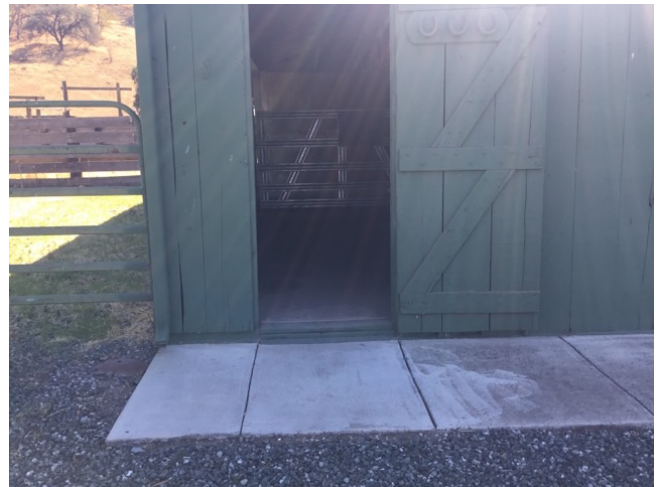
Item no., Rm no. and Name	Existing Architectural Barrier and Proposed Solution	Codes / Mitigation Info	Qty	Unit	Cost	Total
2425	<ul style="list-style-type: none"> As-Built Description: Surface of required maneuvering clearance at door slopes more than 1/4":12" (2.0%). As-Built: 2.8%-4% Proposed Solution: Modify surface slope at door. 	PCODE ID11 ADAAG 91 4.13.6 ADA 2010 404.2.4.4 CBC 2007 1133B.2.4 CBC 2019 11B-404.2.4	20	SF	\$120	\$2,400
						Priority 1 Severity 3

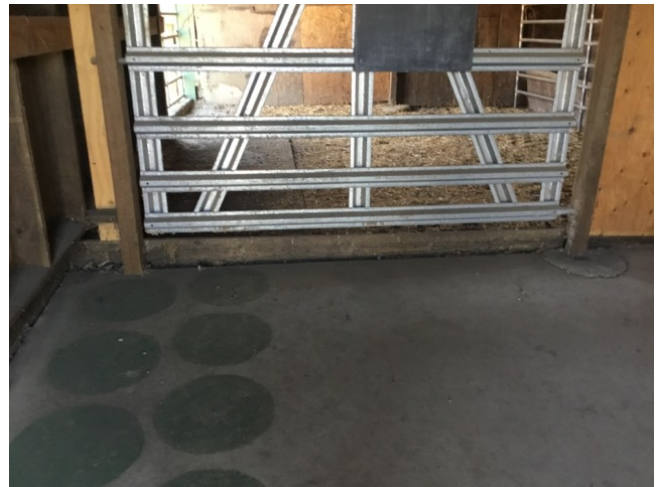
Item no., Rm no. and Name	Existing Architectural Barrier and Proposed Solution	Codes / Mitigation Info	Qty	Unit	Cost	Total
2423	<ul style="list-style-type: none"> • <i>As-Built Description:</i> Door inaccessible due to threshold or step at door exceeding 1/2". • <i>Proposed Solution:</i> Modify threshold. 	PCODE ID02A ADAAG 91 4.13.8 ADA 2010 404.2.5 CBC 2007 1133B.2.4.1 CBC 2019 11B-404.2.5	1	JOB	\$1,200	\$1,200
					Priority	1
					Severity	1

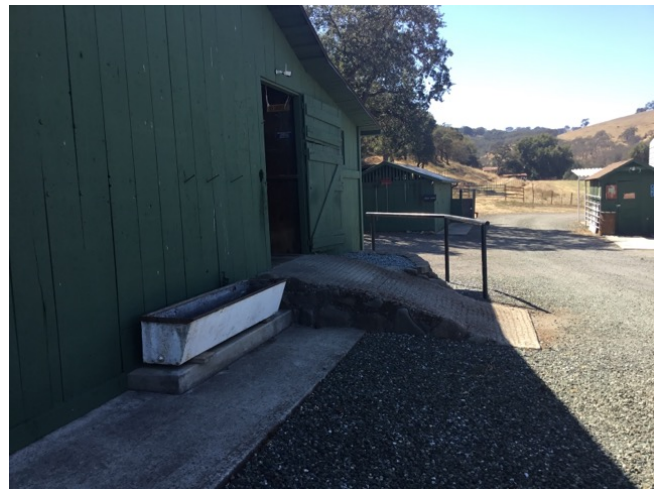
Item no., Rm no. and Name	Existing Architectural Barrier and Proposed Solution	Codes / Mitigation Info	Qty	Unit	Cost	Total
Slope						
2426	<ul style="list-style-type: none"> As-Built Description: Slope greater than 1:12 (8.3%). As-Built: 29% Proposed Solution: Demolish existing and provide new ramp with handrails. 	PCODE EB02 ADAAG 91 4.8.2 ADA 2010 405.2 CBC 2007 1133B.5.3 CBC 2019 11B-405.2	180	SF	\$300	\$54,000
						Priority 3 Severity 3
