Facilities Access Compliance Survey Report for the Santa Clara Valley Open Space Authority

Santa Clara Valley Open Space Access Compliance Survey Report

Santa Clara Valley
April 2023
SSA Project #: 21058

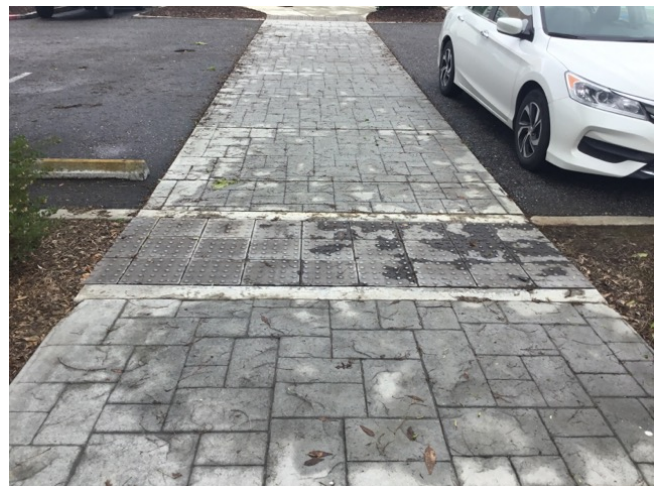
Item no., Rm no. and Name	Existing Architectural Barrier and Proposed Solution	Codes / Mitigation Info	Qty	Unit	Cost	Total
Door						
2503	<ul style="list-style-type: none"> As-Built Description: Surface of required maneuvering clearance at door slopes more than 1/4":12" (2.0%). As-Built: 0.2" level changes in door maneuvering clearance. Caused by detectable warnings. Proposed Solution: Relocate detectable warnings outside the door maneuvering clearance. 	PCODE ID11 ADAAG 91 4.13.6 ADA 2010 404.2.4.4 CBC 2007 1133B.2.4 CBC 2019 11B-404.2.4	25	SF	\$120	\$3,000
						Priority 1
						Severity 3

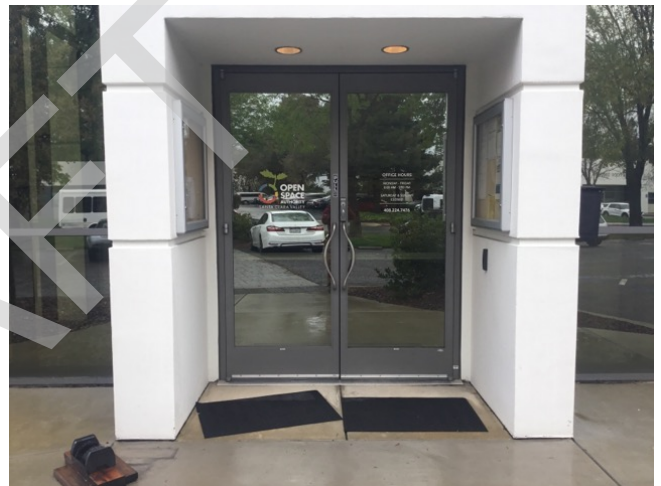
Signage

2437	<ul style="list-style-type: none"> As-Built Description: Signs containing tactile characters is not located so that a clear floor space of 18" min x 18" min., centered on the tactile characters, is provided beyond the arc of any door swing between the closed position and 45 degree open position. As-Built: Stones obstruct the CLFS. Proposed Solution: Modify stone display. 	PCODE SA07B ADA 2010 703.4.2 CBC 2019 11B-703.4.2	1	JOB	\$1,500	\$1,500
					Priority	1
					Severity	1

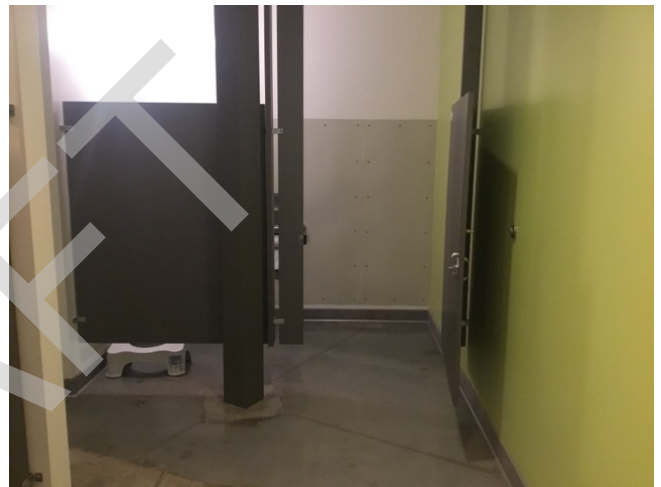
2453	<ul style="list-style-type: none"> As-Built Description: Side grab bar less than 42" long, or located more than 12 inches max. from the rear wall, or extending less than 54" from rear wall (CA only: front end min. 24" in front of water closet). As-Built: Extends 51" Proposed Solution: Provide or relocate accessible side grab bar. 	PCODE WB07A ADAAG 91 Fig. 29(b) ADA 2010 604.5.1 CBC 2007 1115B.4.1.3.1 CBC 2019 11B-604.5.1	1	JOB	\$780	\$780
------	---	---	---	-----	-------	-------

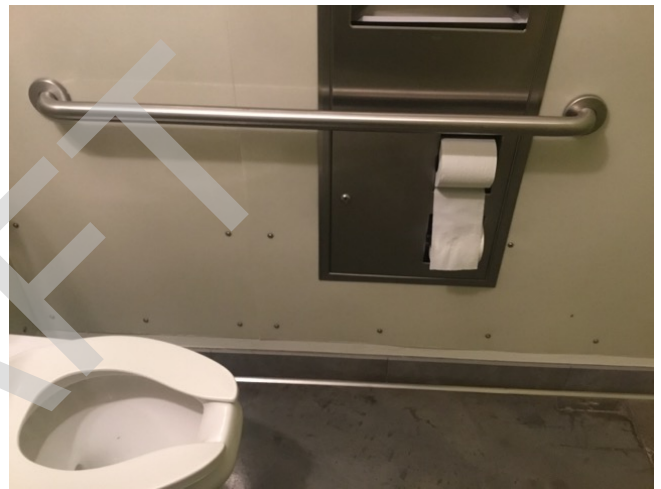
2455	<ul style="list-style-type: none"> As-Built Description: Accessories/dispensers in accessible stall located closer than 1-1/2" below or 12" above grab bar impedes its use. As-Built: 1.325" to toilet paper dispenser enclosure. Proposed Solution: Relocate accessories/dispensers to be no closer than 1-1/2" below and 12" above grab bars (except if accessories are recessed, flush with wall, and have no sharp edges). 	PCODE WB07I ADAAG 91 4.26.2 ADA 2010 609.3 CBC 2007 1133B.4.2.5 CBC 2019 11B-609.3	1	JOB	\$225	\$225
------	--	---	---	-----	-------	-------

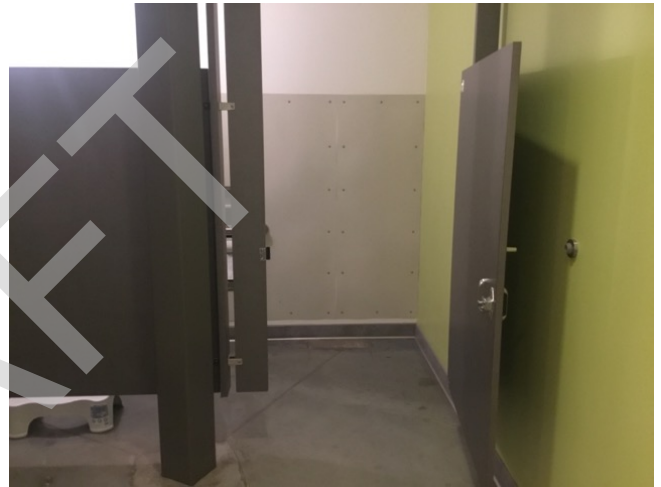
Item no., Rm no. and Name	Existing Architectural Barrier and Proposed Solution	Codes / Mitigation Info	Qty	Unit	Cost	Total
Toilet Stall						
2449	<ul style="list-style-type: none"> As-Built Description: Toilet stall less than 60" wide. As-Built: 58" wide at 47" from rear wall. Obstructed by cross support. Proposed Solution: Provide new accessible stall. 	PCODE WB06 ADAAG 91 4.17.3 ADA 2010 604.8.1.1 CBC 2007 1115B.3.1.4.1 CBC 2019 11B-604.8.1.1	1	JOB	\$4,500	\$4,500
					Priority	2
					Severity	3

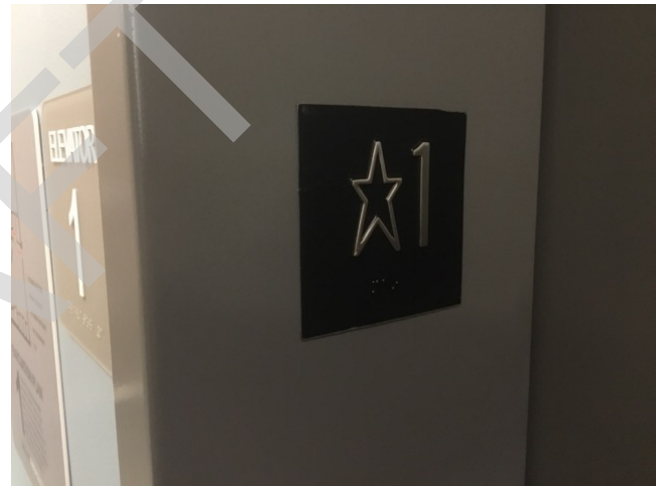
Item no., Rm no. and Name	Existing Architectural Barrier and Proposed Solution	Codes / Mitigation Info	Qty	Unit	Cost	Total
Signage						
2468	<ul style="list-style-type: none"> As-Built Description: Sign does not have non-glare finish and/or good color contrast (dark on light or light on dark). As-Built: Hoistway signs on both floors have glare. Proposed Solution: Provide compliant signage. 	PCODE SA03 ADAAG 91 4.30.5 ADA 2010 703.5.1 CBC 2007 1117B.5.5 CBC 2019 11B -407.4.7.1.3	2	JOB	\$270	\$540
					Priority	1
					Severity	4

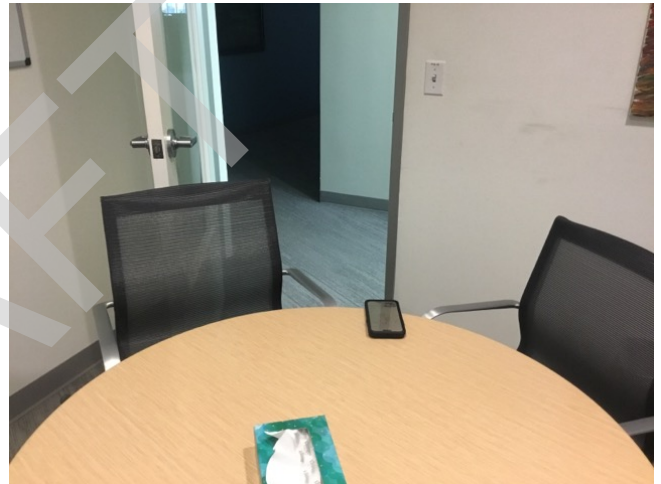
Item no., Rm no. and Name	Existing Architectural Barrier and Proposed Solution	Codes / Mitigation Info	Qty	Unit	Cost	Total
Non-Fixed Desk						
2470	<ul style="list-style-type: none"> As-Built Description: Accessible non-fixed table or desk (top 28" to 34" high; knee space at least 27" high x 19" deep x 30" wide) not provided. As-Built: 9" deep toe clearance. Proposed Solution: Provide table or desk with accessible dimensions when purchasing new furniture. 	PCODE IN02A ADAAG 91 4.32.3 & .4 ADA 2010 306.1 CBC 2007 1122B.3 & 4 CBC 2019 11B-306.1 & 11B-902.3	1	JOB	\$4,800	\$4,800
						Priority 1 Severity 3

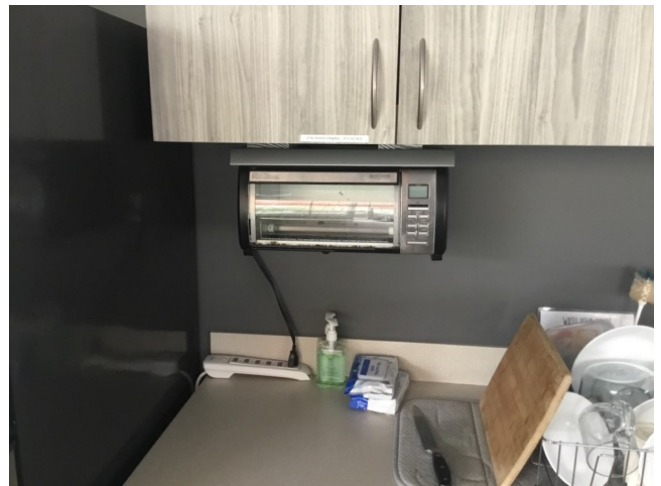
2473	<ul style="list-style-type: none"> As-Built Description: Reach height to control or access point, where side approach is available, exceeds 48" or is less than 15" in height, or exceeds 10" in depth. As-Built: 56" AFF Proposed Solution: Relocate the toaster. 	PCODE IE02 ADAAG 91 4.2.6 ADA 2010 308.3.1 CBC 2007 1118B.6 CBC 2019 11B-308.3	1	JOB	\$300	\$300
------	--	--	---	-----	-------	-------

Priority 4

Severity 3

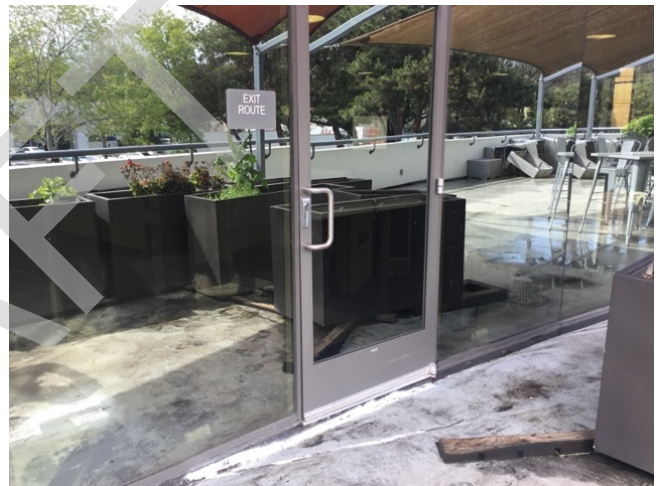
14 Roof Deck

Door Threshold

- *As-Built Description:*

Door inaccessible due to threshold or step at door exceeding 1/2".

- *As-Built:* **3"**

PCODE ID02A
 ADAAG 91 4.13.8
 ADA 2010 404.2.5
 CBC 2007 1133B.2.4.1
 CBC 2019 11B-404.2.5

Priority **1**

Severity **2**

- *Proposed Solution:*

Provide ramp and landing.

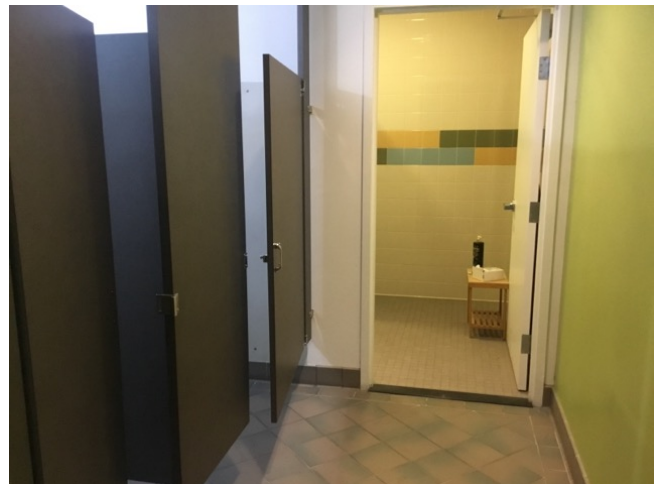
2478	<ul style="list-style-type: none"> As-Built Description: Front approach: At pull side, door does not have clear and level maneuvering space measuring door width plus 18" x 60". (24" x 60" at exterior doors). As-Built: 54" Proposed Solution: Remove standard compartment and completely remodel the accessible compartment. 	PCODE ID23B ADAAG 91 Fig. 25(a) ADA 2010 404.2.4 CBC 2007 11B-26A(a) CBC 2019 11B-404.2.4	1	JOB	\$16,800	\$16,800
					Priority	2
					Severity	3

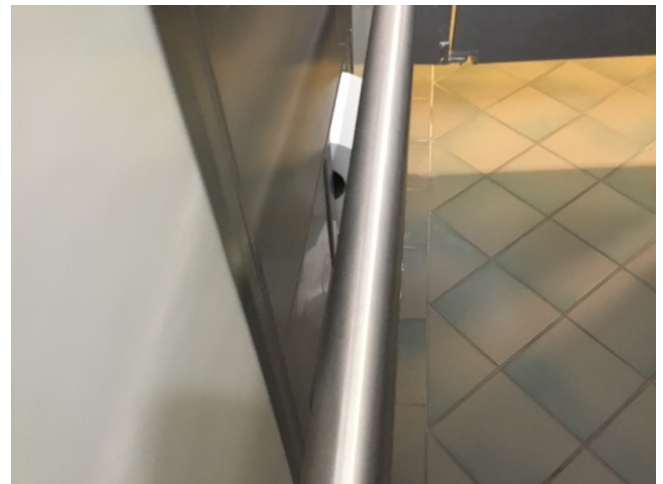
2493	<ul style="list-style-type: none"> As-Built Description: Accessories/dispensers in accessible stall located closer than 1-1/2" below or 12" above grab bar impedes its use. As-Built: 1.125" Proposed Solution: Relocate accessories/dispensers to be no closer than 1-1/2" below and 12" above grab bars (except if accessories are recessed, flush with wall, and have no sharp edges). 	PCODE WB07I ADAAG 91 4.26.2 ADA 2010 609.3 CBC 2007 1133B.4.2.5 CBC 2019 11B-609.3	1	JOB	\$225	\$225
------	---	---	---	-----	-------	-------

Priority 2

Severity 2

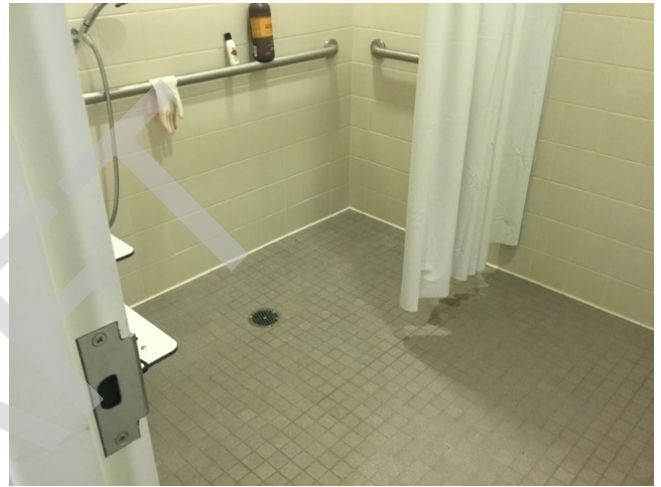
Shower

2483	<ul style="list-style-type: none"> As-Built Description: Floor surface sloped greater than 2.0% (1:48) due to drain. As-Built: 3% Proposed Solution: Remodel floor surface to compliance. 	PCODE WF06A ADA 2010 608.9 CBC 2019 11B-608.9	1	JOB	\$1,500	\$1,500
						Priority 2 Severity 4

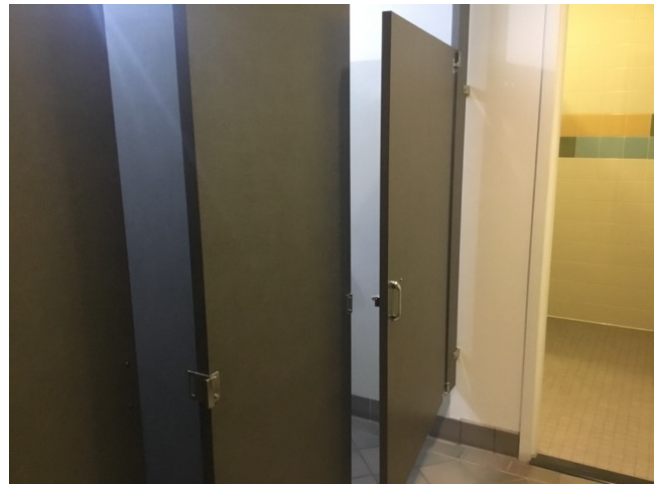
Stall Door

2479	<ul style="list-style-type: none"> As-Built Description: Stall door to accessible compartment not self closing. Proposed Solution: Adjust closer. 	PCODE WB05B ADAAG 91 4.22.4 ADA 2010 604.8.1.2 CBC 2007 1115B.3.1.4.4 CBC 2019 11B-604.8.1.2	1	JOB	\$75	\$75
						Priority 2 Severity 3

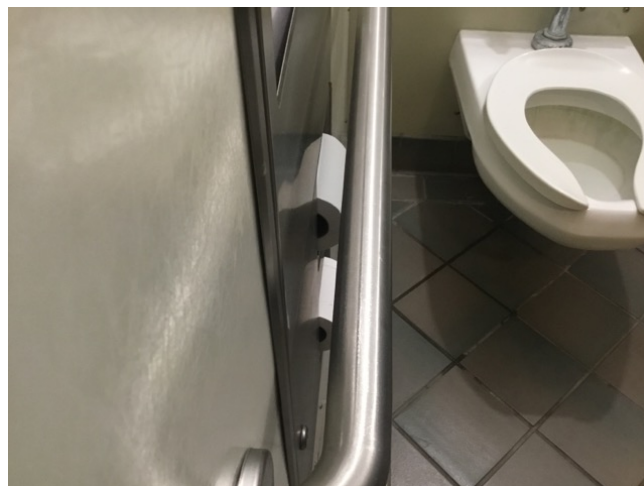
2489

- *As-Built Description:*
Accessories/dispensers in accessible stall located closer than 1-1/2" below or 12" above grab bar impedes its use.
- *As-Built:* **1.25"**
- *Proposed Solution:*
Relocate accessories/dispensers to be no closer than 1-1/2" below and 12" above grab bars (except if accessories are recessed, flush with wall, and have no sharp edges).

Priority 2
Severity 3

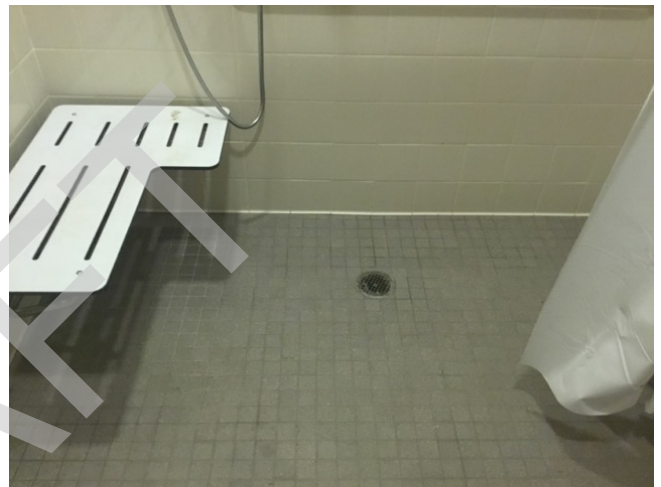
Item no., Rm no. and Name	Existing Architectural Barrier and Proposed Solution	Codes / Mitigation Info	Qty	Unit	Cost	Total
Shower						
2490	<ul style="list-style-type: none"> As-Built Description: Floor surface sloped greater than 2.0% (1:48) due to drain. As-Built: 2.9% Proposed Solution: Remodel floor surface to compliance. 	PCODE WF06A ADA 2010 608.9 CBC 2019 11B-608.9	1	JOB	\$1,500	\$1,500
						Priority 2 Severity 4

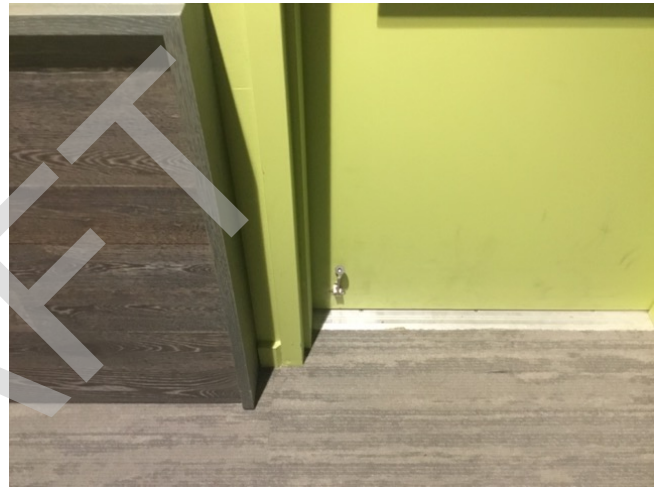
Item no., Rm no. and Name	Existing Architectural Barrier and Proposed Solution	Codes / Mitigation Info	Qty	Unit	Cost	Total
Door Stopper						
2445	<ul style="list-style-type: none"> • <i>As-Built Description:</i> At push side of door on accessible route, bottom 10" does not have a smooth, uninterrupted surface. • <i>Proposed Solution:</i> Relocate doorstop. 	<p>PCODE ID06A</p> <p>ADA 2010 404.2.10</p> <p>CBC 2007 1133B.2.6</p> <p>CBC 2019 11B-404.2.10</p>	10	JOB	\$1,800	\$18,000
						<p>Priority 1</p> <p>Severity 3</p>

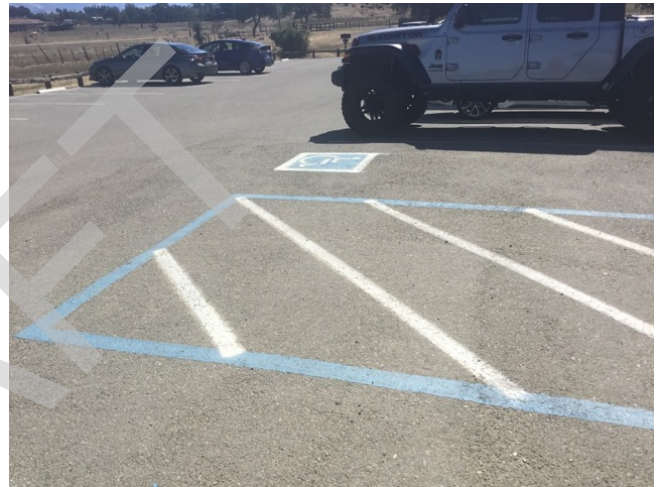
Item no., Rm no. and Name	Existing Architectural Barrier and Proposed Solution	Codes / Mitigation Info	Qty	Unit	Cost	Total
Floor or Ground Surfaces						
2279	<ul style="list-style-type: none"> As-Built Description: Accessible parking space has slope greater than 1/4":12" (2%). As-Built: To 9% Proposed Solution: Modify slope at accessible parking space. 	PCODE EA05 ADAAG 91 4.6.3 ADA 2010 502.4 CBC 2007 1129B.3.3 CBC 2019 11B-502.4	15	SF	\$36	\$540
						Priority 3
						Severity 2

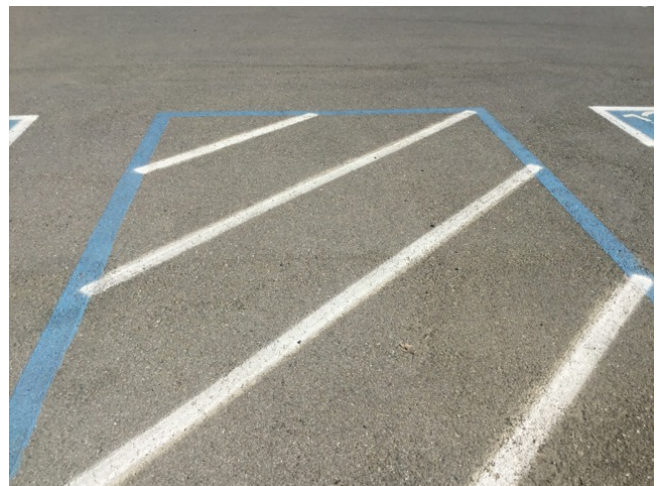
2281	<ul style="list-style-type: none"> As-Built Description: The words "NO PARKING" not painted on the ground within loading and unloading access aisle (12" min high white letters), located so that it is visible to traffic enforcement officials (required in CA only). Proposed Solution: Provide the words "NO PARKING" in each access aisle, painted in 12" high letters, when altering area. 	PCODE EA04D CBC 2007 1129B.3.1 CBC 2019 11B-502.3.3	1	JOB	\$300	\$300
					Priority	3
					Severity	4

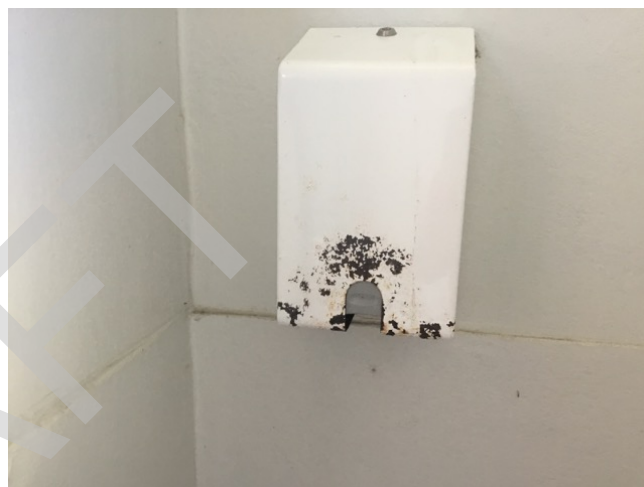
Item no., Rm no. and Name	Existing Architectural Barrier and Proposed Solution	Codes / Mitigation Info	Qty	Unit	Cost	Total
2287	<ul style="list-style-type: none"> • <i>As-Built Description:</i> Dispensers in sanitary facilities, such as for towels, soap, sanitary napkins, seat covers, etc., and waste receptacles more than 48" (CA only: 40") from floor to highest operating slot or control. • <i>As-Built:</i> 51" • <i>Proposed Solution:</i> Relocate existing restroom accessories. 	PCODE WG01A ADAAG 91 4.23.7 ADA 2010 308.2.1 CBC 2007 1115B.8.3 CBC 2019 11B-603.5	1	JOB	\$300	\$300

Priority 2
Severity 3

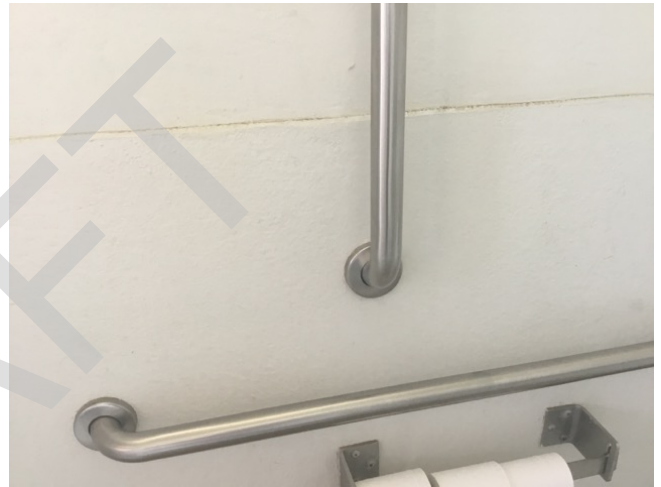
Item no., Rm no. and Name	Existing Architectural Barrier and Proposed Solution	Codes / Mitigation Info	Qty	Unit	Cost	Total
Grab Bars						
2288	<ul style="list-style-type: none"> As-Built Description: Accessories/dispensers in accessible stall located closer than 1-1/2" below or 12" above grab bar impedes its use. As-Built: 6" Proposed Solution: Remove the vertical grab bar. 	PCODE WB07I ADAAG 91 4.26.2 ADA 2010 609.3 CBC 2007 1133B.4.2.5 CBC 2019 11B-609.3	1	JOB	\$225	\$225
					Priority	2
					Severity	3

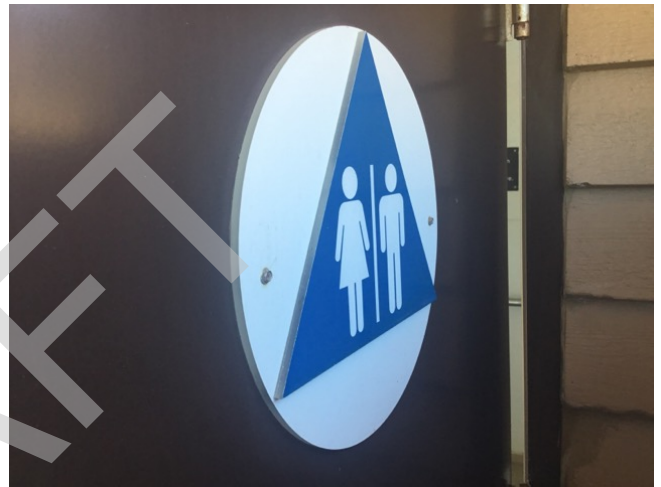
Item no., Rm no. and Name	Existing Architectural Barrier and Proposed Solution	Codes / Mitigation Info	Qty	Unit	Cost	Total
2289	<ul style="list-style-type: none"> • <i>As-Built Description:</i> Required in CA only: identification symbol centered 58" to 60" high on sanitary facility door that contrasts with the door not provided (women: 12" ø circle, men: 12" triangle, unisex: combined symbol). • <i>As-Built:</i> Not beveled. • <i>Proposed Solution:</i> Provide properly mounted sanitary facility symbol when altering area. If wheelchair accessible, include International Symbol of Accessibility on sign. 	PCODE SA15 CBC 2007 1115B.6 CBC 2019 11B-703.7.2.6	1	JOB	\$270	\$270

Priority 2
Severity 3

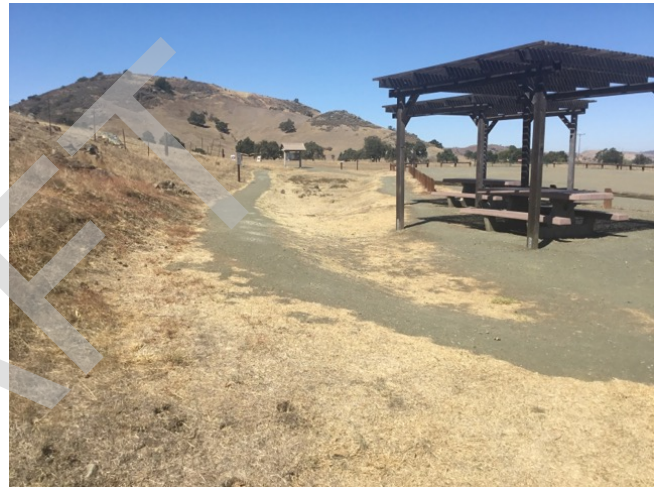
Item no., Rm no. and Name	Existing Architectural Barrier and Proposed Solution	Codes / Mitigation Info	Qty	Unit	Cost	Total
Cross Slope						
2294	<ul style="list-style-type: none"> As-Built Description: Cross slope more than 1":48" (2.083%). As-Built: To 13% Proposed Solution: Modify cross slope. Notes: Occurs on both trails from picnic and restrooms to information and trail head. 	PCODE EF07 ADAAG 91 4.3.7 ADA 2010 403.3 CBC 2007 1133B.7.1.3 CBC 2019 11B-403.3	1600	SF	\$30	\$48,000
						Priority 1
						Severity 3

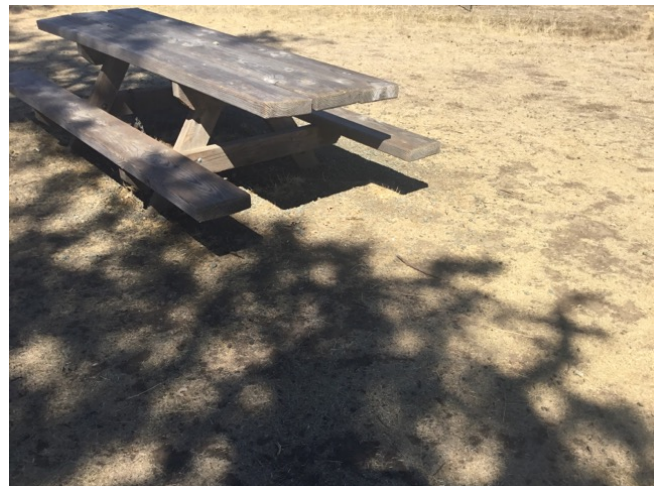
Clear Floor Space

2300	<ul style="list-style-type: none"> • <i>As-Built Description:</i> Clear space has slopes greater than 1:48. • <i>As-Built:</i> To 9% at picnic tables. • <i>Proposed Solution:</i> Grade surface. 	PCODE NI07 ADAAG 91 16.6.6 ADA 2010 305.2 CBC 2007 1132B.1 CBC 2019 11B-305.2	1	JOB	\$1,200	\$1,200
						Priority 1 Severity 3

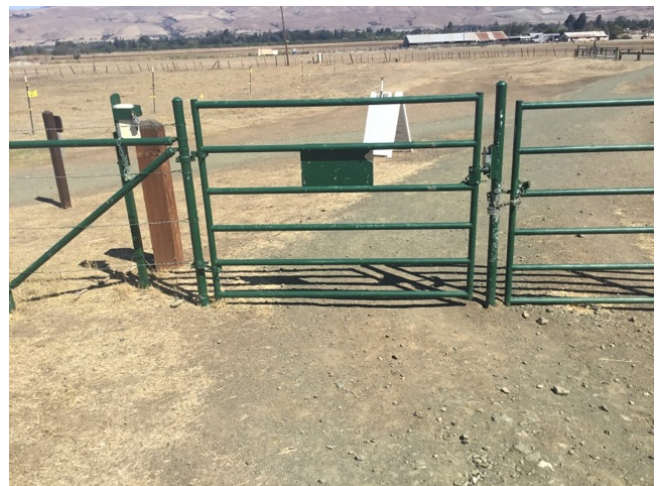
2308	<ul style="list-style-type: none"> <i>As-Built Description:</i> Surface of required maneuvering clearance at door slopes more than 1/4":12" (2.0%). <i>As-Built:</i> 11% <i>Proposed Solution:</i> Modify surface slope at door. 	PCODE ID11REF ADAAG 91 4.13.6 ADA 2010 404.2.4.4 CBC 2007 1133B.2.4 CBC 2019 11B-404.2.4		REF		
					Priority	1
					Severity	3

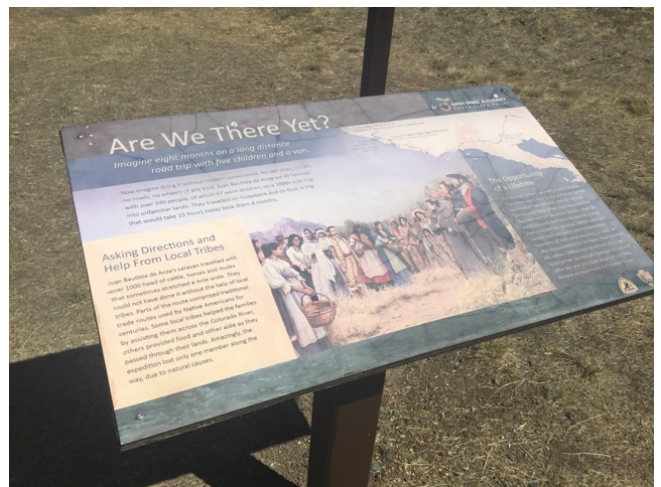
2298	<ul style="list-style-type: none"> • As-Built Description: Sign characters not readable because they are not sized for viewing distance. • Proposed Solution: Provide compliant signage. 	PCODE SA02A ADAAG 91 4.30.3 ADA 2010 703.5.5 CBC 2007 1117B.5.4 CBC 2019 11B-403.3	1	JOB	\$3,000	\$3,000
						Priority 1
						Severity 3

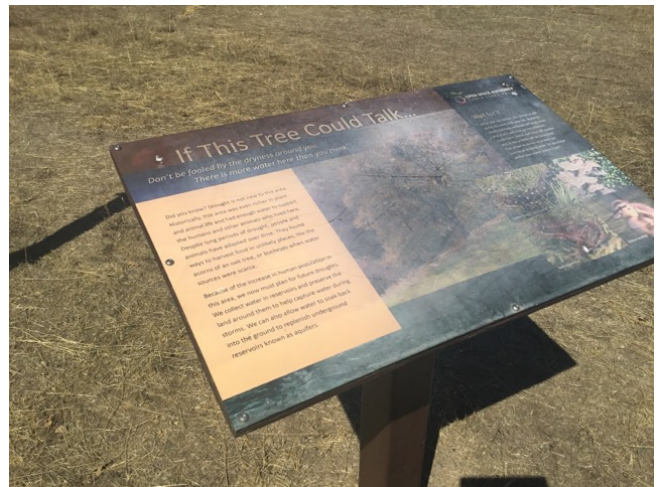
2301	<ul style="list-style-type: none"> As-Built Description: Sign characters not readable because they are not sized for viewing distance. .25" characters Proposed Solution: Provide compliant signage. 	PCODE SA02A ADAAG 91 4.30.3 ADA 2010 703.5.5 CBC 2007 1117B.5.4 CBC 2019 11B-305.2	1	JOB	\$3,000	\$3,000
					Priority	1
					Severity	3

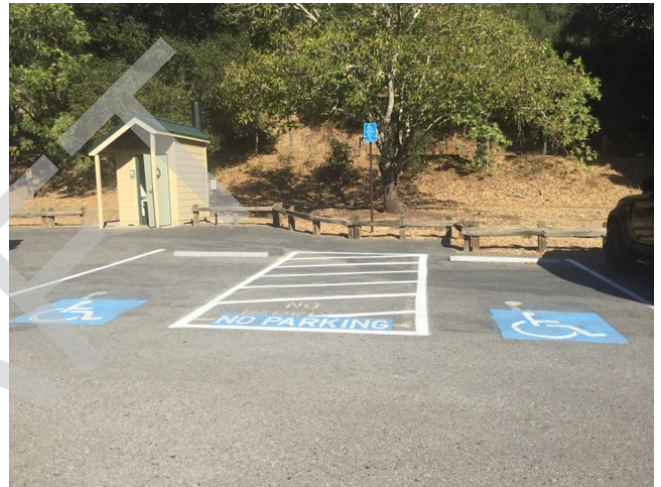
Item no., Rm no. and Name	Existing Architectural Barrier and Proposed Solution	Codes / Mitigation Info	Qty	Unit	Cost	Total
Floor or Ground Surfaces						
2311	<ul style="list-style-type: none"> As-Built Description: Accessible parking space has slope greater than 1/4":12" (2%). As-Built: To 4% Proposed Solution: Modify slope at accessible parking space. 	PCODE EA05 ADAAG 91 4.6.3 ADA 2010 502.4 CBC 2007 1129B.3.3 CBC 2019 11B-502.4	468	SF	\$36	\$16,848
					Priority	3
					Severity	3

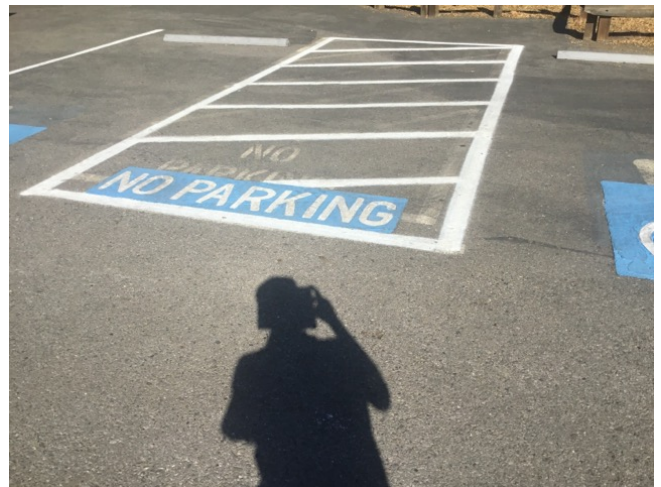
2314	<ul style="list-style-type: none"> As-Built Description: An accessible parking space shall be outlined or painted blue (required in CA only). Proposed Solution: Identify accessible parking space using blue markings. 	PCODE EA04K CBC 2019 11B-502.6	1	JOB	\$360	\$360
					Priority	3
					Severity	3

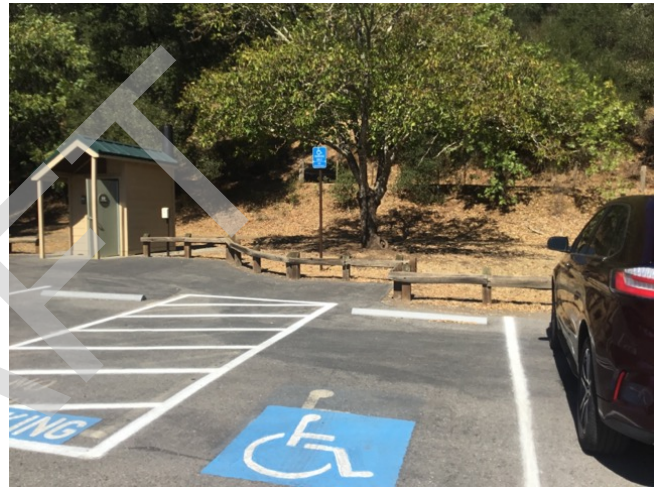
Item no., Rm no. and Name	Existing Architectural Barrier and Proposed Solution	Codes / Mitigation Info	Qty	Unit	Cost	Total
<u>Parking Signage</u>						
2345	<ul style="list-style-type: none"> • <i>As-Built Description:</i> No "Tow Away" sign at parking lot entrance (required in CA only). • <i>Proposed Solution:</i> Provide "Tow Away" sign at parking lot entrance when altering area. 	<p>PCODE EA04C</p> <p>CBC 2007 1129B.4</p> <p>CBC 2019 11B-502.8.2</p>	1	JOB	\$975	\$975
						<p>Priority 3</p> <p>Severity 3</p>

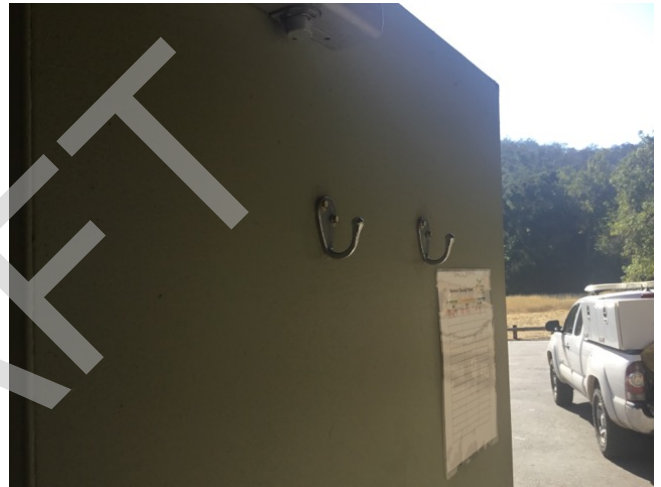
Item no., Rm no. and Name	Existing Architectural Barrier and Proposed Solution	Codes / Mitigation Info	Qty	Unit	Cost	Total
Coat Hook						
2322	<ul style="list-style-type: none"> As-Built Description: Accessible coat hook not within reach range. As-Built: 68" Proposed Solution: Adjust existing or provide new coat hook at maximum 48" height. 	PCODE WG03A ADAAG 91 4.2.5 ADA 2010 603.4 CBC 2007 1118B.5 CBC 2019 11B-603.4	1	JOB	\$150	\$150
					Priority	2
					Severity	3

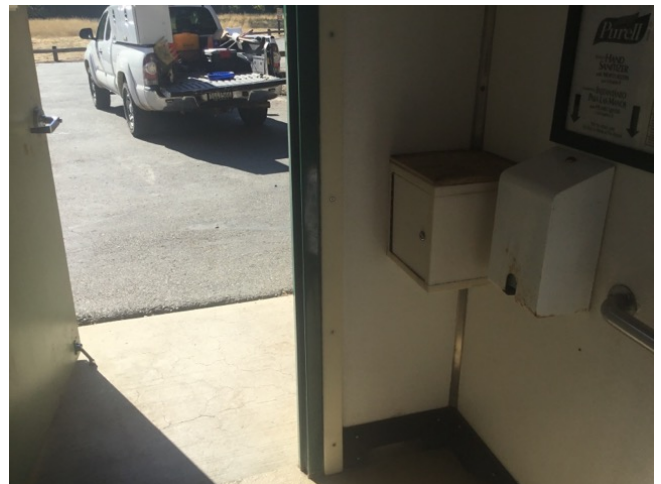
2323	<ul style="list-style-type: none"> • <i>As-Built Description:</i> Front approach: At push side, door does not have clear and level maneuvering space measuring door width x 48" (door width plus 12" if door has both, latch and closer). • <i>As-Built:</i> 10.5" to box. • <i>Proposed Solution:</i> Relocate box. 	<p>PCODE ID24A</p> <p>ADAAG 91 Fig. 25(a)</p> <p>ADA 2010 404.2.4</p> <p>CBC 2007 11B-26A(a)</p> <p>CBC 2019 11B-404.2.4</p>	1	JOB	\$150	\$150
------	--	--	---	-----	-------	-------

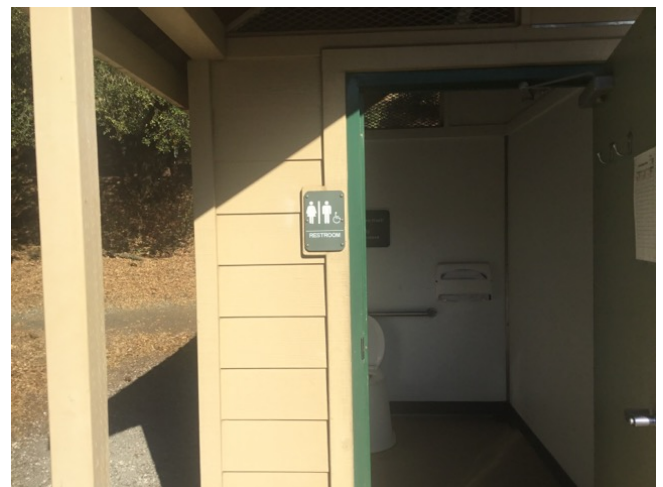
2318	<ul style="list-style-type: none"> As-Built Description: Signs containing tactile characters is not located so that a clear floor space of 18" min x 18" min., centered on the tactile characters, is provided beyond the arc of any door swing between the closed position and 45 degree open position. As-Built: 5.5" from door swing. Proposed Solution: Relocate compliant signage on latch side of door located at compliant height with a clear floor space. 	PCODE SA07B ADA 2010 703.4.2 CBC 2019 11B-703.4.2	1	JOB	\$150	\$150
						Priority 2 Severity 3

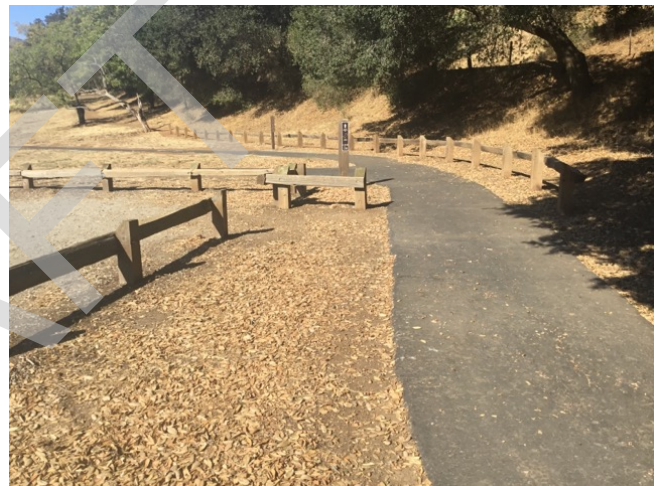
- 2328
- *As-Built Description:*
Walk: Pavement dislocation creates abrupt change in level exceeding 1/2" in accessible route.
 - *As-Built:* **To 2" where path meets soil.**
 - *Proposed Solution:*
Remove, replace or repair area of pavement sufficient to correct abrupt change in level.

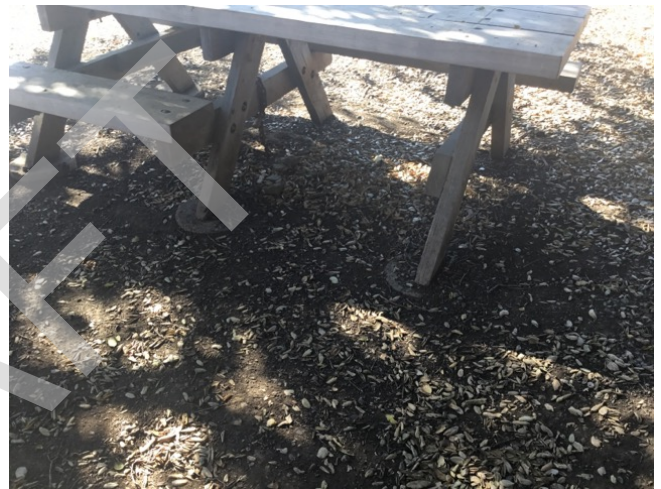
Item no., Rm no. and Name	Existing Architectural Barrier and Proposed Solution	Codes / Mitigation Info	Qty	Unit	Cost	Total
Clear floor space						
2331	<ul style="list-style-type: none"> As-Built Description: Clear space has slopes greater than 1:48. As-Built: 4% Proposed Solution: Modify surface. 	PCODE NI07 ADAAG 91 16.6.6 ADA 2010 305.2 CBC 2007 1132B.1 CBC 2019 11B-305.2	1	JOB		
					Priority	1
					Severity	3

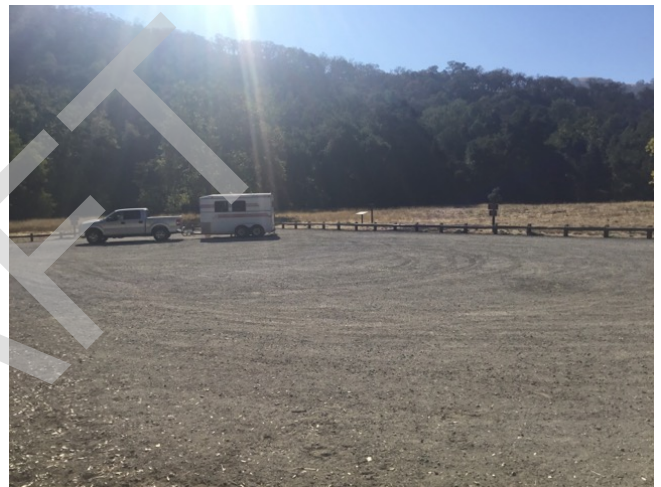
Item no., Rm no. and Name	Existing Architectural Barrier and Proposed Solution	Codes / Mitigation Info	Qty	Unit	Cost	Total
Minimum Number						
2330	<ul style="list-style-type: none"> <i>As-Built Description:</i> At parking lot with 1-25 spaces, the number of accessible spaces is less than required by code; 1 space required <i>Proposed Solution:</i> Provide required accessible parking space with sign including a minimum of one van space. 	PCODE EA01A ADAAG 91 4.1.2(5) ADA 2010 208.2 CBC 2007 Tbl. 11B-6 CBC 2019 11B-208.2 Tbl. 11B-208.2	1	JOB	\$9,000	\$9,000
					Priority	1
					Severity	3

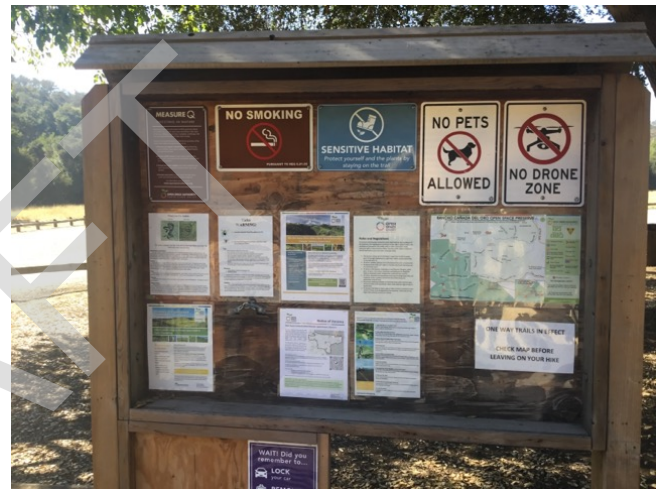
Item no., Rm no. and Name	Existing Architectural Barrier and Proposed Solution	Codes / Mitigation Info	Qty	Unit	Cost	Total
Signage						
2333	<ul style="list-style-type: none"> As-Built Description: Sign characters not readable because they are not sized for viewing distance. As-Built: 1/8" characters. Proposed Solution: Provide compliant signage. 	PCODE SA02A ADAAG 91 4.30.3 ADA 2010 703.5.5 CBC 2007 1117B.5.4 CBC 2019 11B-403.3	1	JOB	\$4,500	\$4,500
					Priority	1
					Severity	3

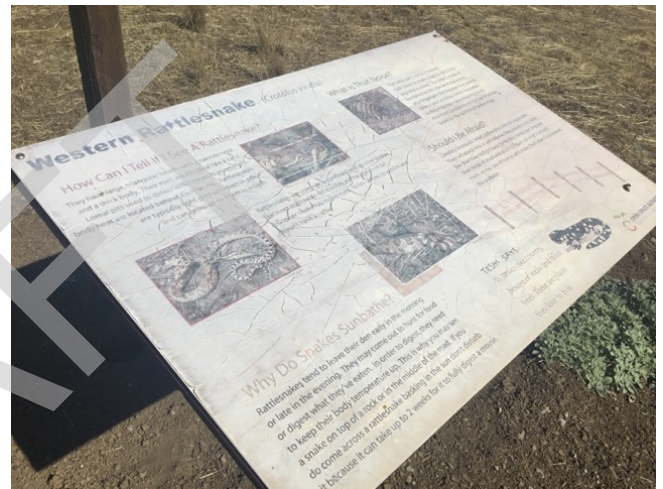
Item no., Rm no. and Name	Existing Architectural Barrier and Proposed Solution	Codes / Mitigation Info	Qty	Unit	Cost	Total
Signage						
2336	<ul style="list-style-type: none"> • <i>As-Built Description:</i> Sign characters not readable because they are not sized for viewing distance. • <i>As-Built:</i> 3/8" characters • <i>Proposed Solution:</i> Provide compliant signage. 	PCODE SA02A ADAAG 91 4.30.3 ADA 2010 703.5.5 CBC 2007 1117B.5.4 CBC 2019 11B-403.3	1	JOB	\$2,400	\$2,400
					Priority	1
					Severity	3

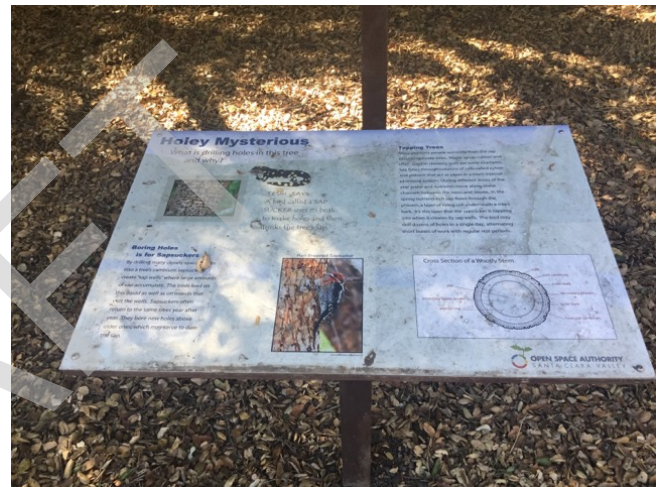
Item no., Rm no. and Name	Existing Architectural Barrier and Proposed Solution	Codes / Mitigation Info	Qty	Unit	Cost	Total
Signage						
2338	<ul style="list-style-type: none"> As-Built Description: Sign characters not readable because they are not sized for viewing distance. As-Built: 3/8" characters Proposed Solution: Provide compliant signage. 	PCODE SA02A ADAAG 91 4.30.3 ADA 2010 703.5.5 CBC 2007 1117B.5.4 CBC 2019 11B-403.3	2	JOB	\$2,400	\$4,800
					Priority	1
					Severity	3

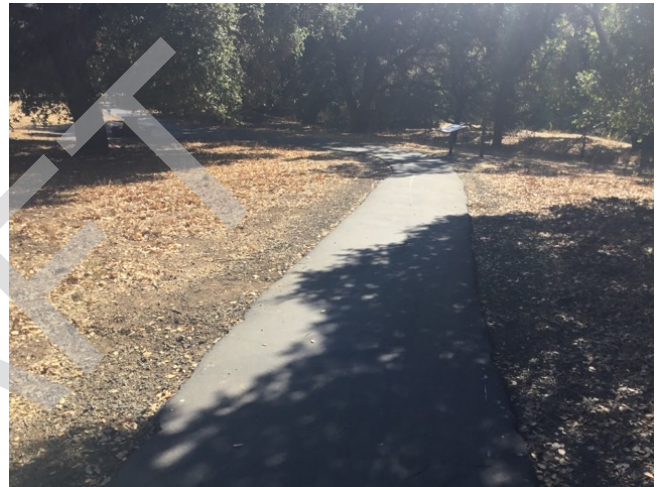
Item no., Rm no. and Name	Existing Architectural Barrier and Proposed Solution	Codes / Mitigation Info	Qty	Unit	Cost	Total
Walk						
2340	<ul style="list-style-type: none"> As-Built Description: Walk: Slope greater than 1:20 (5.0%), and walk does not comply with requirements for ramps. As-Built: 6.8% Proposed Solution: Modify walk/sidewalk slope to 1:20 or less. 	PCODE EF01 ADAAG 91 4.3.7 ADA 2010 403.3 CBC 2007 1133B.7.3 CBC 2019 11B-403.3	100	SF	\$75	\$7,500
						Priority 1
						Severity 3

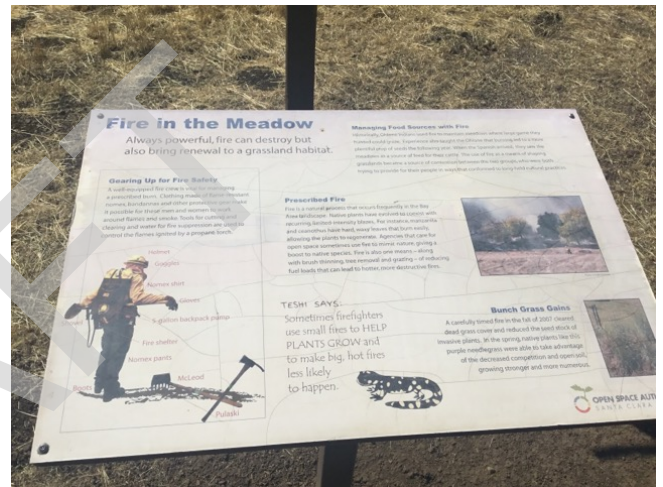
Item no., Rm no. and Name	Existing Architectural Barrier and Proposed Solution	Codes / Mitigation Info	Qty	Unit	Cost	Total
2343	<p>Signage</p> <ul style="list-style-type: none"> • <i>As-Built Description:</i> Sign characters not readable because they are not sized for viewing distance. • <i>As-Built:</i> 3/8" characters. • <i>Proposed Solution:</i> Provide compliant signage. • <i>Notes:</i> In addition there are characters with unusual font and the stroke thickness is approximately 10%. Occurs on signs throughout. 	<p>PCODE SA02A ADAAG 91 4.30.3 ADA 2010 703.5.5 CBC 2007 1117B.5.4 CBC 2019 11B-403.3</p>	1	JOB	\$2,400	\$2,400
					Priority	1
					Severity	3

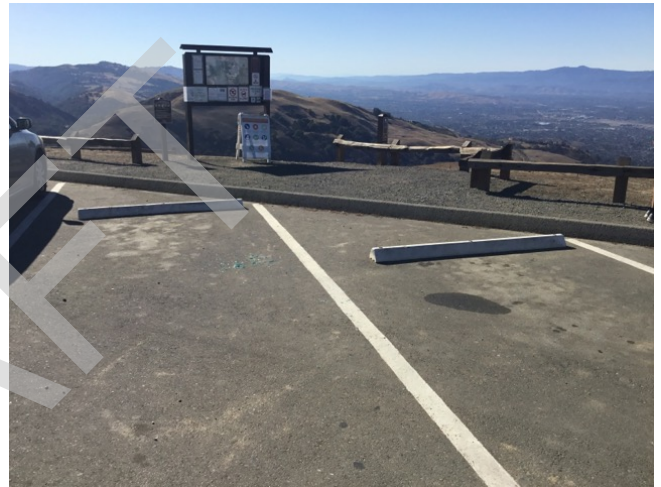
Item no., Rm no. and Name	Existing Architectural Barrier and Proposed Solution	Codes / Mitigation Info	Qty	Unit	Cost	Total
Curb Ramp						
2267	<ul style="list-style-type: none"> • <i>As-Built Description:</i> No curb ramp available where an accessible route crosses a curb. • <i>Proposed Solution:</i> Provide new curb ramp. 	PCODE EH01 ADAAG 91 4.7.1 ADA 2010 303.4 CBC 2007 1127B.5.1 CBC 2019 11B-402.2	1	JOB	\$7,500	\$7,500
					Priority	1
					Severity	2

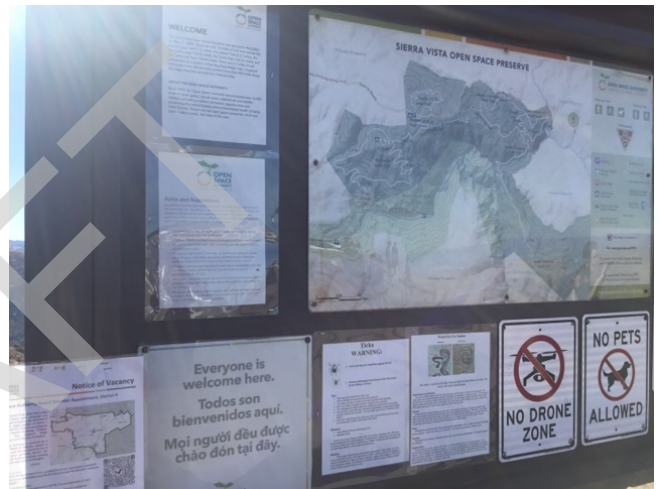
2271	<ul style="list-style-type: none"> • <i>As-Built Description:</i> Walk: Slope greater than 1:20 (5.0%), and walk does not comply with requirements for ramps. • <i>As-Built:</i> 16% • <i>Proposed Solution:</i> Install trails with compliant slopes and cross slopes. • <i>Notes:</i> See 11B=246.7 for unimproved trails. The steep slopes begin immediately. 	<p>PCODE EF01</p> <p>ADAAG 91 4.3.7</p> <p>ADA 2010 403.3</p> <p>CBC 2007 1133B.7.3</p> <p>CBC 2019 11B-403.3</p>	2000	SF	\$45	\$900,000
------	--	---	------	----	------	------------------

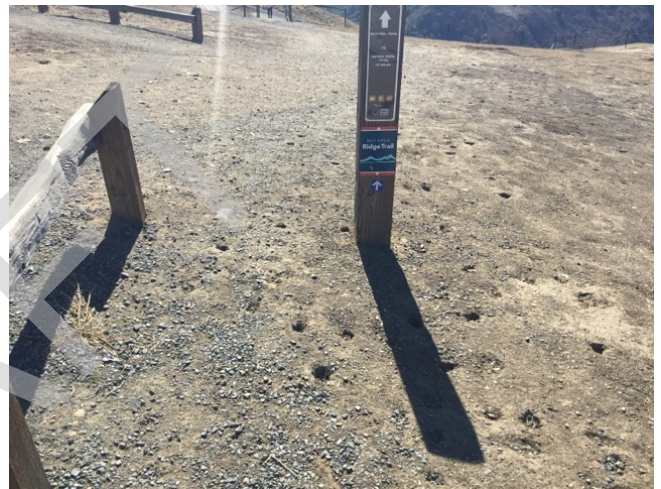
2 North Side of Sierra Rd

Cross Slope

- 2275
- *As-Built Description:*
Cross slope more than 1":48" (2.083%).
 - *As-Built:* **8% cross slope. 10% slope.**
 - *Proposed Solution:*
Install accessible trail.
 - *Notes:*
See 11B-246.7 for trails.

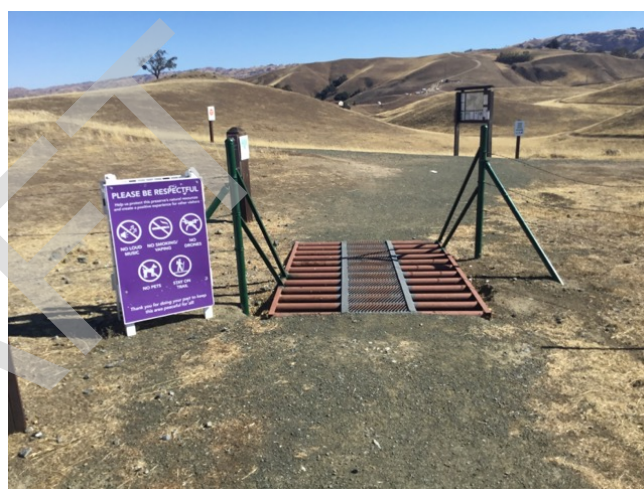
2272

- As-Built Description:*
Refer to notes for observation and recommendation.
- Proposed Solution:*
Consider providing accessible parking here and/or installing an accessible route from the existing parking lot.

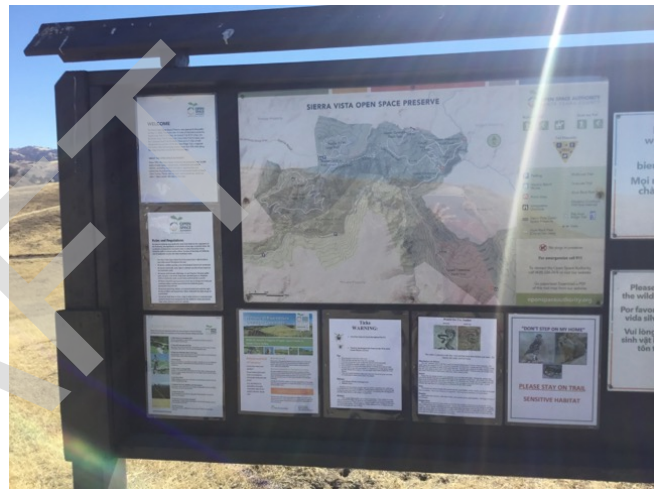
Item no., Rm no. and Name	Existing Architectural Barrier and Proposed Solution	Codes / Mitigation Info	Qty	Unit	Cost	Total
Signage						
2276	<ul style="list-style-type: none"> As-Built Description: Sign characters not readable because they are not sized for viewing distance. As-Built: 1/8"-3/8" characters. Proposed Solution: Provide compliant signage. 	PCODE SA02A ADAAG 91 4.30.3 ADA 2010 703.5.5 CBC 2007 1117B.5.4 CBC 2019 11B-403.3	1	JOB	\$4,500	\$4,500
					Priority	3
					Severity	3

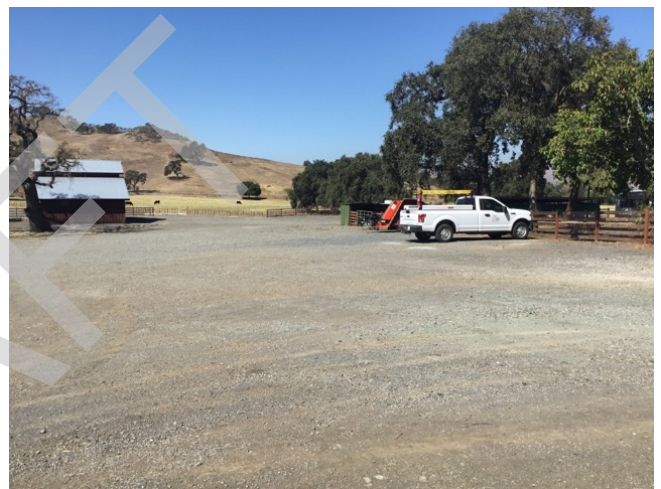
Item no., Rm no. and Name	Existing Architectural Barrier and Proposed Solution	Codes / Mitigation Info	Qty	Unit	Cost	Total
Minimum Number						
2433	<ul style="list-style-type: none"> <i>As-Built Description:</i> At parking lot with 101-150 spaces, the number of accessible spaces is less than required by code; 5 spaces required. <i>Proposed Solution:</i> Provide required accessible parking spaces with signs including a minimum of one van space. <i>Notes:</i> Currently no accessible parking provided. Coordinate with use/site plan and accessible route plan. 	PCODE EA01E ADAAG 91 4.1.2(5)* ADA 2010 208.2 CBC 2007 Tbl. 11B-6 CBC 2019 11B-208.2 Tbl. 11B-208.2	6	JOB	\$9,000	\$54,000
						Priority 3 Severity 3

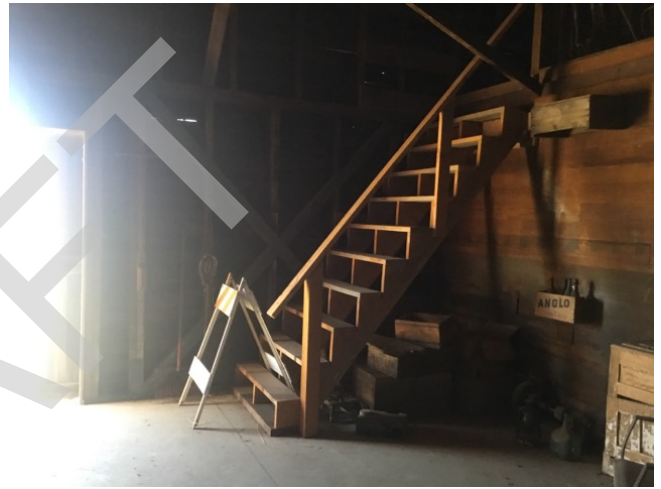
Item no., Rm no. and Name	Existing Architectural Barrier and Proposed Solution	Codes / Mitigation Info	Qty	Unit	Cost	Total
Stairways						
2349	<ul style="list-style-type: none"> • <i>As-Built Description:</i> Exterior stair substantially out of compliance. • <i>Proposed Solution:</i> Provide complete new stair, 4 ft. wide with landing and handrails. 	PCODE EC09 ADAAG 91 4.9 ADA 2010 504 CBC 2007 1133B.4 CBC 2019 11B-504	150	IN	\$270	\$40,500
					Priority	1
					Severity	2
	NA if this remains a maintenance facility.

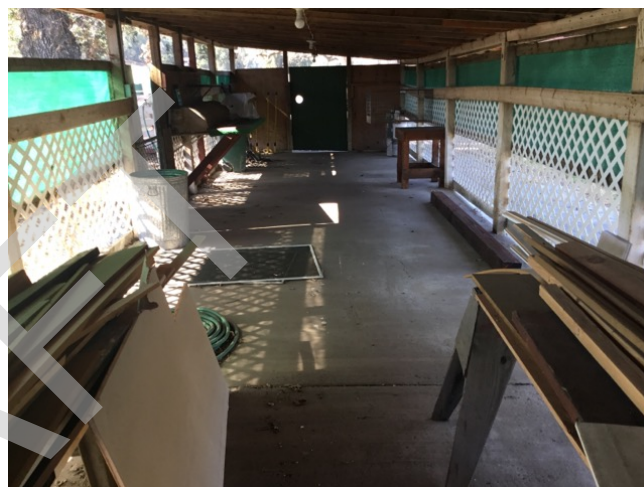
Item no., Rm no. and Name	Existing Architectural Barrier and Proposed Solution	Codes / Mitigation Info	Qty	Unit	Cost	Total
2357	<ul style="list-style-type: none"> As-Built Description: Cross slope more than 1":48" (2.083%). As-Built: 5.2% Proposed Solution: Modify cross slope. Notes: See exceptions for animal containment areas. 	PCODE EF07 ADAAG 91 4.3.7 ADA 2010 403.3 CBC 2007 1133B.7.1.3 CBC 2019 11B-403.3	500	SF	\$75	\$37,500
						Priority 1 Severity 2

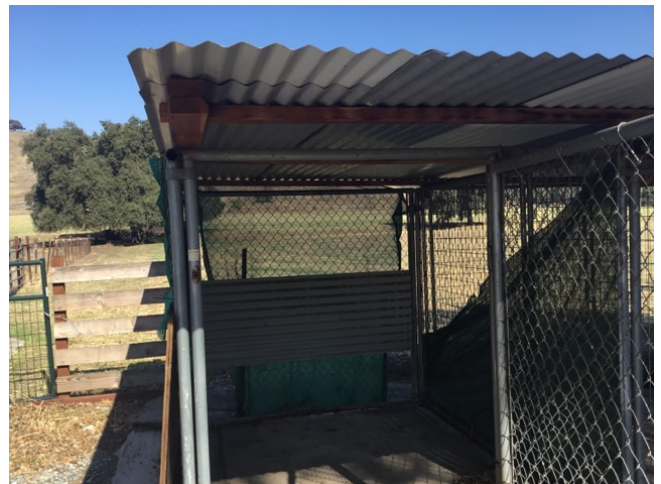
2353	<ul style="list-style-type: none"> • <i>As-Built Description:</i> Overhead clearance less than 80" above finished floor. • <i>As-Built:</i> 72" • <i>Proposed Solution:</i> Alter ceiling. • <i>Notes:</i> See exceptions for animal containment areas. Consider modifications for safety . 	<p>PCODE EG01AREF</p> <p>ADAAG 91 4.4.2</p> <p>ADA 2010 307.4</p> <p>CBC 2007 1133B.8.6.2</p> <p>CBC 2019 11B-307.4</p>		REF		
						<p>Priority 1</p> <p>Severity 1</p>
