Facilities Access Compliance Survey Report for the Santa Clara Valley Open Space Authority

Santa Clara Valley Open Space Access Compliance Survey Report

Santa Clara Valley
April 2023
SSA Project #: 21058

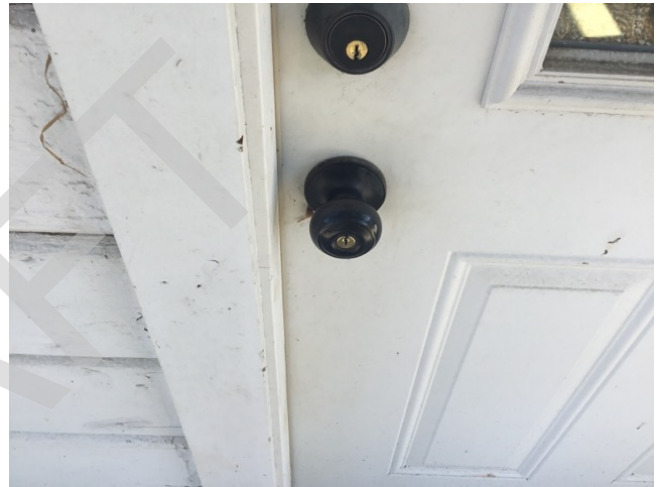
Item no., Rm no. and Name	Existing Architectural Barrier and Proposed Solution	Codes / Mitigation Info	Qty	Unit	Cost	Total
Door Hardware						
2358	<ul style="list-style-type: none"> • <i>As-Built Description:</i> Door does not have accessible operating hardware. • <i>Proposed Solution:</i> Provide lever handle or other accessible hardware. 	PCODE ID07 ADAAG 91 4.13.9 ADA 2010 404.2.7 CBC 2007 1133B.2.5.2 CBC 2019 11B-404.2.7	2	JOB	\$750	\$1,500
					Priority	1
					Severity	3

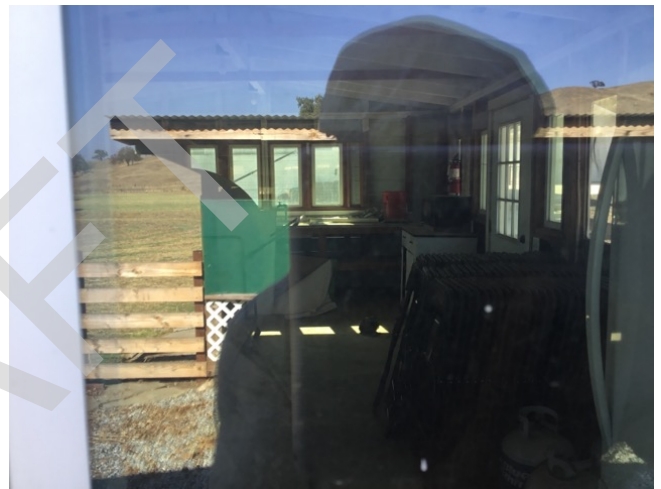
Item no., Rm no. and Name	Existing Architectural Barrier and Proposed Solution	Codes / Mitigation Info	Qty	Unit	Cost	Total
Sink						
2366	<ul style="list-style-type: none"> As-Built Description: Sink rim higher than 34" above floor. As-Built: 37" Proposed Solution: Remodel sink cabinet to lower sink. Notes: No access at time of survey. Approximation. 	PCODE IN06 ADAAG 91 4.24.2 ADA 2010 606.3 CBC 2007 1115B.4.7.1 CBC 2019 11B-606.3	1	JOB	\$5,250	\$5,250
						Priority 3
						Severity 3

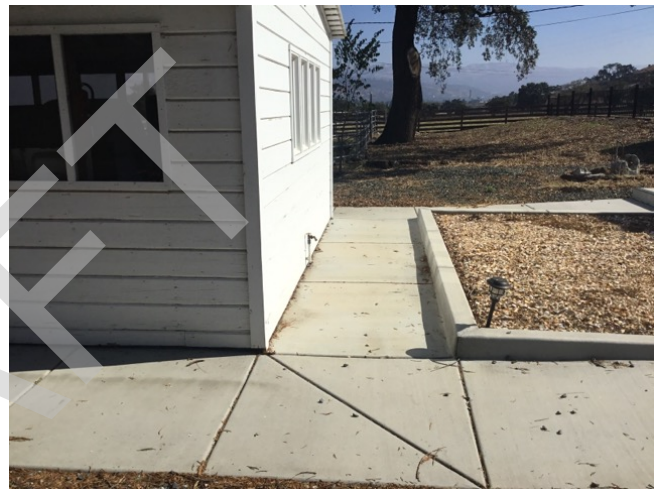
Item no., Rm no. and Name	Existing Architectural Barrier and Proposed Solution	Codes / Mitigation Info	Qty	Unit	Cost	Total
Walk						
2361	<ul style="list-style-type: none"> As-Built Description: Walk more than 36" but less than 48" wide (required in CA only). As-Built: 46" Proposed Solution: Enlarge width of walk to 48". 	PCODE EF08 CBC 2007 1133B.7.1 CBC 2019 11B-403.5.1.3	20	SF	\$135	\$2,700
						Priority 1 Severity 3

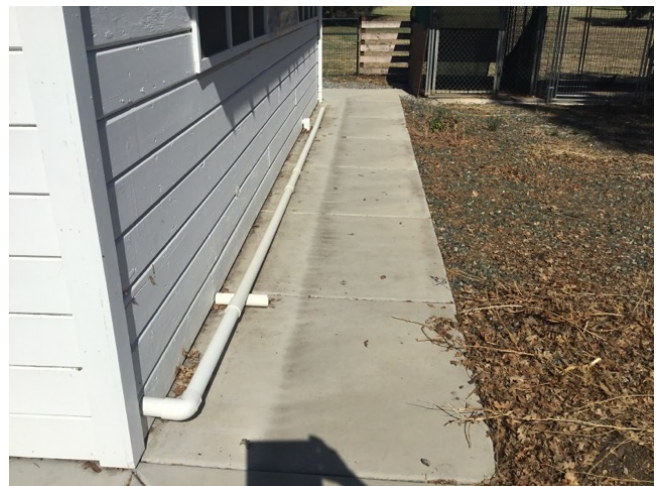
2362	<ul style="list-style-type: none"> As-Built Description: Walk more than 36" but less than 48" wide (required in CA only). As-Built: 39" to pipe 46" to wall. Proposed Solution: Enlarge width of walk to 48". 	PCODE EF08 CBC 2007 1133B.7.1 CBC 2019 11B-403.5.1.3	20	SF	\$135	\$2,700
						Priority 1 Severity 3

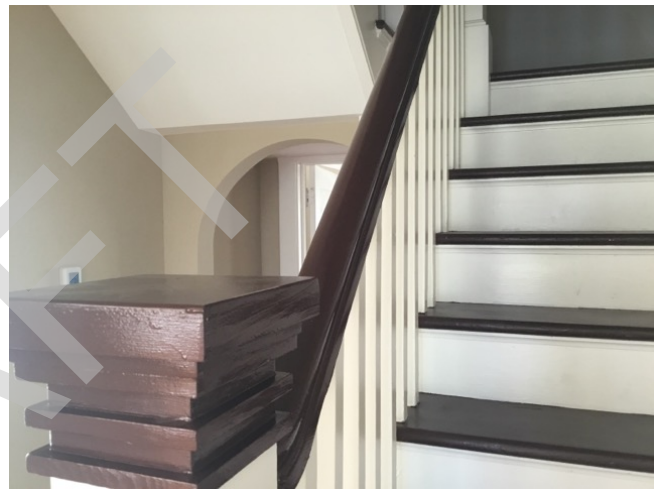
Item no., Rm no. and Name	Existing Architectural Barrier and Proposed Solution	Codes / Mitigation Info	Qty	Unit	Cost	Total
Cross Section						
2389	<ul style="list-style-type: none"> <i>As-Built Description:</i> Non-circular cross-section: Perimeter dimension shall be between 4 inches and 6-1/4 inches. <i>Proposed Solution:</i> Provide new handrail. <i>Notes:</i> Handrail perimeter 12" 	<p>PCODE ED16</p> <p>ADA 2010 505.7.2</p> <p>CBC 2007 1133B.4.2.6</p> <p>CBC 2019 11B-505.7.2</p>	20	LF	\$225	\$4,500
						Priority 3
						Severity 3

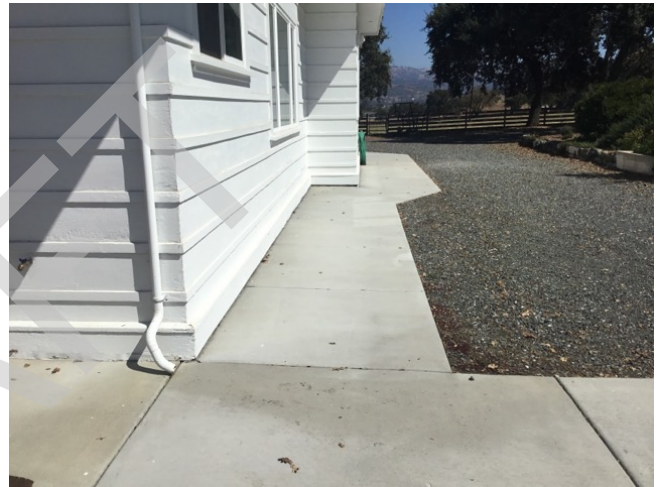
Item no., Rm no. and Name	Existing Architectural Barrier and Proposed Solution	Codes / Mitigation Info	Qty	Unit	Cost	Total
Cross Slope						
2409	<ul style="list-style-type: none"> As-Built Description: Cross slope more than 1":48" (2.083%). As-Built: 3.1% Proposed Solution: Modify cross slope. 	PCODE EF07 ADAAG 91 4.3.7 ADA 2010 403.3 CBC 2007 1133B.7.1.3 CBC 2019 11B-403.3	120	SF	\$75	\$9,000
					Priority	1
					Severity	3

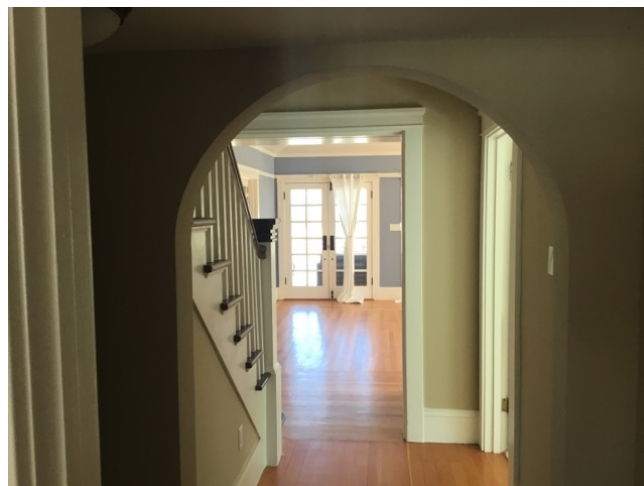
2390 • *As-Built Description:*
 Door on accessible route has less than 32" clear and 80" (78" min. to closer if provided) opening width when 90° open.

• *As-Built:* **71" high at 32" wide**

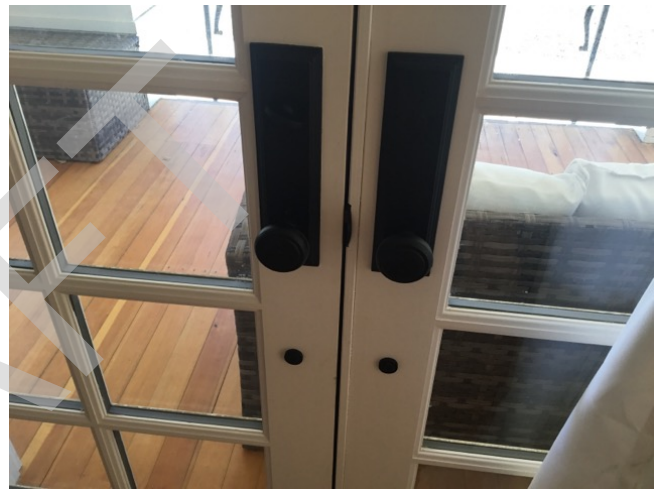
Item no., Rm no. and Name	Existing Architectural Barrier and Proposed Solution	Codes / Mitigation Info	Qty	Unit	Cost	Total
Door Hardware						
2375	<ul style="list-style-type: none"> • <i>As-Built Description:</i> Door does not have accessible operating hardware. • <i>Proposed Solution:</i> Provide lever handle or other accessible hardware. 	PCODE ID07 ADAAG 91 4.13.9 ADA 2010 404.2.7 CBC 2007 1133B.2.5.2 CBC 2019 11B-404.2.7	22	JOB	\$750	\$16,500
					Priority	1
					Severity	3

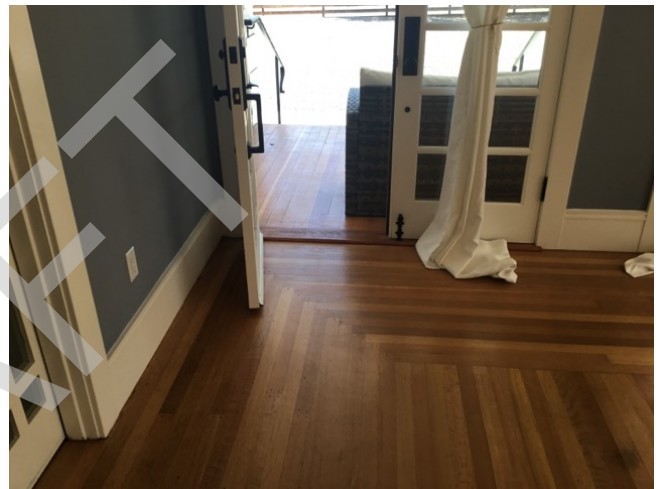
Item no., Rm no. and Name	Existing Architectural Barrier and Proposed Solution	Codes / Mitigation Info	Qty	Unit	Cost	Total
Door Threshold						
2376	<ul style="list-style-type: none"> As-Built Description: Door inaccessible due to threshold or step at door exceeding 1/2". As-Built: 1" Proposed Solution: Modify threshold. 	PCODE ID02A ADAAG 91 4.13.8 ADA 2010 404.2.5 CBC 2007 1133B.2.4.1 CBC 2019 11B-404.2.5	8	JOB	\$1,200	\$9,600
					Priority	1
					Severity	1

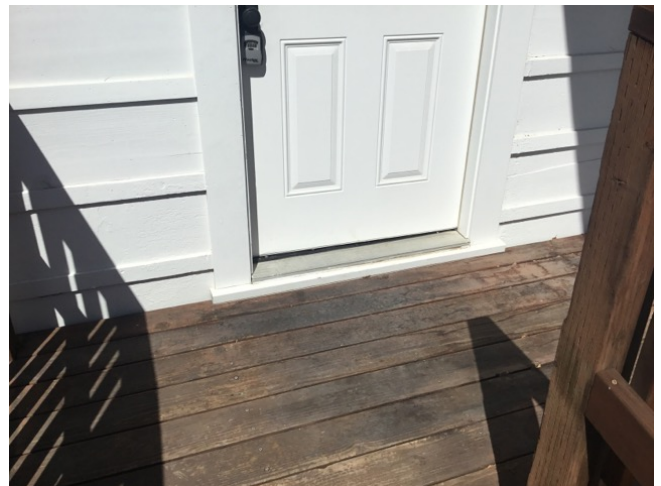
2411	<ul style="list-style-type: none"> As-Built Description: Door inaccessible due to threshold or step at door exceeding 1/2". As-Built: 2.5" Proposed Solution: Modify threshold when providing access with ramps or other accessible routes. 	PCODE ID02A ADAAG 91 4.13.8 ADA 2010 404.2.5 CBC 2007 1133B.2.4.1 CBC 2019 11B-404.2.5	2	JOB	\$1,200	\$2,400
					Priority	1
					Severity	1

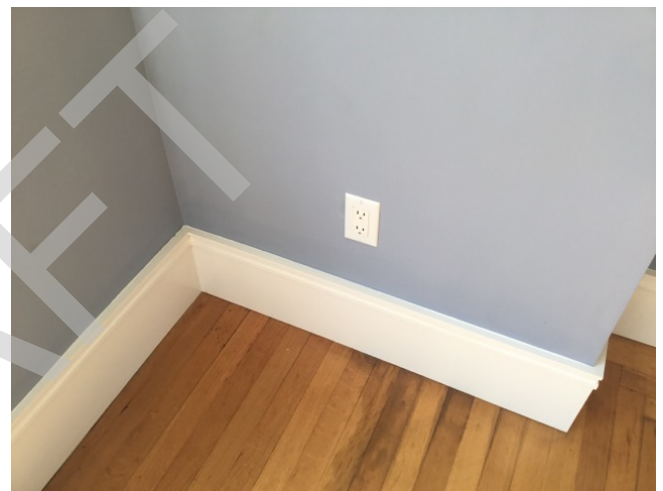
2373	<ul style="list-style-type: none"> • <i>As-Built Description:</i> Electric switch or control mounted less than 15" measured to the bottom of the outlet box or greater than 48 inches measured to the top of the outlet box. • <i>As-Built:</i> 14" to the bottom of the box. • <i>Proposed Solution:</i> Relocate light switches or control to between 15" and 48" height. • <i>Notes:</i> Includes upstairs. It appears the house was recently remodeled. Verify whether safe harbor applies. 	<p>PCODE IC01</p> <p>ADAAG 91 4.2.5 & 6</p> <p>ADA 2010 308.2.1 &</p> <p>CBC 2007 1117B.6.3</p> <p>CBC 2019 11B-308.2.1 & 11B-308.2.2</p>	14	JOB	\$900	\$12,600
------	---	---	----	-----	-------	----------

Priority 3

Severity 3

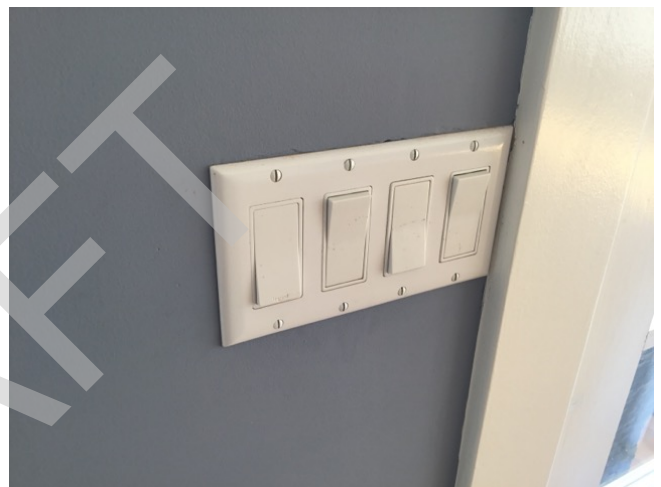
Item no., Rm no. and Name	Existing Architectural Barrier and Proposed Solution	Codes / Mitigation Info	Qty	Unit	Cost	Total
2374	<ul style="list-style-type: none"> As-Built Description: Electric switch or control mounted less than 15" measured to the bottom of the outlet box or greater than 48 inches measured to the top of the outlet box. As-Built: 50.5" to switch. 52" to top of the box. Proposed Solution: Relocate light switches or control to between 15" and 48" height. Notes: Includes upstairs. It appears the house was recently remodeled. Verify whether safe harbor applies. 	PCODE IC01 ADAAG 91 4.2.5 & 6 ADA 2010 308.2.1 & CBC 2007 1117B.6.3 CBC 2019 11B-308.2.1 & 11B-308.2.2	14	JOB	\$900	\$12,600

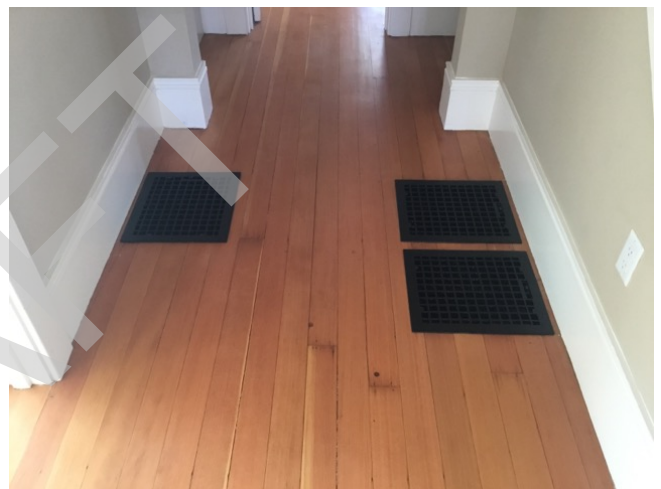
Item no., Rm no. and Name	Existing Architectural Barrier and Proposed Solution	Codes / Mitigation Info	Qty	Unit	Cost	Total
Floor or Ground Surface						
2379	<ul style="list-style-type: none"> As-Built Description: Walk: Grating has grid openings greater than 1/2" along the line of traffic flow. As-Built: 1" x 1" Proposed Solution: Provide new grating, with grid openings 1/2" max. along the line of traffic flow. 	PCODE EF04 ADAAG 91 4.3.6; 4.5.4 ADA 2010 403.2; 302.3 CBC 2007 1133B.7.2 CBC 2019 11B-403.2; 11B-302.3	5	SF	\$240	\$1,200
						Priority 1
						Severity 3

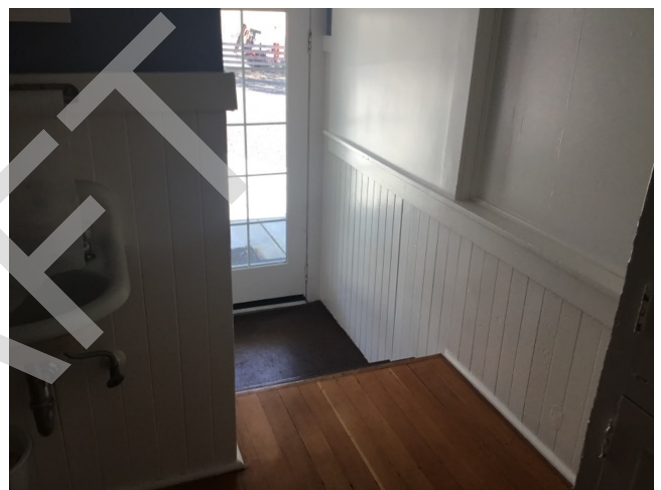
Item no., Rm no. and Name	Existing Architectural Barrier and Proposed Solution	Codes / Mitigation Info	Qty	Unit	Cost	Total
Handrails						
2401	<ul style="list-style-type: none"> • <i>As-Built Description:</i> Handrail not provided at stairs or ramp, required on both sides (not required at curb ramps or adjacent to seating areas). • <i>Proposed Solution:</i> Provide new handrail for each side including extensions. 	PCODE ED01 ADAAG 91 4.8.5 & 4.9.4 ADA 2010 505.2 CBC 2007 1133B.4.1.1 & .5.5 CBC 2019 11B-505.2	12	LF	\$285	\$3,420
					Priority	3
					Severity	3

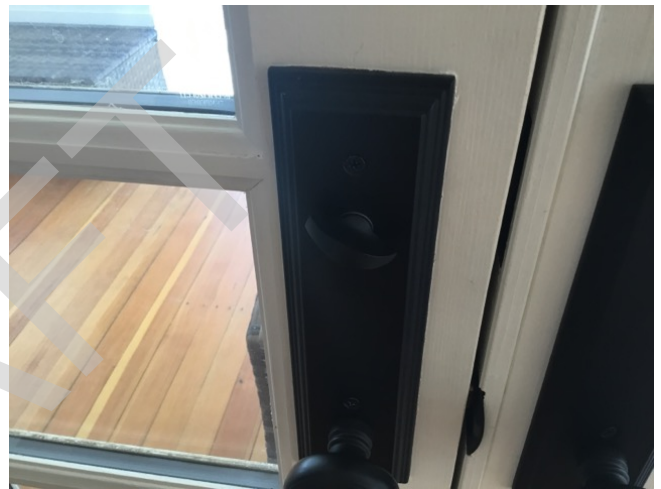
2378	<ul style="list-style-type: none"> As-Built Description: Operable part(s) require tight grasping, pinching, or twisting of the wrist with one hand. As-Built: 10lbs Proposed Solution: Modify or replace the operable part(s) to not require tight grasping, pinching, or twisting of the wrist with one hand. 	PCODE IC02 ADAAG 91 4.27.4 ADA 2010 309.4 CBC 2007 1117B.6.4 CBC 2019 11B-309.4	5	JOB	\$900	\$4,500
------	--	---	---	-----	-------	---------

Priority 3

Severity 3

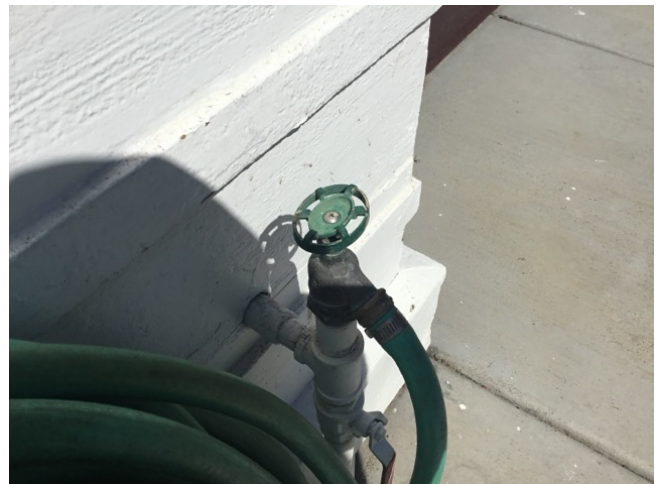
2408	<ul style="list-style-type: none"> As-Built Description: Operable part(s) require tight grasping, pinching, or twisting of the wrist with one hand. As-Built: Not operable without grasping. Proposed Solution: Modify or replace the operable part(s) to not require tight grasping, pinching, or twisting of the wrist with one hand. 	PCODE IC02 ADAAG 91 4.27.4 ADA 2010 309.4 CBC 2007 1117B.6.4 CBC 2019 11B-309.4	1	JOB	\$900	\$900
------	---	---	---	-----	-------	-------

Priority 3

Severity 3

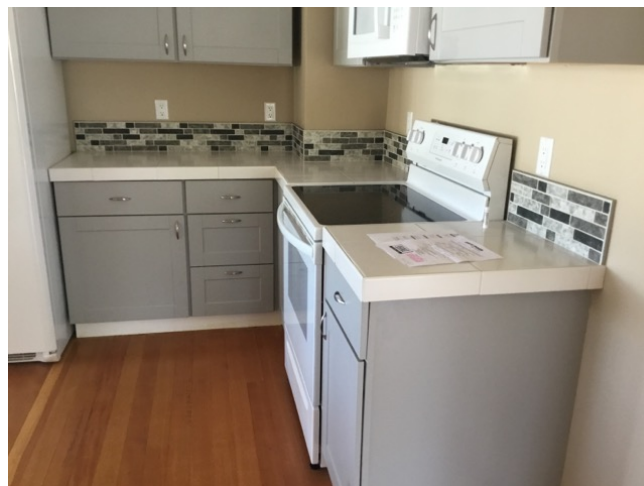
2381	<ul style="list-style-type: none"> As-Built Description: Reach height to control or access point, where side approach is available, exceeds 48" or is less than 15" in height, or exceeds 10" in depth. As-Built: Side reach obstructed by 37" high counter. Proposed Solution: Lower counters. Provide 24" maximum reach to electrical outlets. 	PCODE IE02 ADAAG 91 4.2.6 ADA 2010 308.3.1 CBC 2007 1118B.6 CBC 2019 11B-308.3	1	JOB	\$60,000	\$60,000
------	--	--	---	-----	----------	----------

Priority 3

Severity 3

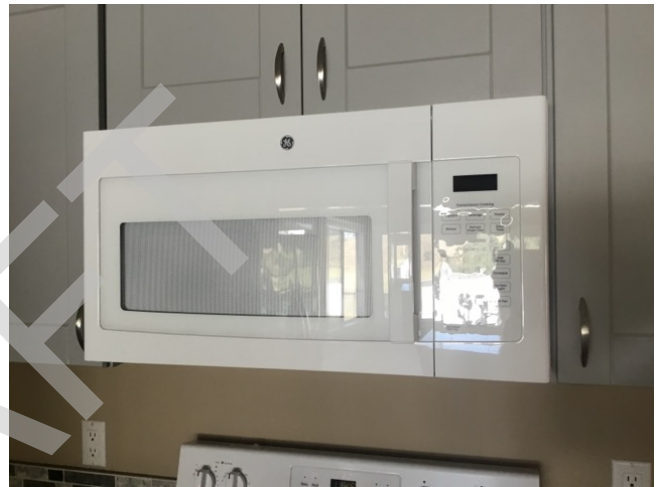
Item no., Rm no. and Name	Existing Architectural Barrier and Proposed Solution	Codes / Mitigation Info	Qty	Unit	Cost	Total
2382	<ul style="list-style-type: none"> • <i>As-Built Description:</i> Reach height to control or access point, where side approach is available, exceeds 48" or is less than 15" in height, or exceeds 10" in depth. • <i>As-Built:</i> 66" • <i>Proposed Solution:</i> Modify equipment or mounting. 	PCODE IE02 ADAAG 91 4.2.6 ADA 2010 308.3.1 CBC 2007 1118B.6 CBC 2019 11B-308.3	1	JOB	\$300	\$300
					Priority	3
					Severity	3

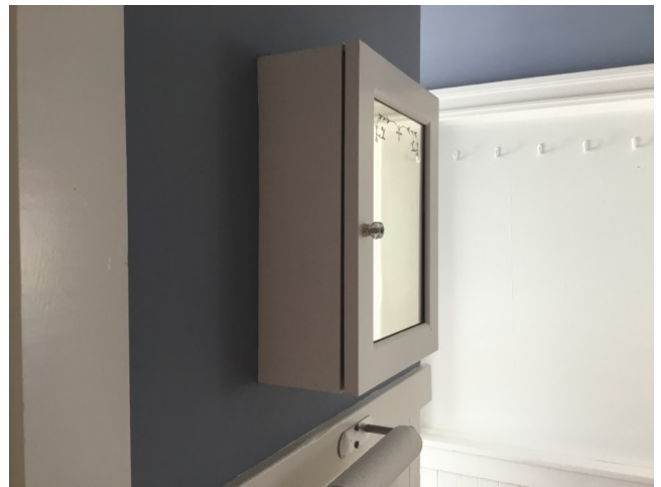
2392	<ul style="list-style-type: none"> • <i>As-Built Description:</i> Reach height to control or access point, where side approach is available, exceeds 48" or is less than 15" in height, or exceeds 10" in depth. • <i>As-Built:</i> 63" • <i>Proposed Solution:</i> Modify equipment or mounting. 	PCODE IE02 ADAAG 91 4.2.6 ADA 2010 308.3.1 CBC 2007 1118B.6 CBC 2019 11B-308.3	1	JOB	\$300	\$300
					Priority	3
					Severity	3

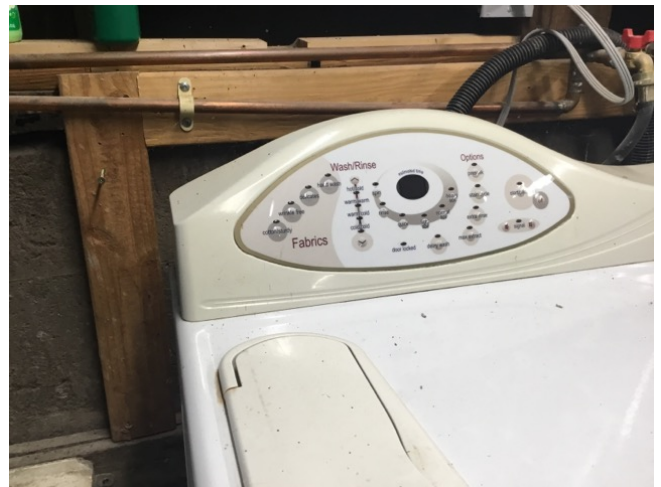
2400	<ul style="list-style-type: none"> As-Built Description: Reach height to control or access point, where side approach is available, exceeds 48" or is less than 15" in height, or exceeds 10" in depth. As-Built: 24" deep 52" AFF. Proposed Solution: Modify equipment or mounting. 	PCODE IE02 ADAAG 91 4.2.6 ADA 2010 308.3.1 CBC 2007 1118B.6 CBC 2019 11B-308.3	1	JOB	\$300	\$300
						Priority 3
						Severity 3

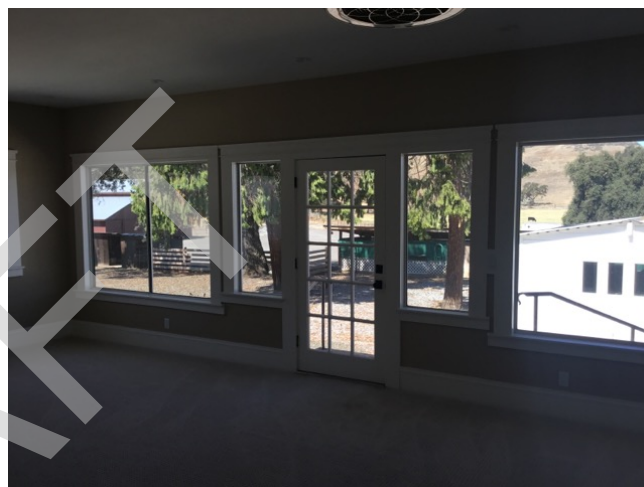
Item no., Rm no. and Name	Existing Architectural Barrier and Proposed Solution	Codes / Mitigation Info	Qty	Unit	Cost	Total
2395	<ul style="list-style-type: none"> As-Built Description: At door leading into exit stairway: Where required exit signs are installed, signs to provide exiting information for people with vision impairment are not provided. Proposed Solution: Provide raised letter/Braille "EXIT STAIR UP/DOWN" sign at door. 	PCODE SA10B ADAAG 91 4.1.3(16) ADA 2010 216.4.1 CBC 2007 1011.3 CBC 2019 11B-216.4.1	7	JOB	\$270	\$1,890
						Priority 1 Severity 3

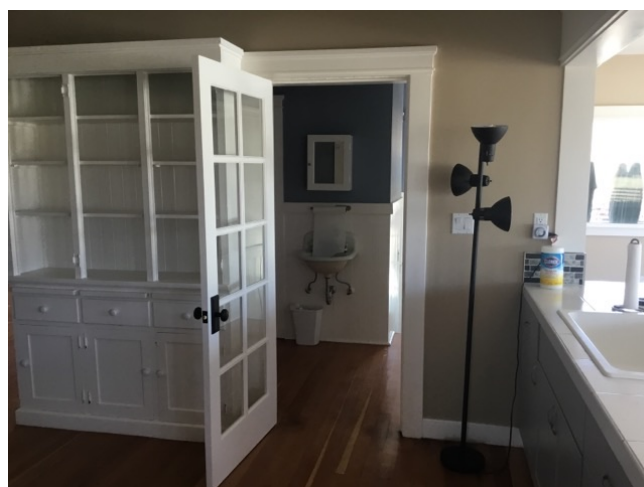
2434	<ul style="list-style-type: none"> As-Built Description: At door leading into exit corridor: Where required exit signs are installed, signs to provide exiting information for people with vision impairment are not provided. Proposed Solution: Provide raised letter/Braille "EXIT ROUTE" sign at door. 	PCODE SA10D ADAAG 91 4.1.3(16) ADA 2010 216.4.1 CBC 2007 1011.3 CBC 2019 11B-216.4.1	7	JOB	\$270	\$1,890
						Priority 1 Severity 3

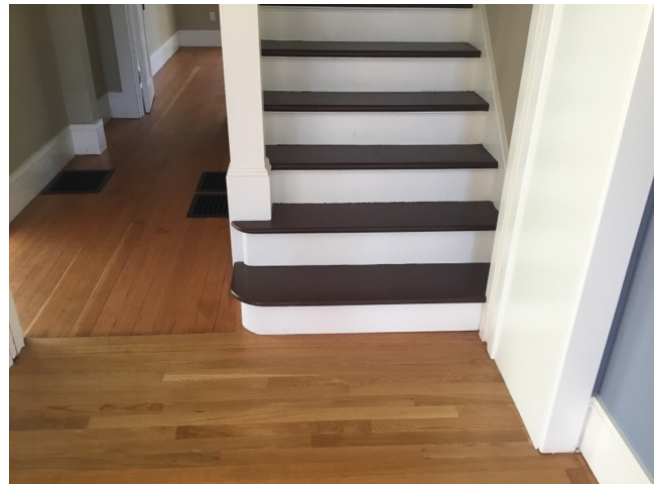
2403	<ul style="list-style-type: none"> As-Built Description: The leading 2" of the tread does not have visual contrast of dark-on-light or light-on-dark from the remainder of the tread. Proposed Solution: Provide 2" min., 4" max. wide contrasting color strip 1" max. from nosing on top & bottom treads when altering area. 	<p>PCODE II02B</p> <p>ADA 2010 504.4</p> <p>CBC 2007 1133B.4.4</p> <p>CBC 2019 11B-504.4.1</p>	16	LF	\$42	\$672
------	---	--	----	----	------	-------

Priority 3

Severity 3

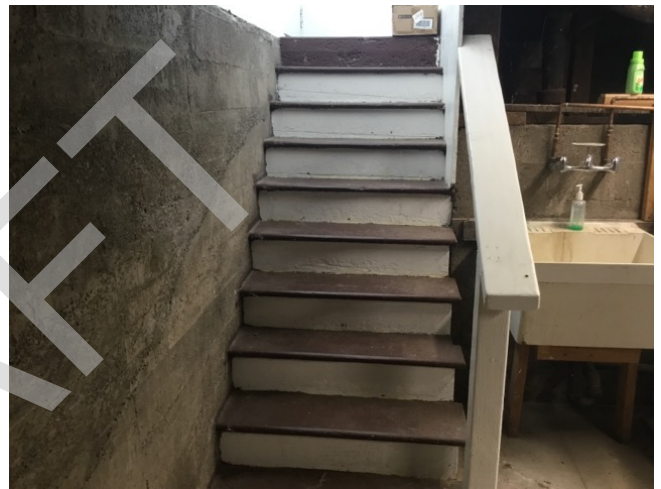
Item no., Rm no. and Name	Existing Architectural Barrier and Proposed Solution	Codes / Mitigation Info	Qty	Unit	Cost	Total
Stairways						
2397	<ul style="list-style-type: none"> As-Built Description: Exterior stair substantially out of compliance. As-Built: Consider technical feasibility. Proposed Solution: Provide complete new stair, 4 ft. wide with landing and handrails. 	PCODE EC09 ADAAG 91 4.9 ADA 2010 504 CBC 2007 1133B.4 CBC 2019 11B-504	100	IN	\$270	\$27,000
					Priority	3
					Severity	3

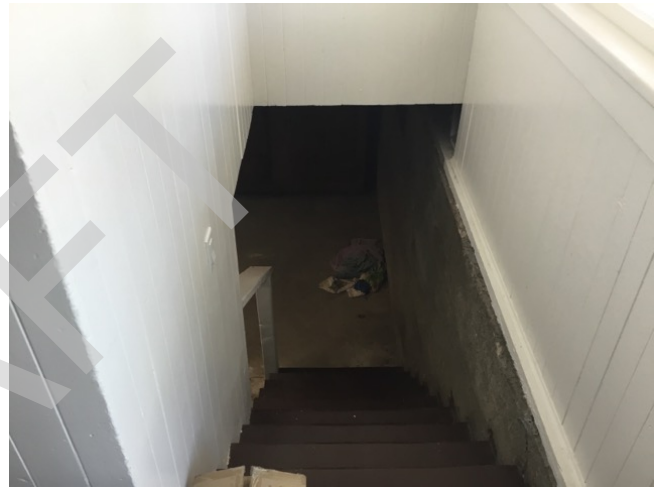
2396	<ul style="list-style-type: none"> • <i>As-Built Description:</i> Overhead clearance less than 80" above finished floor. • <i>As-Built:</i> 68.5" • <i>Proposed Solution:</i> Alter headroom. • <i>Notes:</i> Consider technical feasibility. Consider equivalent facilitation. Occurs at stairs to basement. 	PCODE EG01A	8	LF	\$300	\$2,400
		ADAAG 91 4.4.2				
		ADA 2010 307.4				
		CBC 2007 1133B.8.6.2				
		CBC 2019 11B-307.4				
						Priority 3 Severity 3

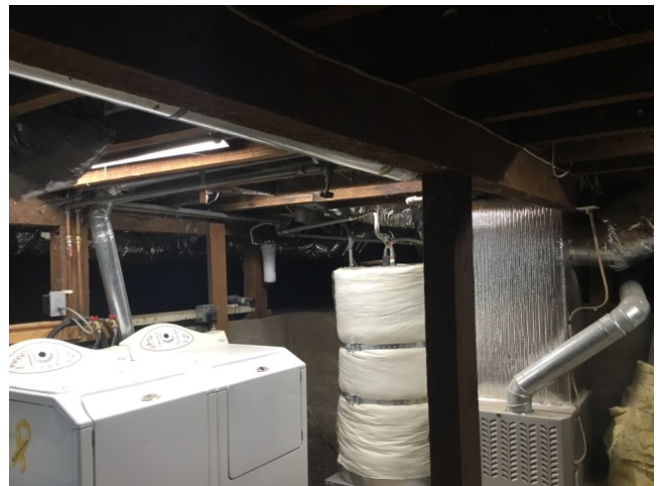
2399	<ul style="list-style-type: none"> • <i>As-Built Description:</i> Overhead clearance less than 80" above finished floor. • <i>As-Built:</i> 73" • <i>Proposed Solution:</i> Dig out the basement. • <i>Notes:</i> Consider technical feasibility. 	PCODE EG01A	1	JOB	?	\$120,000
		ADAAG 91 4.4.2				
		ADA 2010 307.4				
		CBC 2007 1133B.8.6.2				
		CBC 2019 11B-307.4				
						Priority 3 Severity 3

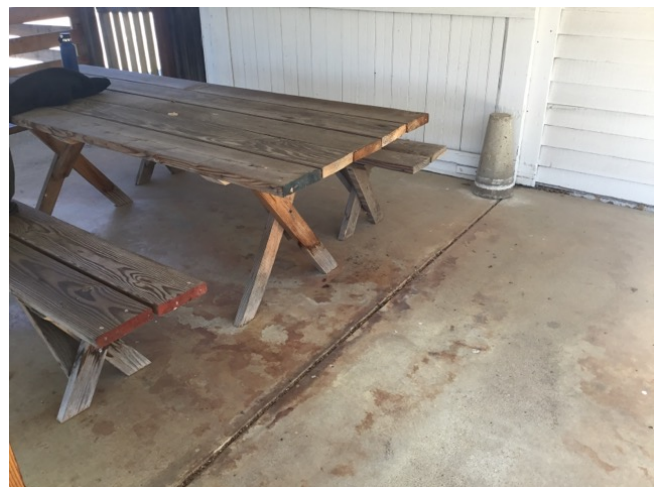
2414 • *As-Built Description:*
Accessible non-fixed table or desk (top 28" to 34" high; knee space at least 27" high x 19" deep x 30" wide) not provided.

Provide table or desk with accessible dimensions when purchasing new furniture.

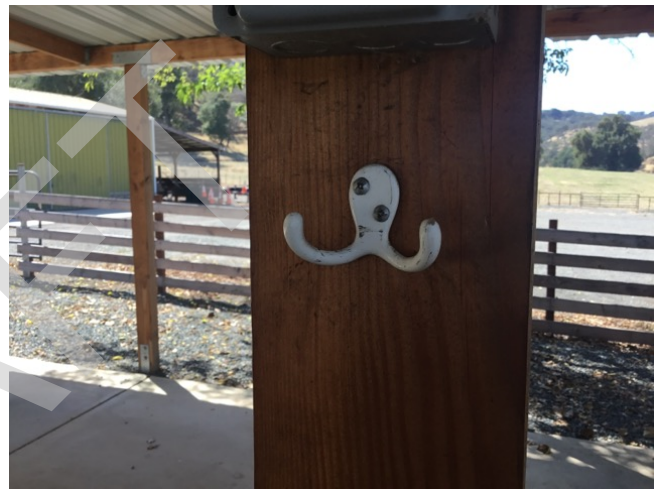
Item no., Rm no. and Name	Existing Architectural Barrier and Proposed Solution	Codes / Mitigation Info	Qty	Unit	Cost	Total
Reach Range						
2416	<ul style="list-style-type: none"> As-Built Description: Reach height to control or access point, where side approach is available, exceeds 48" or is less than 15" in height, or exceeds 10" in depth. As-Built: 61" Proposed Solution: Modify equipment or mounting. 	PCODE IE02 ADAAG 91 4.2.6 ADA 2010 308.3.1 CBC 2007 1118B.6 CBC 2019 11B-308.3	1	JOB	\$300	\$300
						Priority 3
						Severity 3

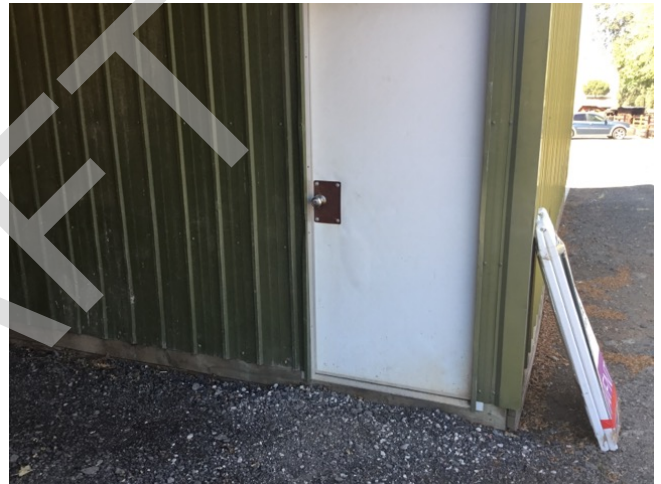
<p>2420</p> <ul style="list-style-type: none"> • <i>As-Built Description:</i> Door does not have accessible operating hardware. • <i>Proposed Solution:</i> Provide lever handle or other accessible hardware. • <i>Notes:</i> See exceptions for machinery spaces. 	<p>PCODE ID07</p> <p>ADAAG 91 4.13.9</p> <p>ADA 2010 404.2.7</p> <p>CBC 2007 1133B.2.5.2</p> <p>CBC 2019 11B-404.2.7</p>	<p>1 JOB \$750 \$750</p> <p>Priority 1</p> <p>Severity 3</p>
--	--	---

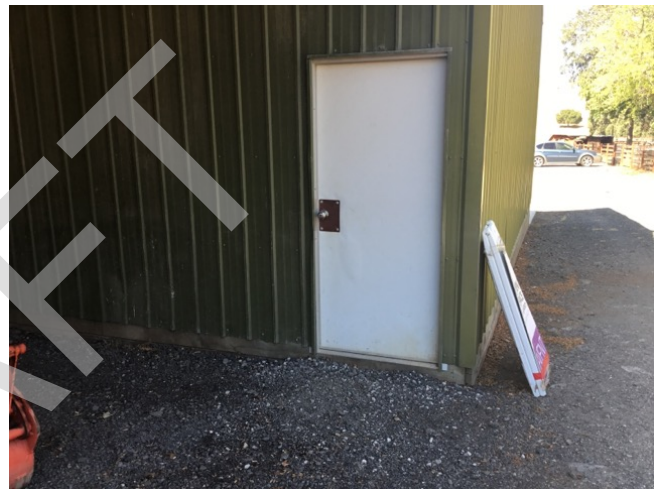
2419	<ul style="list-style-type: none"> • <i>As-Built Description:</i> Door inaccessible due to threshold or step at door exceeding 1/2". • <i>As-Built:</i> 4" • <i>Proposed Solution:</i> Modify threshold to be no more than 1/2" by removing existing paving at door and providing landing with edge ramping (slope 1:20 max). • <i>Notes:</i> See exceptions for machinery spaces. Verify whether this is to remain a machinery space/maintenance facility and whether there is public access. 	<p>PCODE ID02A</p> <p>ADAAG 91 4.13.8</p> <p>ADA 2010 404.2.5</p> <p>CBC 2007 1133B.2.4.1</p> <p>CBC 2019 11B-404.2.5</p>	1	JOB	\$1,200	\$1,200
						<p>Priority 1</p> <p>Severity 1</p>

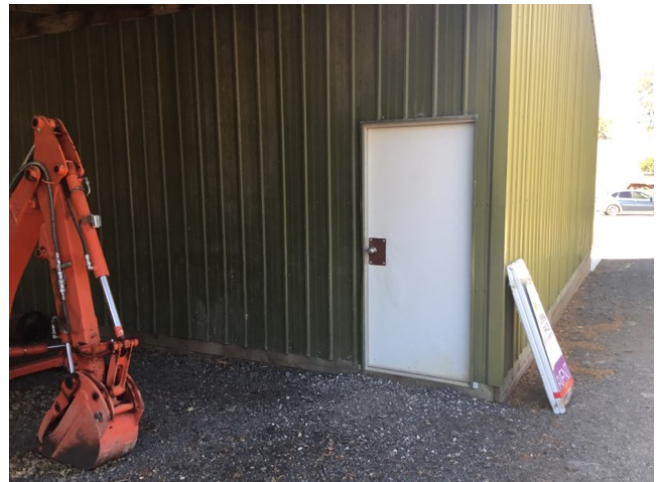
2418	<ul style="list-style-type: none"> • <i>As-Built Description:</i> At time of survey, room was locked and could not be accessed. • <i>Proposed Solution:</i> Verify elements in room are compliant with ADA. 	<p>PCODE XA03</p> <p>CBC 2019 11B-403.5.1.3</p>		REF		
						<p>Priority 3</p> <p>Severity 3</p>

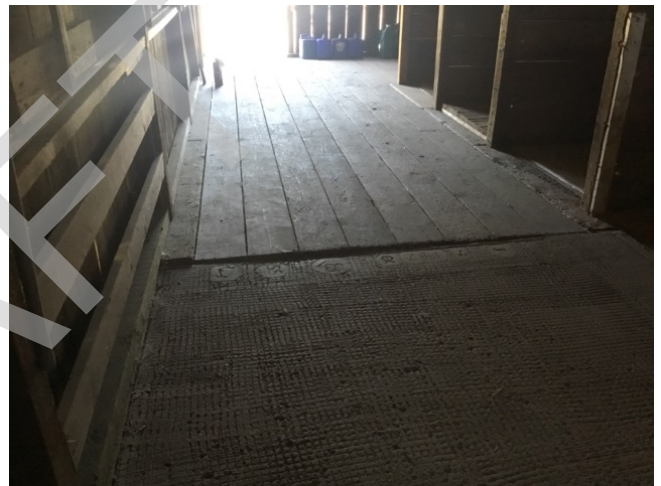
- 2427
- *As-Built Description:*
Walk: Pavement dislocation creates abrupt change in level exceeding 1/2" in accessible route.
 - *As-Built:* **1"**
 - *Proposed Solution:*
Remove, replace or repair area of pavement sufficient to correct abrupt change in level.

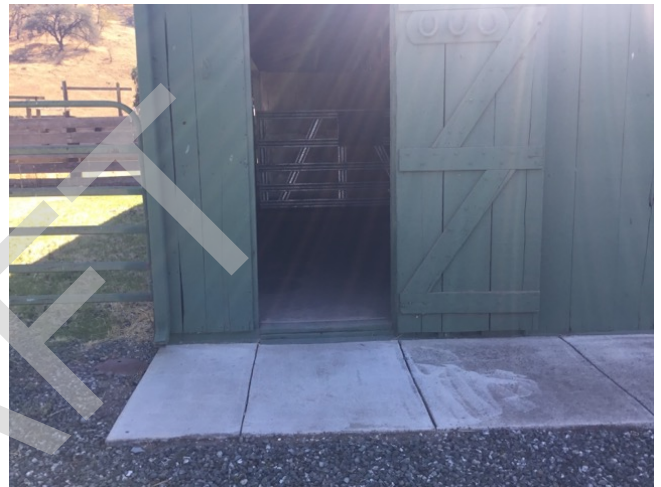
Item no., Rm no. and Name	Existing Architectural Barrier and Proposed Solution	Codes / Mitigation Info	Qty	Unit	Cost	Total
2425	<ul style="list-style-type: none"> • <i>As-Built Description:</i> Surface of required maneuvering clearance at door slopes more than 1/4":12" (2.0%). • <i>As-Built:</i> 2.8%-4% • <i>Proposed Solution:</i> Modify surface slope at door. 	PCODE ID11 ADAAG 91 4.13.6 ADA 2010 404.2.4.4 CBC 2007 1133B.2.4 CBC 2019 11B-404.2.4	20	SF	\$120	\$2,400
						Priority 1 Severity 3

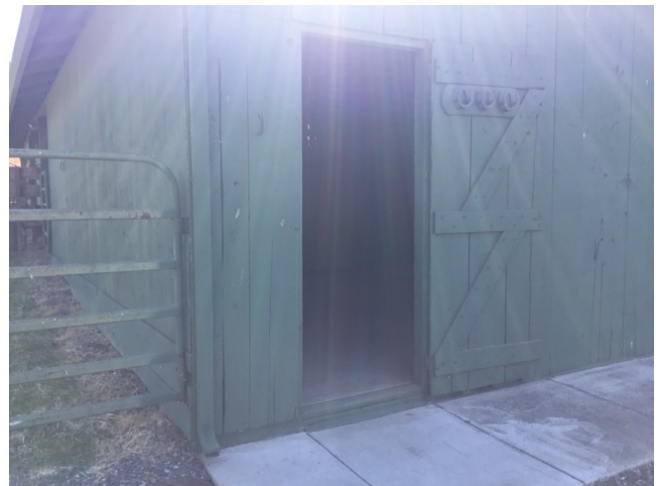
2422	<ul style="list-style-type: none"> • <i>As-Built Description:</i> Door inaccessible due to threshold or step at door exceeding 1/2". • <i>As-Built:</i> 5" • <i>Proposed Solution:</i> Modify threshold to be no more than 1/2" by removing existing paving at door and providing landing with edge ramping (slope 1:20 max). 	PCODE ID02A ADAAG 91 4.13.8 ADA 2010 404.2.5 CBC 2007 1133B.2.4.1 CBC 2019 11B-404.2.5	1	JOB	\$1,200	\$1,200
						Priority 1 Severity 1

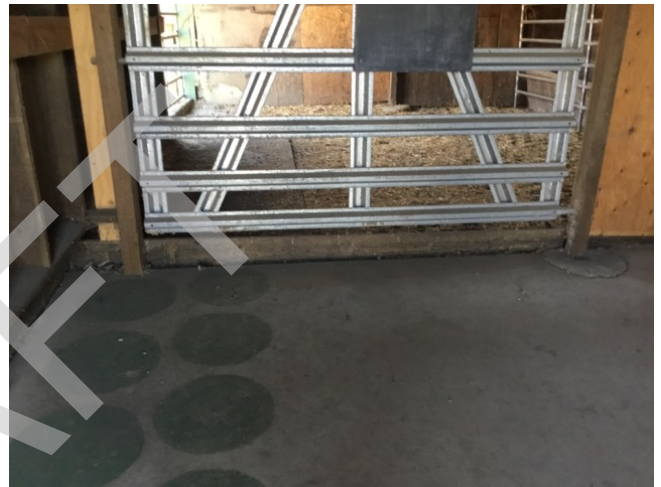
Item no., Rm no. and Name	Existing Architectural Barrier and Proposed Solution	Codes / Mitigation Info	Qty	Unit	Cost	Total
2423	<ul style="list-style-type: none"> • <i>As-Built Description:</i> Door inaccessible due to threshold or step at door exceeding 1/2". • <i>Proposed Solution:</i> Modify threshold. 	PCODE ID02A ADAAG 91 4.13.8 ADA 2010 404.2.5 CBC 2007 1133B.2.4.1 CBC 2019 11B-404.2.5	1	JOB	\$1,200	\$1,200
						Priority 1 Severity 1

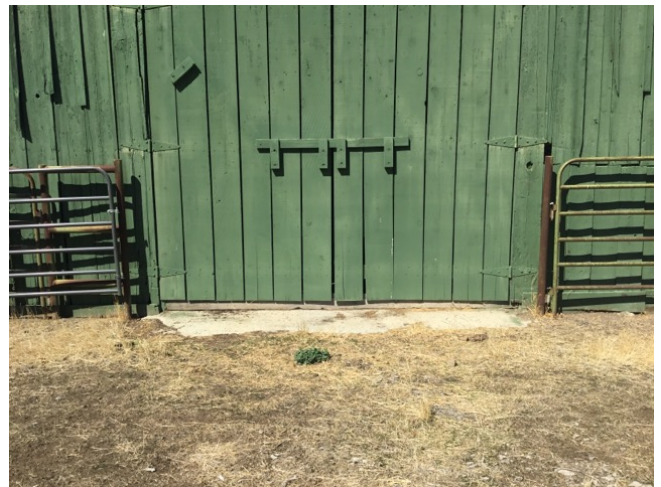
2430	<ul style="list-style-type: none"> • <i>As-Built Description:</i> Door inaccessible due to threshold or step at door exceeding 1/2". • <i>As-Built:</i> 7" • <i>Proposed Solution:</i> Modify threshold. 	PCODE ID02A ADAAG 91 4.13.8 ADA 2010 404.2.5 CBC 2007 1133B.2.4.1 CBC 2019 11B-404.2.5	1	JOB	\$1,200	\$1,200
						Priority 1 Severity 1

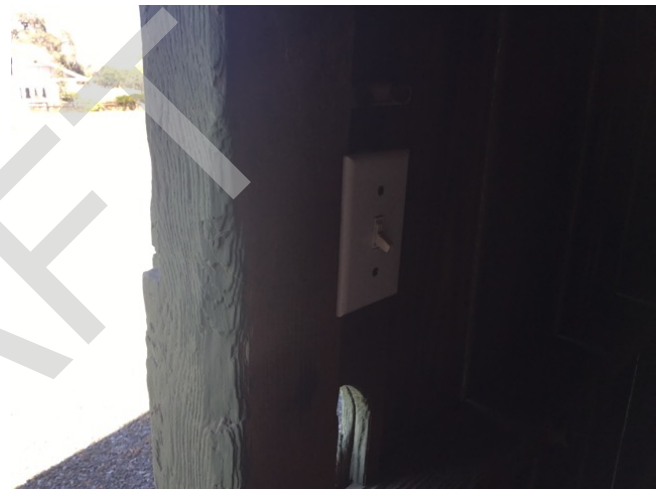
2429	<ul style="list-style-type: none"> • <i>As-Built Description:</i> Electric switch or control mounted less than 15" measured to the bottom of the outlet box or greater than 48 inches measured to the top of the outlet box. • <i>As-Built:</i> 54" • <i>Proposed Solution:</i> Relocate light switches or control to between 15" and 48" height. • <i>Notes:</i> 11B-203.12 Animal containment areas Recommendation. 	<p>PCODE IC01</p> <p>ADAAG 91 4.2.5 & 6</p> <p>ADA 2010 308.2.1 &</p> <p>CBC 2007 1117B.6.3</p> <p>CBC 2019 11B-308.2.1 & 11B-308.2.2</p>	1	JOB	\$900	\$900
------	---	---	---	-----	-------	-------
